II Manor House

2.6.2 OUTER COURT

16 East–West Barn

17 North-South Barn

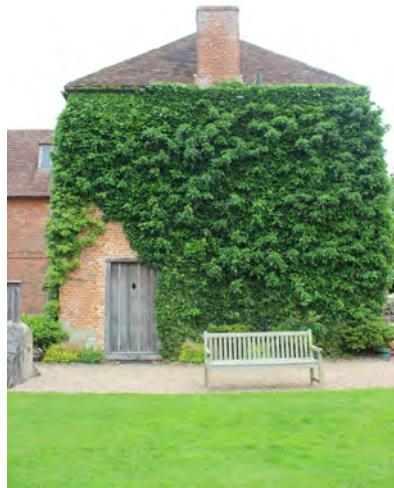
Whilst the rear (north) elevation of the main range, is also built in red brick with a chamfered stone plinth, this elevation retains 16th century elements including two round-headed windows at first floor and a blocked rectangular ground-floor window with a chamfered brick architrave and brick cornice. The attic features two dormer windows. The west elevation is also in brick with a stone plinth, although this is damaged in places. Ivy obscures most of the west elevation.

Figure 43: View of the west elevation of the main range which is largely obscured by ivy

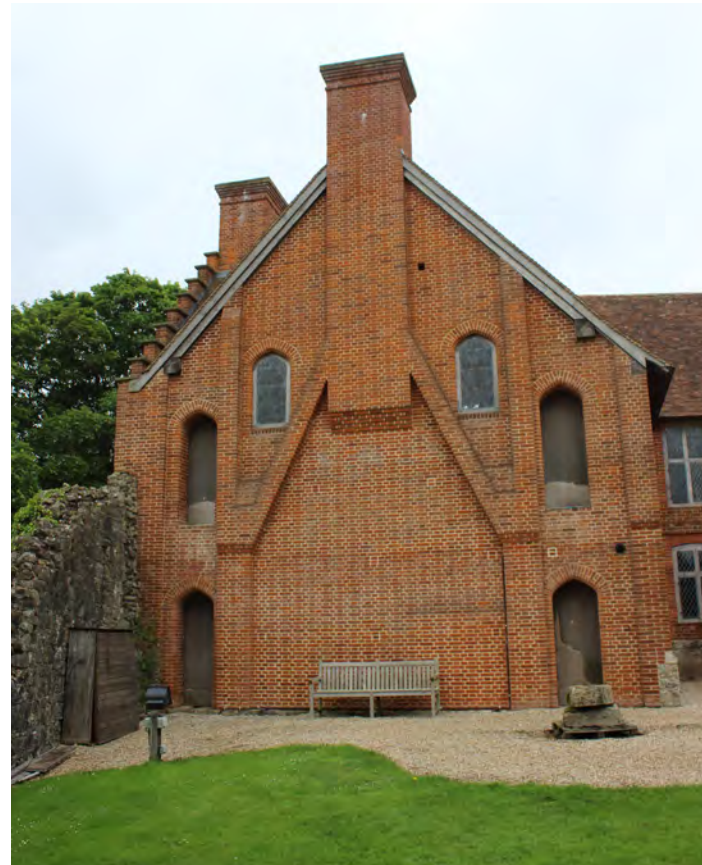
The 'Tudor Kitchen' Extension (north range), constructed by the former private owner in 2002-2004, abuts the north end of the rear wing and follows the footprint of an earlier north range. The range is a red brick and timber-framed construction in the Tudor style with a pitched, tile roof. The gable end features a central chimney stack and a number of boarded openings, indicating the range has not been completed.

Figure 51: View of the west gable end of the modern north range

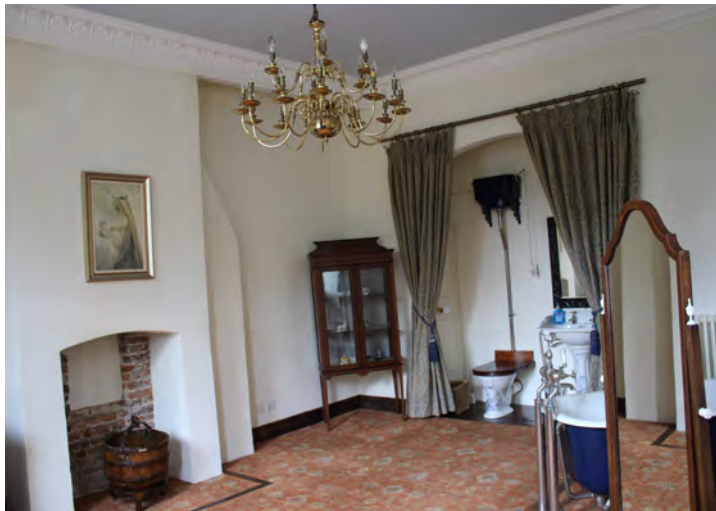
Figure 58: View of part of the bridal preparation suite at first floor showing modern corning poorly applied across the chimney breast

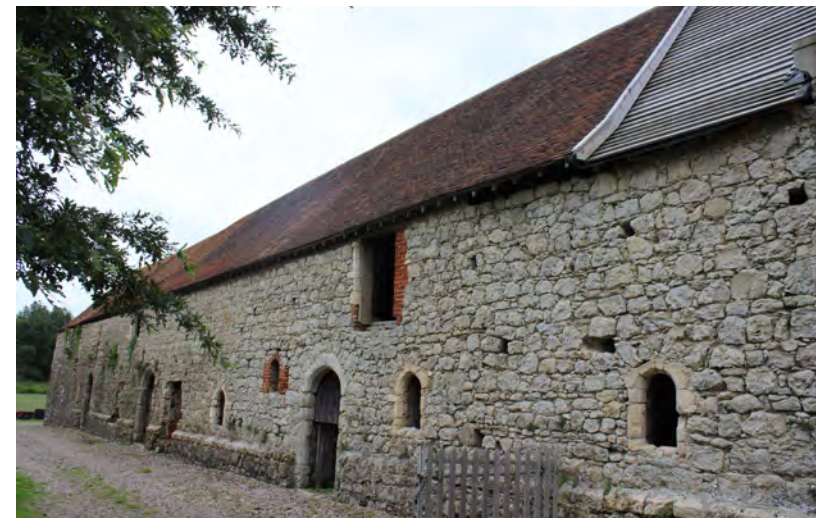
The east-west barn is constructed in roughly coursed, galleted ragstone with a chamfered stone plinth, which terminates at the west end of the south elevation. The plain tile roof features a short section at the east end with a higher ridge, abutting the roof of the attached north-south range; this section is currently not tiled. The east-west range was not included in the early 21st century renovation of its counterpart range and is in poor condition.

Figure 85: View of the south elevation looking north-west showing piecemeal fenestration and a section of untiled roof

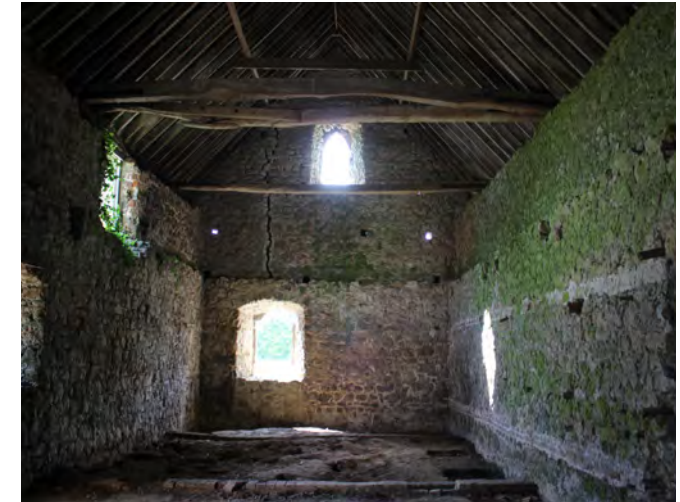
The barn is in disrepair and its condition is deteriorating; walls are leaning and cracked in places, ivy is eroding features and the timber joist floor to the loft is unsound.

Figure 91: View of the west room looking east showing historic and later openings and a crack in the west gable

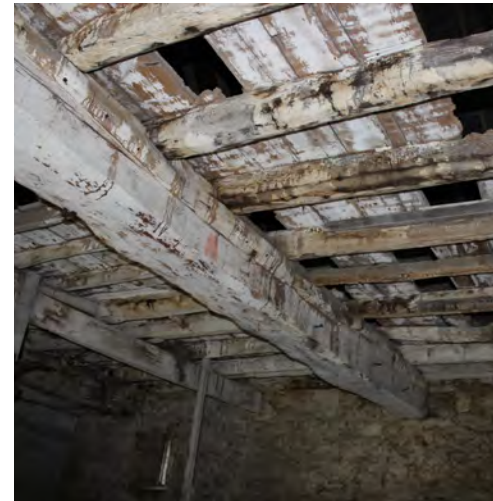
Figure 99: Detail of the timber joist floor above the east room

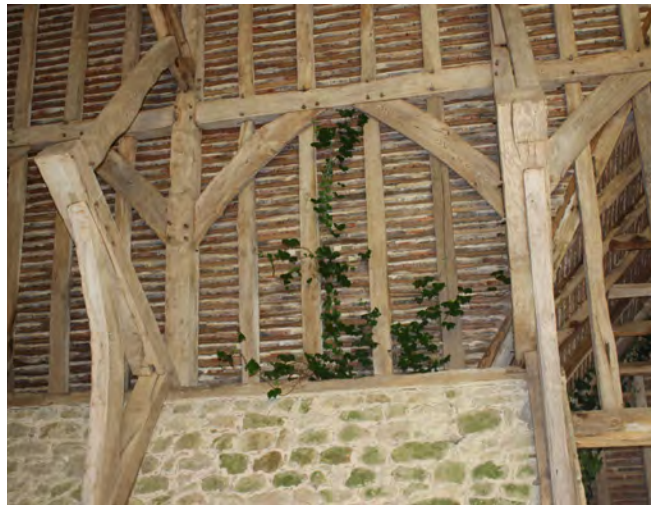
Although the barn's interior is in good condition, ivy is beginning to make its way into the roof structure towards the north end.

Figure 111: Detail of the roof structure towards the north end of the barn showing encroaching ivy
