OTTERPOOL PARK

Environmental Statement Appendix 7.13 - Bat Building
Assessment and Emergence / Re-entry Surveys – Update
to include 2020 and 2021 Survey Data

MARCH 2022

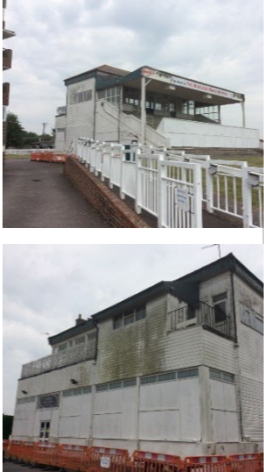
1	1A	1d	Disused two storey utility building (former racecourse spectator sitting area) with associated building	Wood	Absent	Unknown	Unknown	Tiles	Fibre/wood boards	27/06/2017	Hardstanding, arena buildings, improved grassland near to Castle & grounds with mature trees	Yes	Yes	Largely unmaintained building with rotten wood fascia with several gaps leading to the wider roof space. Black birds and wood pigeons observed nesting within the roof space

High (potential for significant voids at a stable temperature)	Potential, low	Yes in cluster - 1A	No – surveyed in 2017	In early phases. Surveyed as a cluster with surrounding buildings	No	No change. Very dilapidated	No change

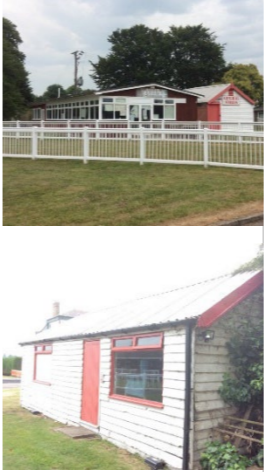
Area Number	Cluster	Building Identification	Building type*	Wall material	Cladding	Wall construction	Hanging tiles	Roof material	Roof lining	Date of assessment	Surrounding habitat	Access for external survey requested	External access permitted	Features and signs	Photograph	Summer roost Potential	Hibernation potential assessment	Surveyed in 2017?	Surveyed in 2018?	Rationale (2018)	Roost(Y/N/P)	2020	2021
1	1B	1e	Disused two single storey utility buildings (former Jazz bar and general storage)	Wood	Absent	Unknown	Absent	Mixed felt and corrugated fibreboard / metal	Fibre/wood boards	27/06/2017	Hardstanding, arena buildings, improved grassland near to Castle & grounds with mature trees	Yes	Yes	Gaps present within the soffit potentially leading into the roof space were present. Open vent present and partially open windows also observed

Low (potential for crevice dwelling but no significant roost potential)	Negligible	Yes in Cluster 1B	No – surveyed in 2017	In early phases. Surveyed as a cluster with surrounding buildings	No	Upgraded to Moderate. Holes at cable end allow access.

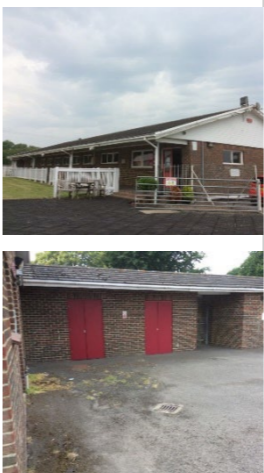
1	1B	1f(a)	Single storey utility building (currently used as office / storage building)	Brick	Absent	Solid	Present	Tiles	Fibre/wood board	27/06/2017	Hardstanding, arena buildings, improved grassland near to Castle & grounds with mature trees	Yes	Yes	Some tiles slightly lifted potentially leading into the roof space. Some gaps observed within the wooden fascia boards

Moderate (potential for significant voids at a stable temperature)	Negligible	Yes in Cluster 1B	No – surveyed in 2017	In early phases. Surveyed as a cluster with surrounding buildings	Probable entry of soprano pipistrelle	No change	No change
1	1B	1f(b)	Two storeys residential building	Brick	Absent	Solid	Absent	Tiles	Unknown	27/06/2017	Hardstanding, arena buildings, improved grassland near to Castle & grounds with mature trees	Yes	Yes	Well maintained large residential building with no obvious features observed but due to size and location, low potential was considered

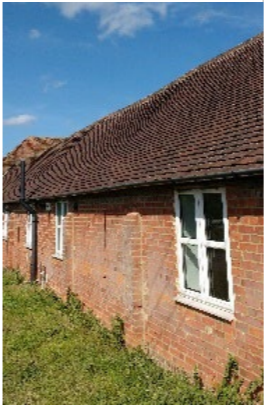
Area Number	Cluster	Building Identification	Building type*	Wall material	Cladding	Wall construction	Hanging tiles	Roof material	Roof lining	Date of assessment	Surrounding habitat	Access for external survey requested	External access permitted	Features and signs	Photograph	Summer roost Potential	Hibernation potential assessment	Surveyed in 2017?	Surveyed in 2018?	Rationale (2018)	Roost(Y/N/P)	2020	2021
3	3A	3b	Single storey farm building	Brick	Absent	Solid	Absent	Tiles	Unknown	12/07/2017	Active farm with mature trees, a small pond, a wet ditch, arable and grazed fields surrounding.	Yes	Yes	Gaps leading to the roof space

High (potential for suitable crevices to be present)	Potential	Yes, in cluster 3A	No – surveyed in 2017	In early phases. Surveyed as a cluster with surrounding buildings	No	No change. Some new boarding up at windows. No significant changes	No change
3	3A	3c	Single storey farm building	Brick	Absent	Unknown	Absent	Tiles	Underfelt	12/07/2017	Active farm with mature trees, a small pond, a wet ditch, arable and grazed fields surrounding.	Yes	Yes	Multiple holes within the soffits

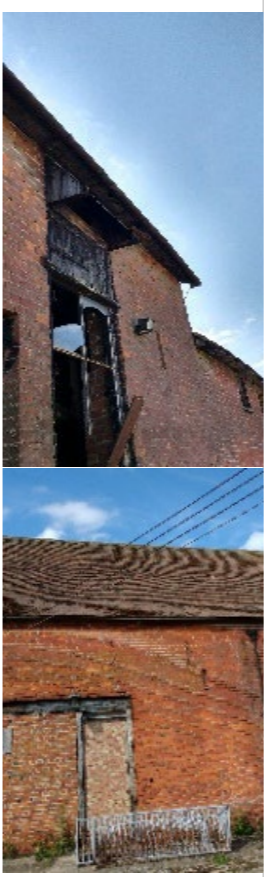
High (potential for suitable crevices to be present)	Potential	Yes, in cluster 3A	No – surveyed in 2017	In early phases. Surveyed as a cluster with surrounding buildings	Y	No change. Some new boarding up at windows. No significant changes	No change

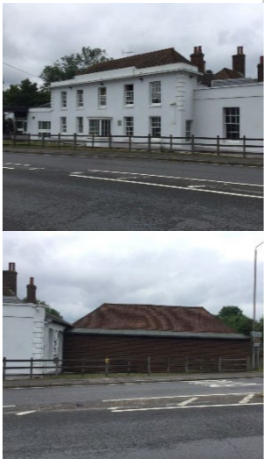
Low	Potential	No	No	Survey not required due to low potential	N/A	No change	No access
5	5A	5c*	Two storey utility building	Brick	Present	Unknown	Absent	Tiles	Unknown	27/06/2017	Hedgerows, hardstanding and grazed and arable fields.	No (outside works area) Roadside inspection	N/A	Only slightly lifted tiles observed

Low (preliminary assessment)	Unknown (off-site)	No	No	Survey not required due to outside works area	N/A	No change	No access, no change visible

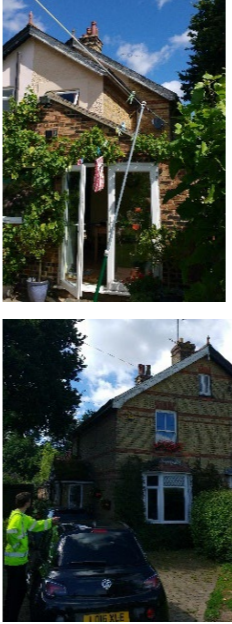
Area Number	Cluster	Building Identification	Building type*	Wall material	Cladding	Wall construction	Hanging tiles	Roof material	Roof lining	Date of assessment	Surrounding habitat	Access for external survey requested	External access permitted	Features and signs	Photograph	Summer roost Potential	Hibernation potential assessment	Surveyed in 2017?	Surveyed in 2018?	Rationale (2018)	Roost(Y/N/P)	2020	2021
											nearby to the west.												
7	7C	7j	Three storey residential building	Brick	Absent	Solid	Present	Tiles	Unknown	28/06/2017, initial inspection, detailed inspection 04/08/2018.	On/near to small industrial estate bordered by arable/improved grassland and residential gardens. Adjacent to A21 road. Tree-lined stream nearby to the west.	Yes	Yes	Cobtree house resident reported a bat roost within the property. The bat roost was reportedly located at the rear of the garage and dead bats were previously found nearby. Access to loft space and into garage through gaps at the eaves and through tiles.

High (known roost)	Potential - likelihood increasing due to presence of brown long-eared bats which hibernate in residential structures.	Yes	No – surveyed in 2017	In early phases	Yes – roost confirmed	No change.	No access, no change visible

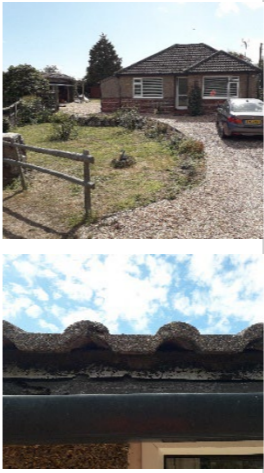
Area Number	Cluster	Building Identification	Building type*	Wall material	Cladding	Wall construction	Hanging tiles	Roof material	Roof lining	Date of assessment	Surrounding habitat	Access for external survey requested	External access permitted	Features and signs	Photograph	Summer roost Potential	Hibernation potential assessment	Surveyed in 2017?	Surveyed in 2018?	Rationale (2018)	Roost(Y/N/P)	2020	2021
15	15A	15a	Residential House, adjacent shed/outbuilding	Brick	No – upper walls are rendered	Cavity - insulated	No	Concrete tiles	Felt	09/08/2018	Residential gardens	Yes	Yes	Some potential oil staining around eaves where access between felt and concrete tiles was possible.

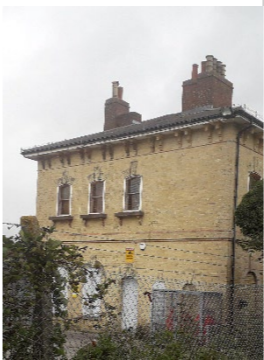
16	16A	16a	Station building	Stone	Absent	Unknown	No	Slate	Unknown	06/10/2016	Railway Carpark	No (to be retained)	N/A	Some small areas of crevice

Moderate	Potential – to be retained	No	No	To be retained	Y – roost recorded within desk study.	No change	No access, no visible change
16	16A	16b	Residential property	Stone	Absent	Unknown	No	Tiles	Unknown	06/10/2016	Racecourse, amenity grassland, farmland.	No	Viewable from on site.	Appears to be recently renovated with roof dwelling spaces.

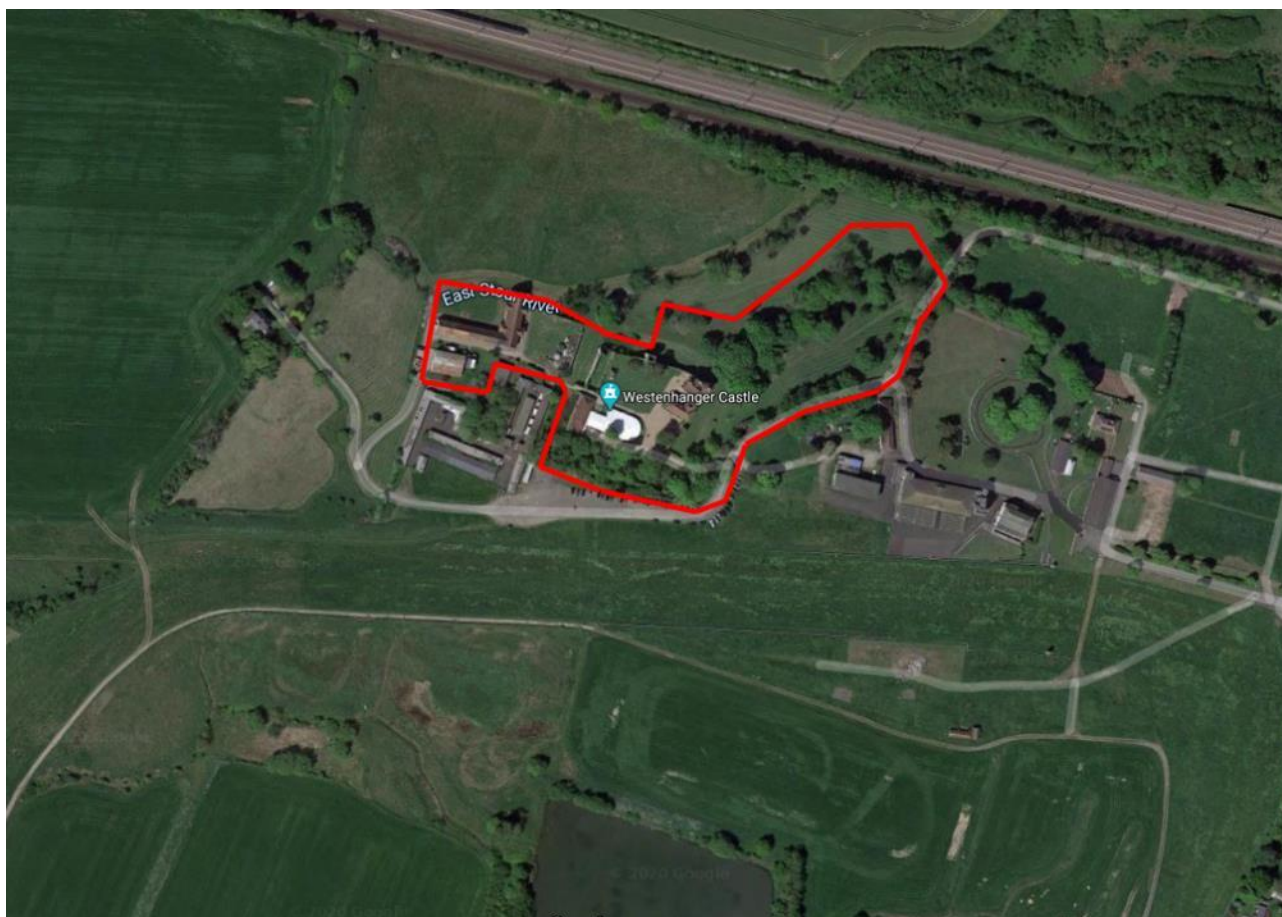
Image 1: Aerial imagery of the site (detailed survey area presented within the red line)

An aerial image illustrating the site and an indicative redline of the area of works is presented in Image 1.

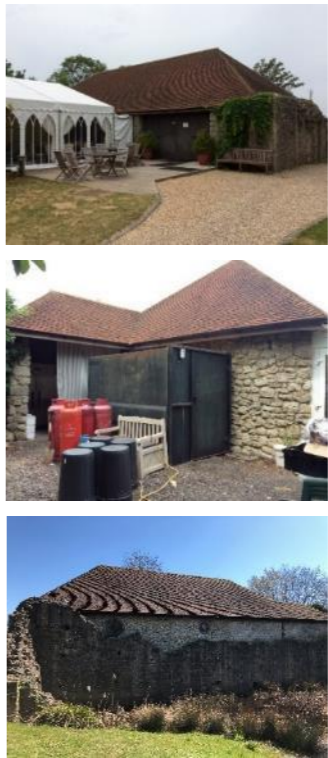
Area & cluster number	Building reference	Building type	Building description	Date of assessment	Surrounding habitat	Internal inspection conducted?	Potential roosting features	Evidence of bats	Photograph	Summer roost potential (initial assessment)	Further survey recommended
2A	2f	Converted barn with marquee attached on the south eastern aspect	<p>Single storey stone building with pitched, tile roof. On southern aspect, there is an outbuilding extension, open on the eastern aspect. This is used for storage.</p> <p>Ridge tiles, brickwork and mortar in good condition and well-sealed.</p> <p>Internally, rooms well-sealed, and no gaps or crevices observed on the ground floor. Within the loft, roof lining boarded, insulation was present within the sloped area of the eaves.</p>	25 March 2020	<p>Scattered trees, small watercourse located to the north and moat containing water on the south east of the structure.</p> <p>Arable and grassland with hedgerows surrounds the complex of buildings in wider landscape.</p>	Yes – building and loft inspection	<p>Large opening in soffit on the south eastern corner of building, above entranceway.</p> <p>Lifted tiles on eastern and southern aspect of building.</p> <p>Gaps under the soffit on the southern aspect of building, in outbuilding extension.</p> <p>Gap on the north east corner of stonework which extends in.</p>	<p>Small number of scattered droppings found within loft, midway along the loft floor on the western aspect and towards the south eastern corner of the loft. Droppings were medium sized and characteristic of Brown Long Eared (BLE)/ <i>Myotis</i> spp.</p> <p>Some potential feeding remains (Peacock butterfly <i>Aglais io</i>) were found towards the south east aspect of the loft; on top of loft insulation.</p>

Confirmed bat roost	Yes – three separate surveys. Two dusk emergence and one dawn re-entry survey.

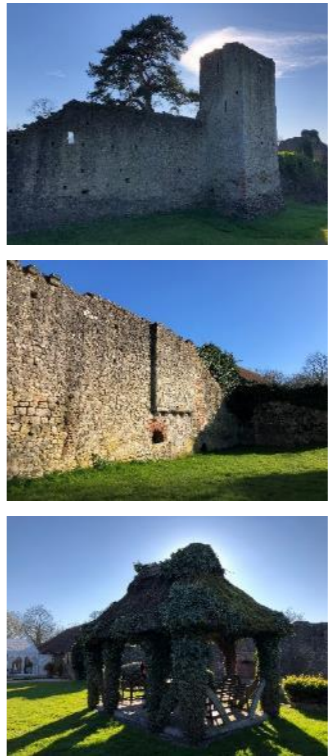
2A	2g	Old castle walls with defensive towers	<p>Stone wall attached to Manor House on the eastern aspect. Two defensive towers are present on the northern extent.</p> <p>Wall is solid stone structure.</p> <p>Small thatched gazebo, with wooden structure located south east of the wall.</p>	25 March 2020	<p>Scattered trees, small watercourse located immediately to the north of structure.</p> <p>Arable and grassland with hedgerows surrounds the complex of buildings in wider landscape.</p>	N/A	<p>Majority of the stonework and mortar forming the wall is in good condition.</p> <p>Openings, where old support beams would have been, extend within stonework.</p> <p>Gazebo had negligible potential to support roosting bats.</p>	N/A

Low	Yes – at least one emergence / re-entry survey

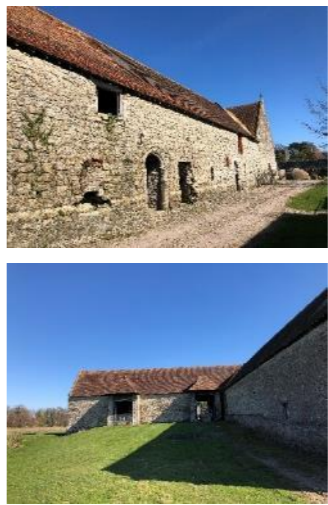
Area & cluster number	Building reference	Building type	Building description	Date of assessment	Surrounding habitat	Internal inspection conducted?	Potential roosting features	Evidence of bats	Photograph	Summer roost potential (initial assessment)	Further survey recommended
2B	2a	Large 'L' shaped farm barn; used for storage.	<p>Stone barn with pitched, tiled roof. Building had open access for all doorways and windows. Large porches with pitched roofs and timber cladding over doorways on the north east and north west aspect of barn.</p> <p>Internally, wooden beams with no roof lining exposing the rafters.</p> <p>Eastern aspect was a large open area within the barn. The south western area of the building had brick walls and a first level floor (in disrepair). In some areas the roof was being repaired and replaced, new roof lining was observed on the southern aspect.</p>	25 March 2020	<p>Scattered trees, small watercourse located immediately to the north of structure.</p> <p>Arable and grassland with hedgerows surrounds the complex of buildings in wider landscape.</p>	Yes – building only	<p>Multiple access points via open doorways and windows observed.</p> <p>Lifted tiles present on all aspects of building.</p> <p>Gaps under eaves between the timber frames and stonework on all aspects of building.</p> <p>Multiple gaps between internal timber frames and joists.</p> <p>On south western aspect of building, cracks and crevices in internal brickwork</p>	<p>Scattered bat droppings were found adjacent to doorway, on top of farm equipment, on the eastern aspect of building. Droppings were of a small size and characteristic of <i>Pipistrellus</i> spp.</p> <p>Potential feeding remains (Peacock butterfly) were found internally, adjacent to the northern building wall.</p>

Confirmed bat roost	<p>Yes – three separate surveys. Two dusk emergence and one dawn re-entry survey.</p>

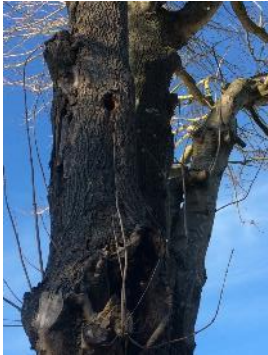
Yes – aerial inspection survey
T2	TR 12324 37129	Maple sp.	Cavity on main stem 2m from ground on E aspect. Pruning cut 5-6m from ground on S aspect	Moderate

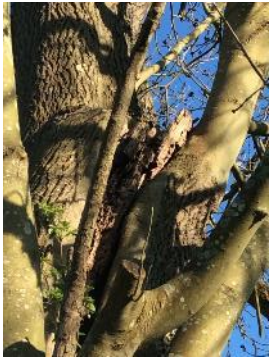
Tree reference	Grid reference	Species	Description of feature(s)	Bat roosting potential	Photograph	Further survey recommended
T10	TR 12357 37211	Ash	Tear out on main stem which may extend into cavity, 2-3m high, on NW aspect	Moderate

Yes – aerial inspection survey

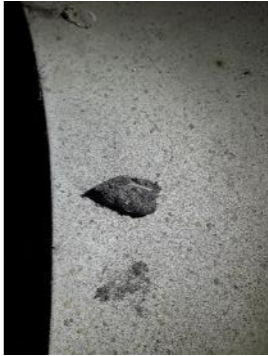
<p>Barn owl pellet</p>	Further survey work may be required in relation to barn owls and any renovation works on Building 2a. This would involve determining if the building is occupied by barn owl when works are scheduled to take place.

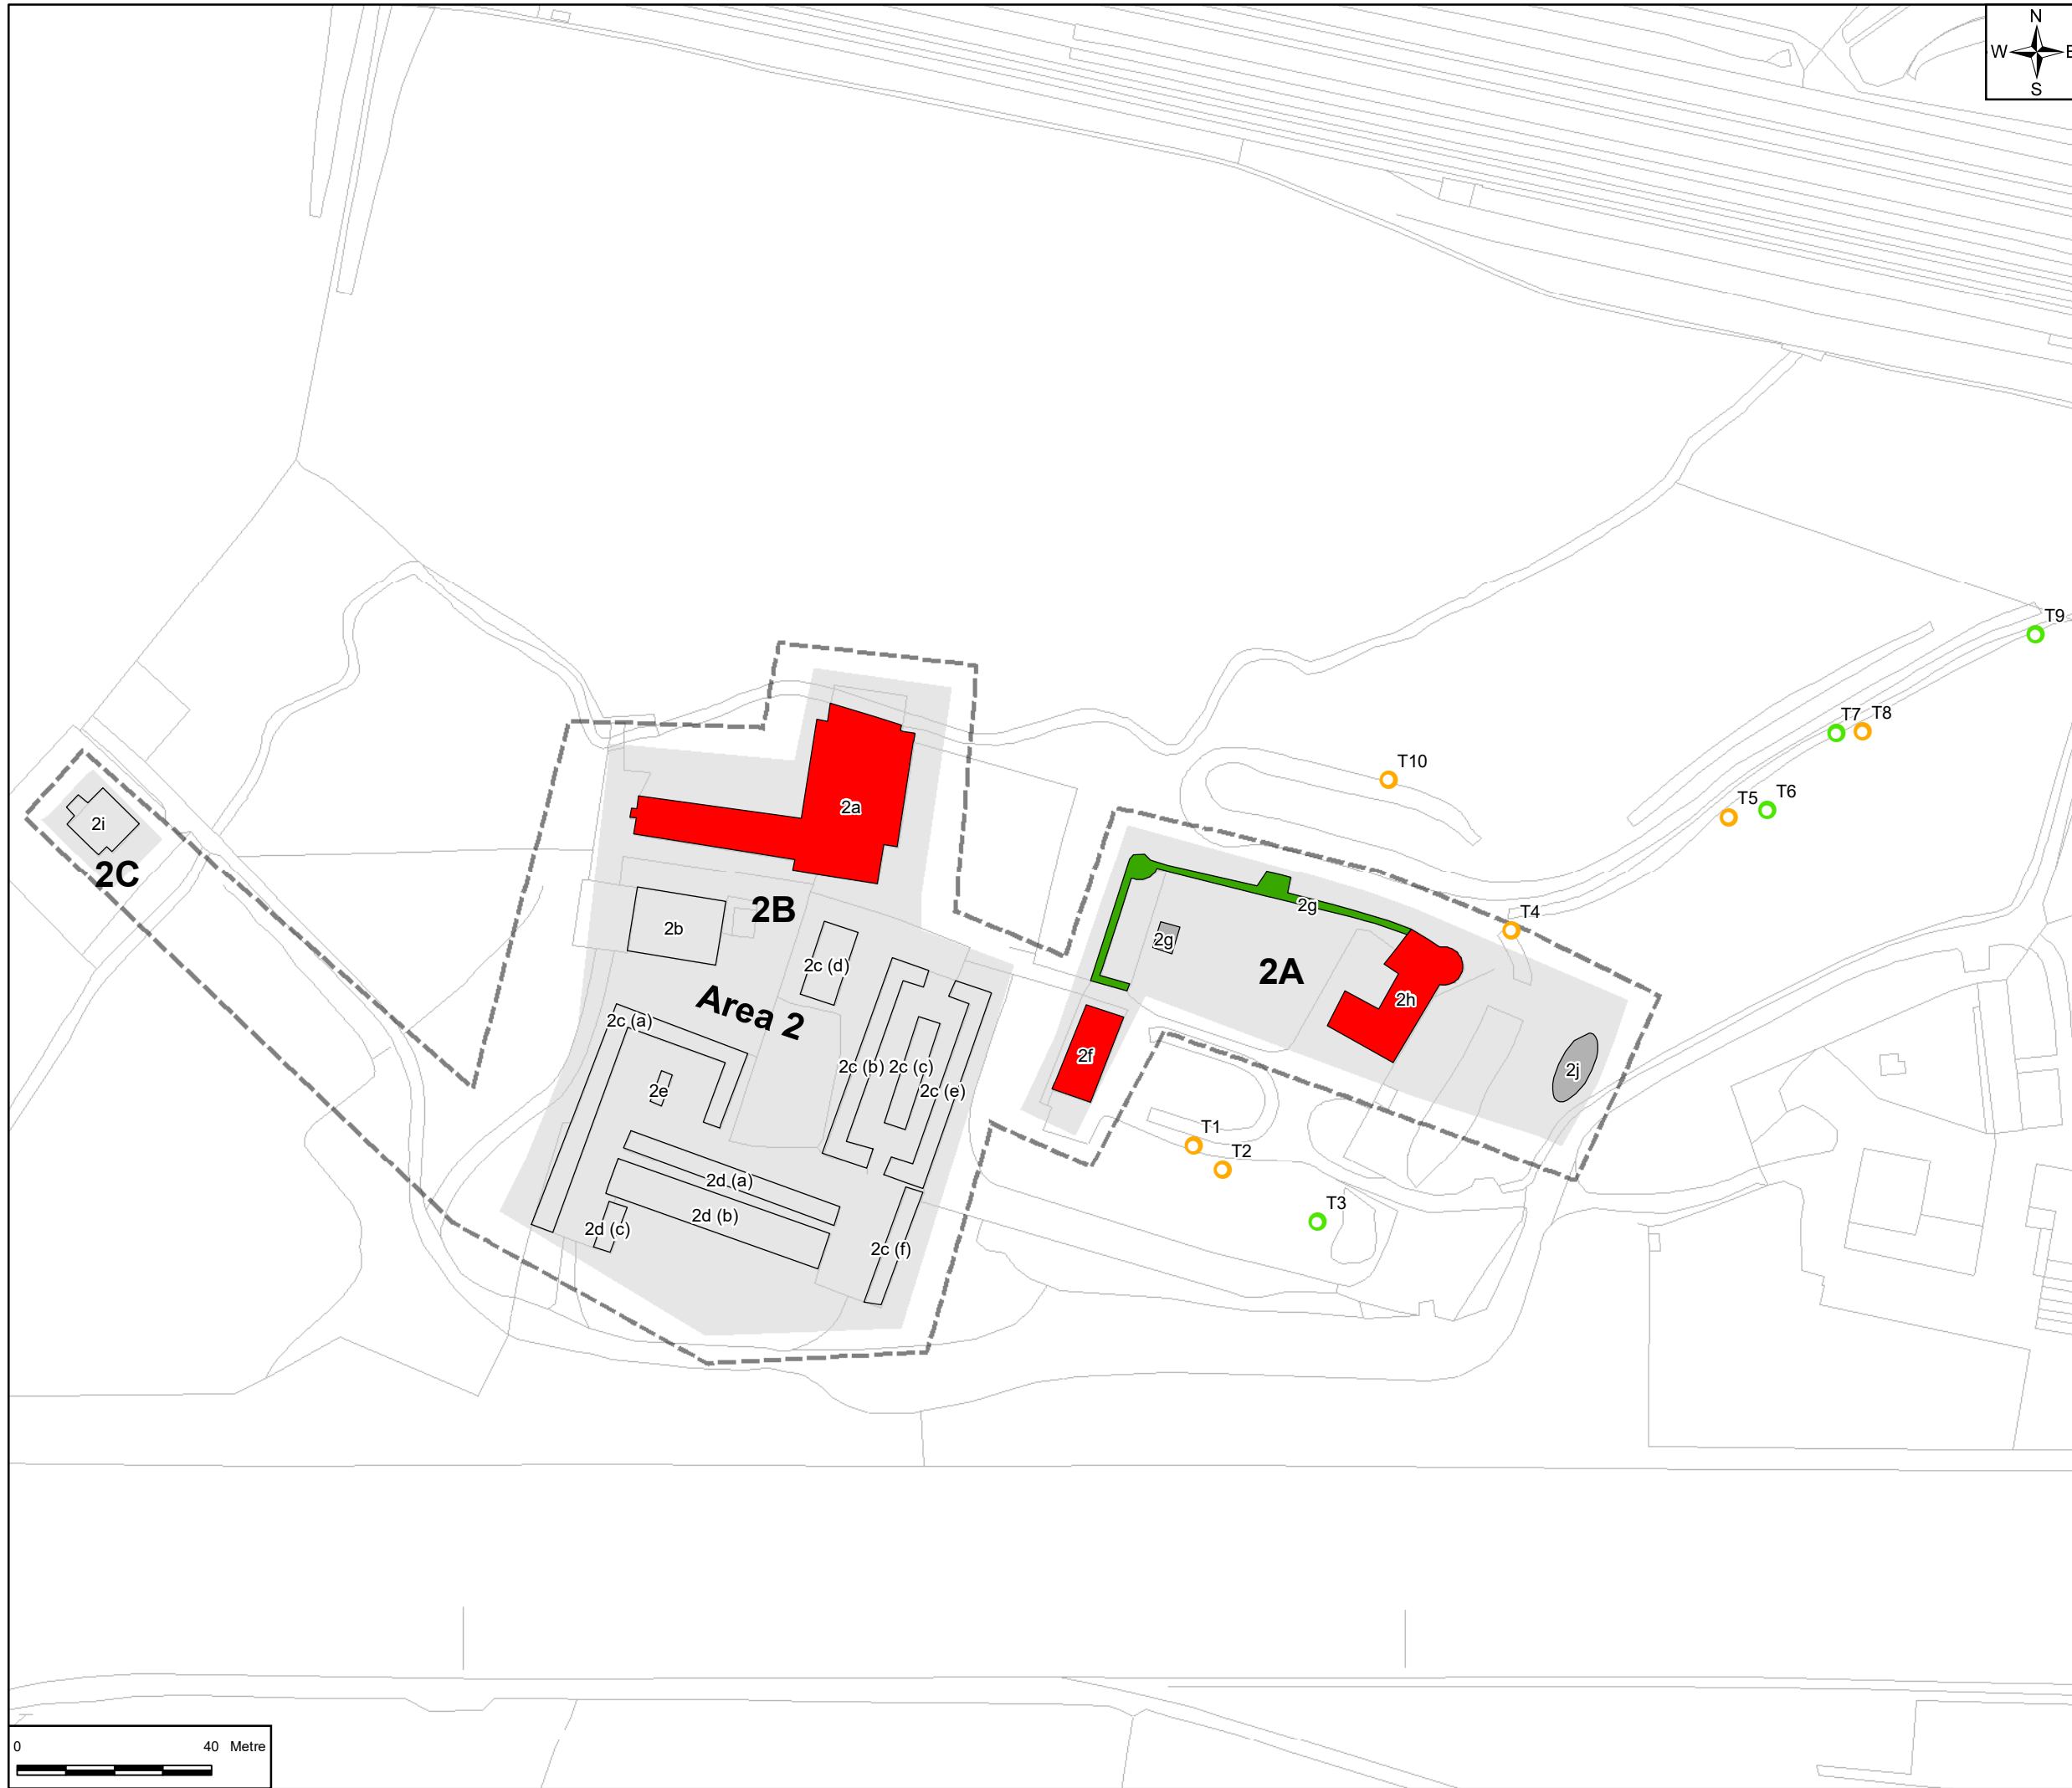
Figure 2: Ground-based Tree Assessment Results 2020

N.B. Access to the entire site has not been possible. This is a draft habitat map only. Not all trees are individually mapped and some areas have been mapped from aerial only.

- Area
- Cluster
- Building with confirmed bat roosts
- Structure with low summer roosting potential
- Structure with negligible summer roosting potential
- Buildings not surveyed
- Trees with low bat roosting potential
- Trees with moderate bat roosting potential

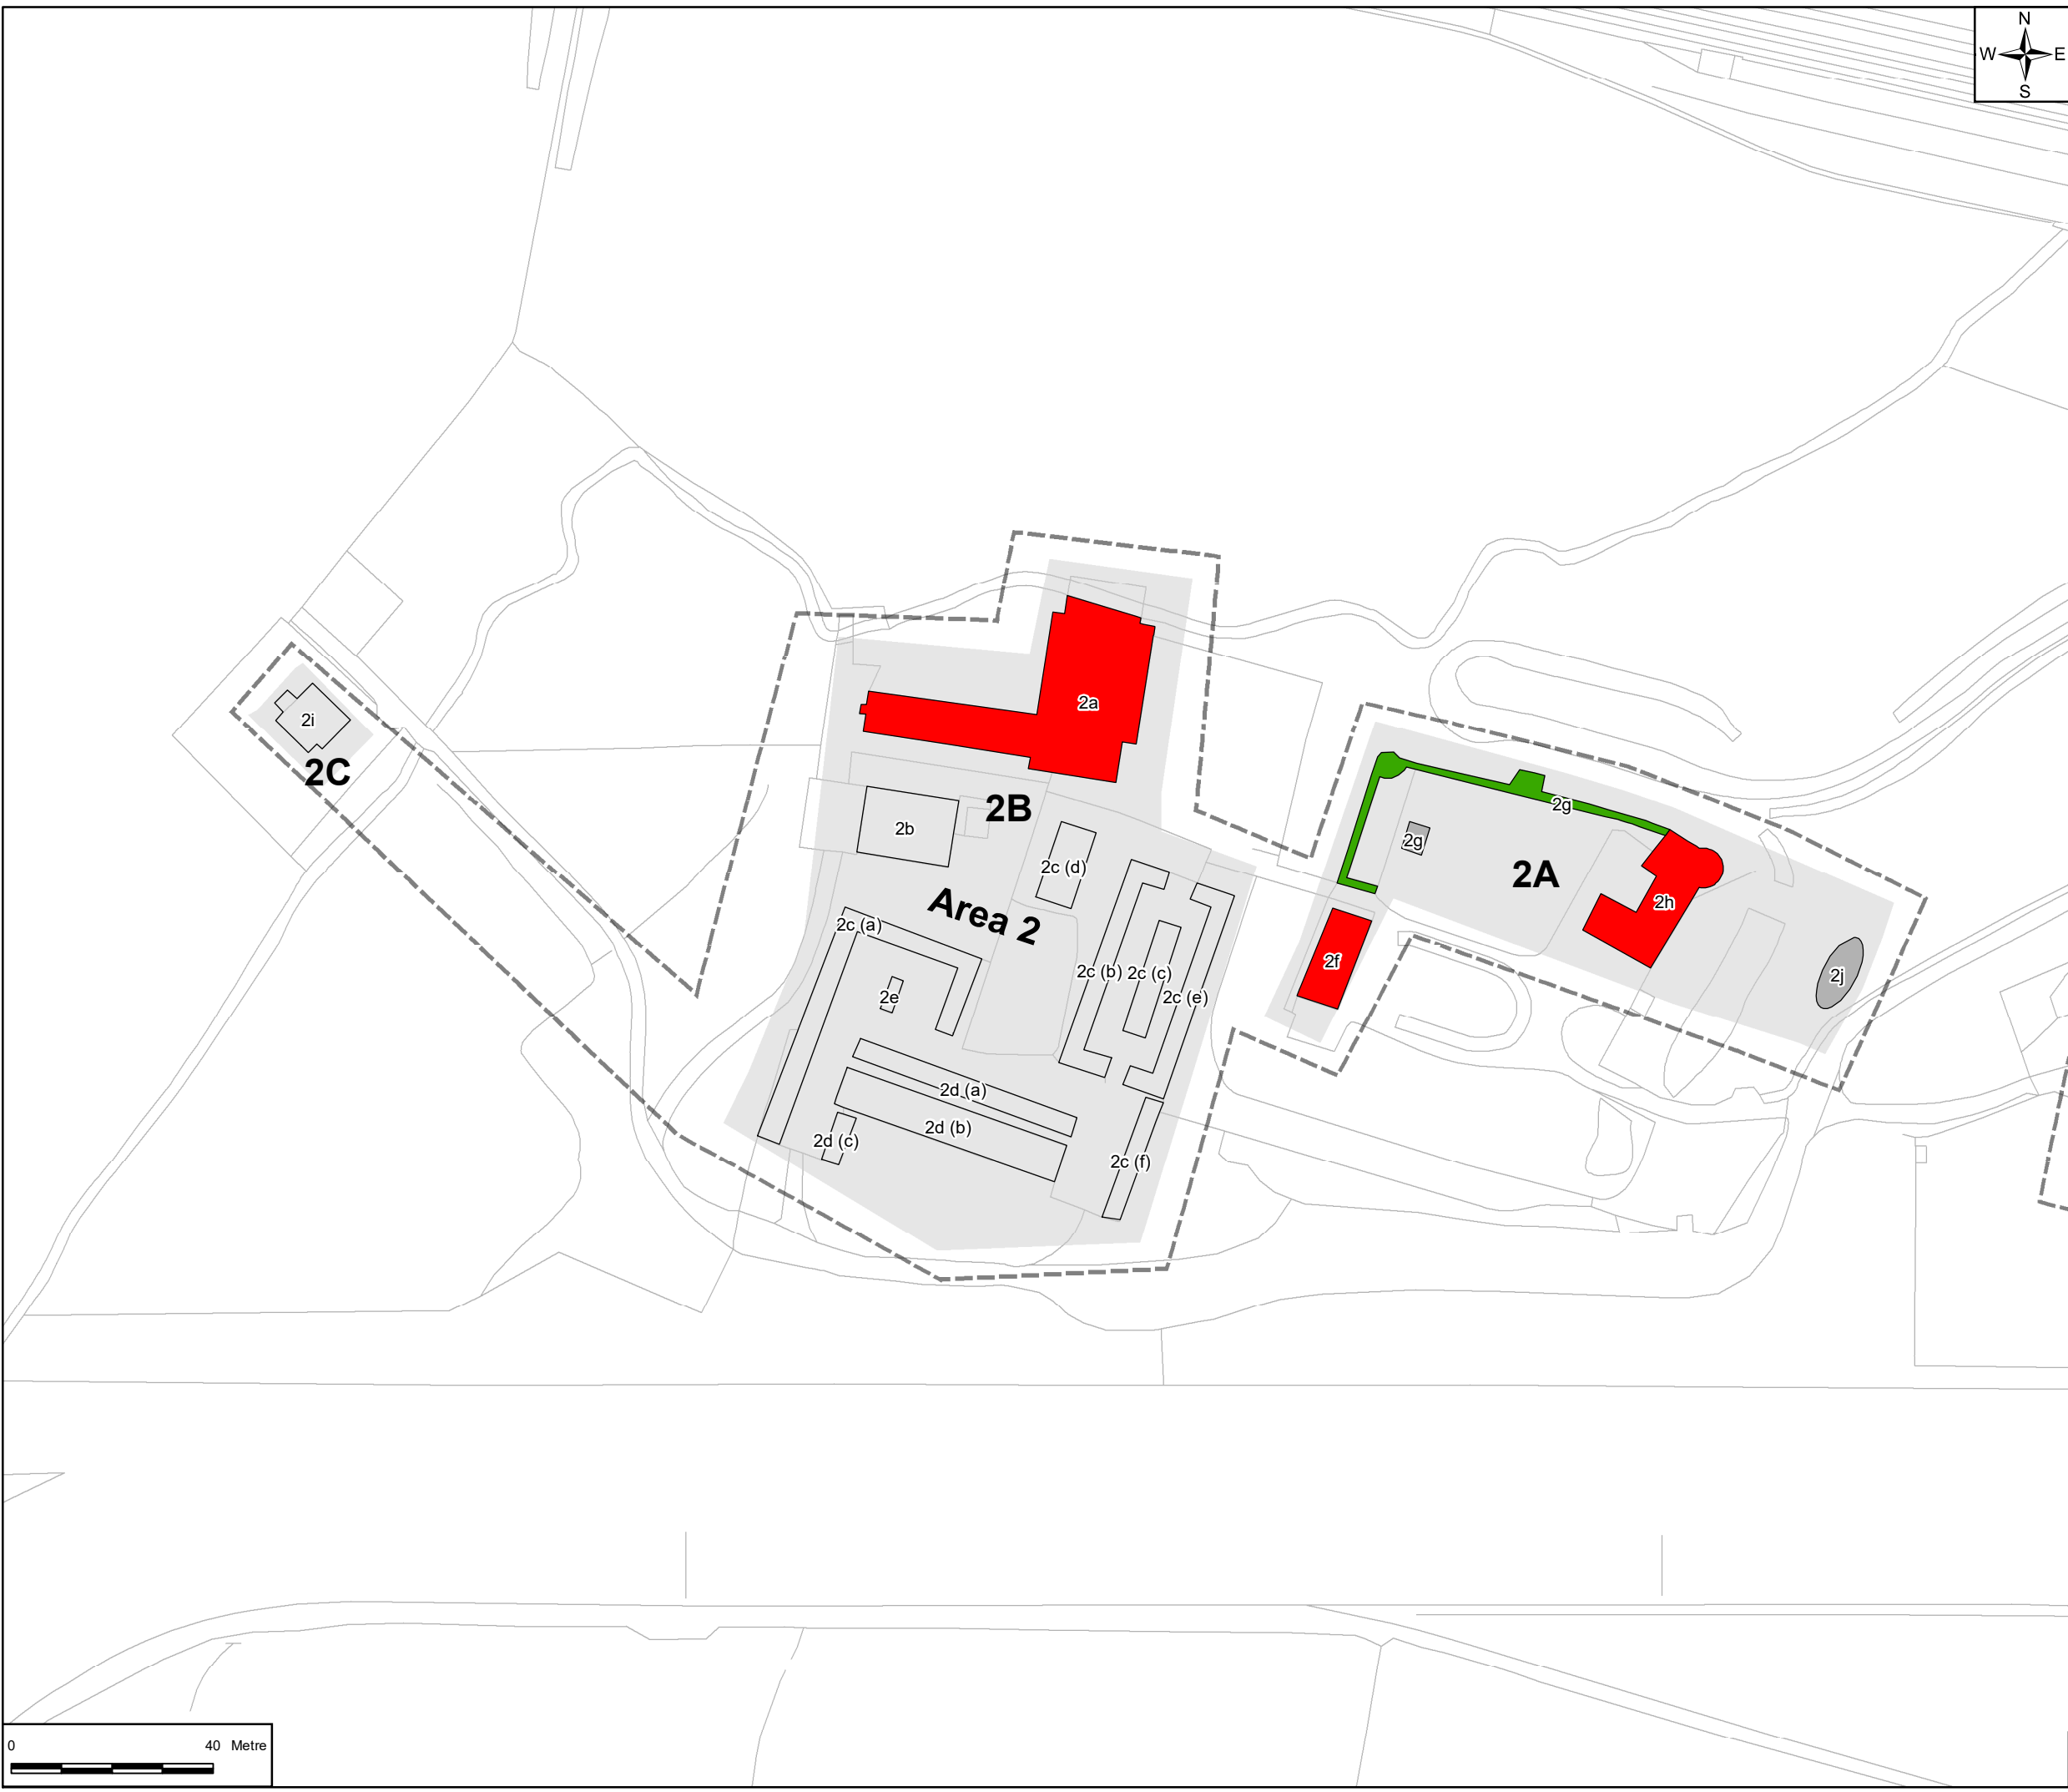
Figure 3: Bat Inspection Results 2020

The table below (Table 4) outlines the areas assessed, the clusters within these areas and the buildings within each of these clusters. This naming convention is consistent with the results from the 2016-2018 surveys. The location of each of these buildings is presented in Figure 3 (Appendix A). Full details of the assessments conducted, and the results are presented in Table 5: Results of the bat building assessment.

A large number of buildings/ structures were originally assessed for their potential to support roosting bats as part of the Otterpool Park outline planning application. These buildings were separated across building ‘areas’ and further divided into ‘clusters’. To remain consistent, this naming convention has been adopted for the Phase 1 habitat survey. The table below outlines the building areas and clusters relevant to the survey site (Westenhanger Castle and surroundings as identified in Image 1). The location of these structures is presented on Figure 3 (Appendix A).
