OTTERPOOL PARK

Environmental Statement Appendix 9.6 Westenhanger
Castle Statement of Significance Addendum, 2022

OTTERPOOL PARK ENVIRONMENTAL STATEMENT

Appendix 9.6 Westenhanger Castle Statement of
Significance, 2018

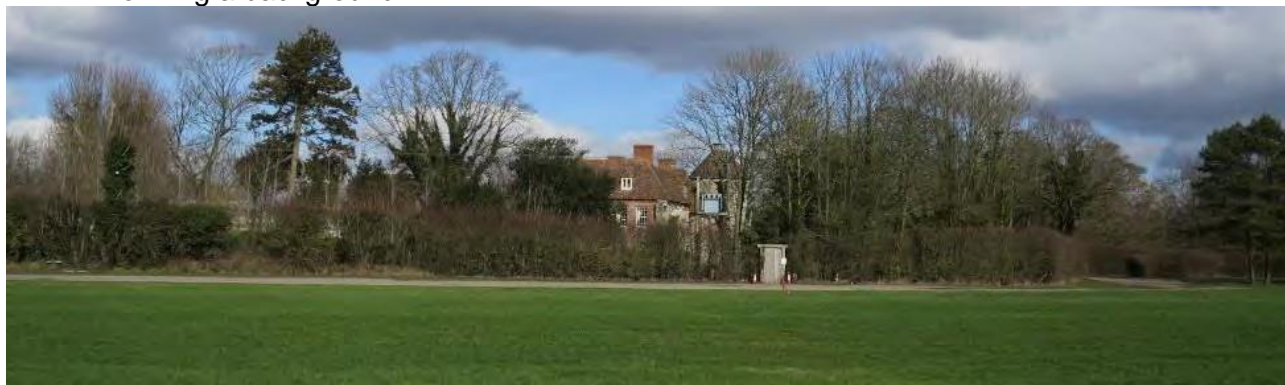
Plate 3: View of the south of Westenhanger Castle from the racecourse

3.2.2. As a group, the scheduled area and its buildings are semi-screened from the racecourse by trees, vegetation and the intervening form of the 20th century stable buildings (Plates 3 and 36). Within this the southern façade and roof of the Grade I listed Manor House are visible and elsewhere there are limited glimpses of structures at the western side of the castle. This screening continues along the eastern side of the castle in the form of a high hedge. Given that survey was carried out in February it is anticipated that the image below (Plate 3) represents a low level of coverage, within which deciduous trees are present. It is likely that this screening is associated with the development of the racecourse (opened in 1898) over the past century given that it does not appear on earlier Ordnance Survey mapping. In addition to the screening to the south of the castle trees to the north are visible in views forming a background.

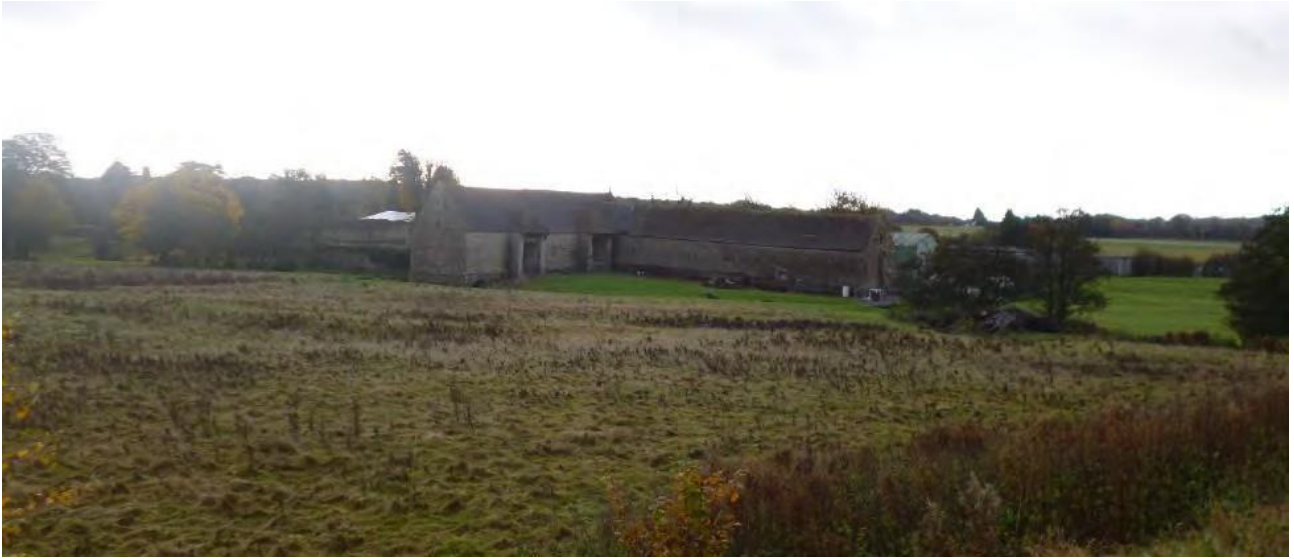
Plate 4: View of Westenhanger Castle and Grade I Listed Barns from the north-west

3.2.3. From the west and north-west the surroundings of the castle and its buildings are more open, presenting clear views of the Grade I Listed barns principally, with the Manor House and other structures forming the backdrop, semi-screened by trees (Plate 4). Views from the adjacent field further to the west are limited by an earthwork bund which formerly provided an approach to a demolished bridge over the railway. There is also some additional screening provided by the farmhouse and surrounding tree-cover. Similarly, from the south-west views of the barns are afforded beyond the intervening form of the later stable buildings and this presents a clear southerly aspect (Plate 5).

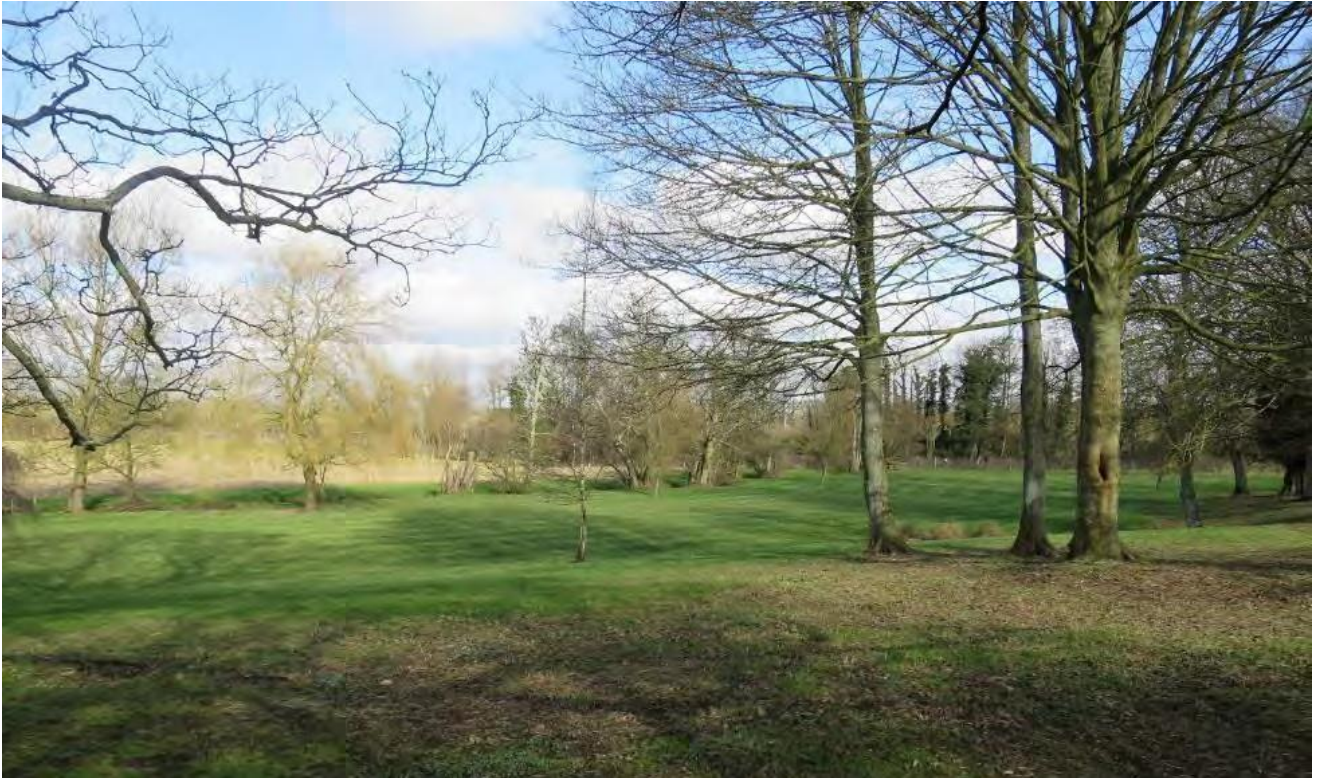
Plate 6: Area to the north of the Castle, view north

3.2.4. The area to the north of the castle comprises the moat and its earthwork dam, built to retain the water. This separates the main castle from a lower lying area which continues up to the railway (Plate 6). Through this area runs the East Stour River which served the castle and fed its moat. Earthworks are suggestive of deliberate landscaping of this area as part of the setting to the house or may represent occupation before the house and park were created. The earthworks might include evidence for a watermill.

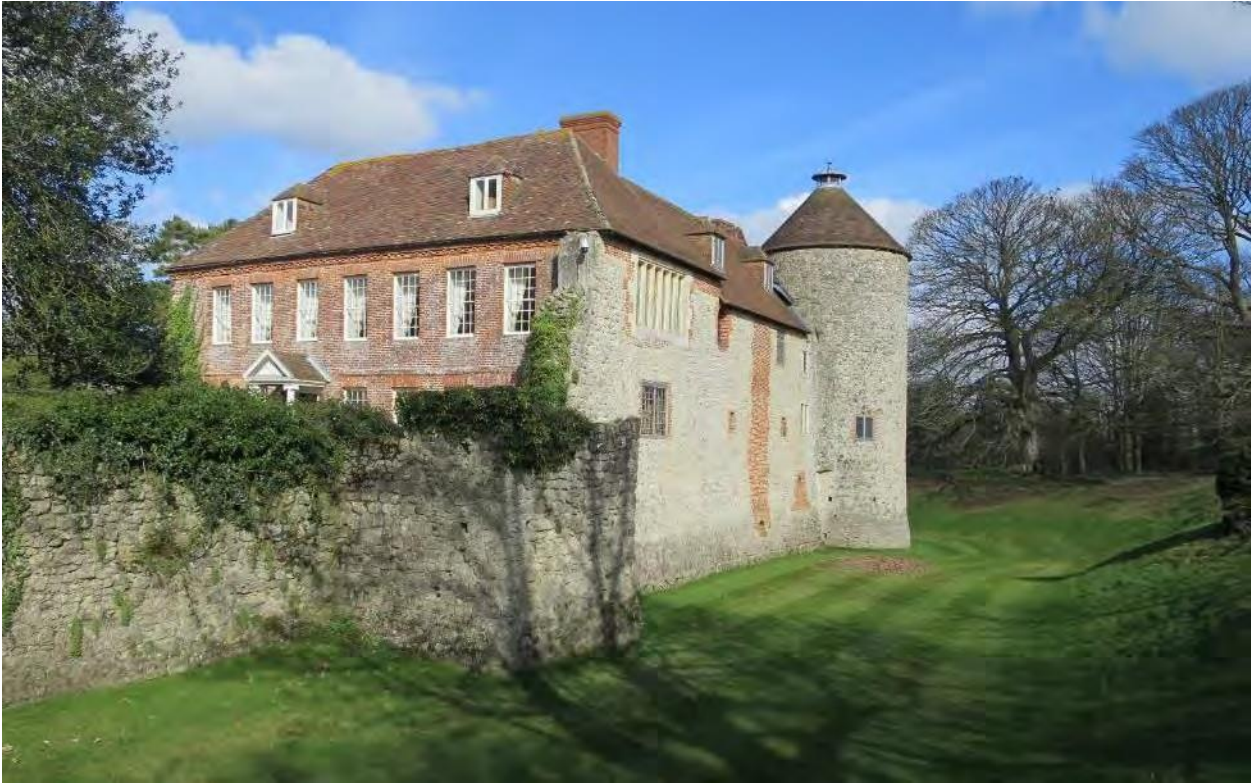
Plate 7: Grade I Listed Manor House and Castle walls viewed from south-east entrance

3.2.5. The dominant feature within the castle interior is the Grade I Listed ‘Manor House’, which with its attached dovecote tower makes a strong impression from within the grounds of the castle. Whilst visible from the Stone Street approach, views at close proximity are obscured by the high perimeter hedge (Plates 3 and 36) and from further afield by the intervening buildings to the north of the Racecourse. The combination of stone from the incorporated surviving castle wall fabric and the redbrick of the Manor House and interventions and repairs to the east elevation of the house provide a visible indicator of the different phases at the castle and its complex development (Plates 7 and 8). A variety of window types are present also reflecting these phases. The larger of these are all insertions demonstrating the changing role from defensive to comfortable residential purposes. This contrasts sharply with the rows of windows on the south facing aspect of the Manor House which reflect the polite architecture of the 18th century Georgian period.

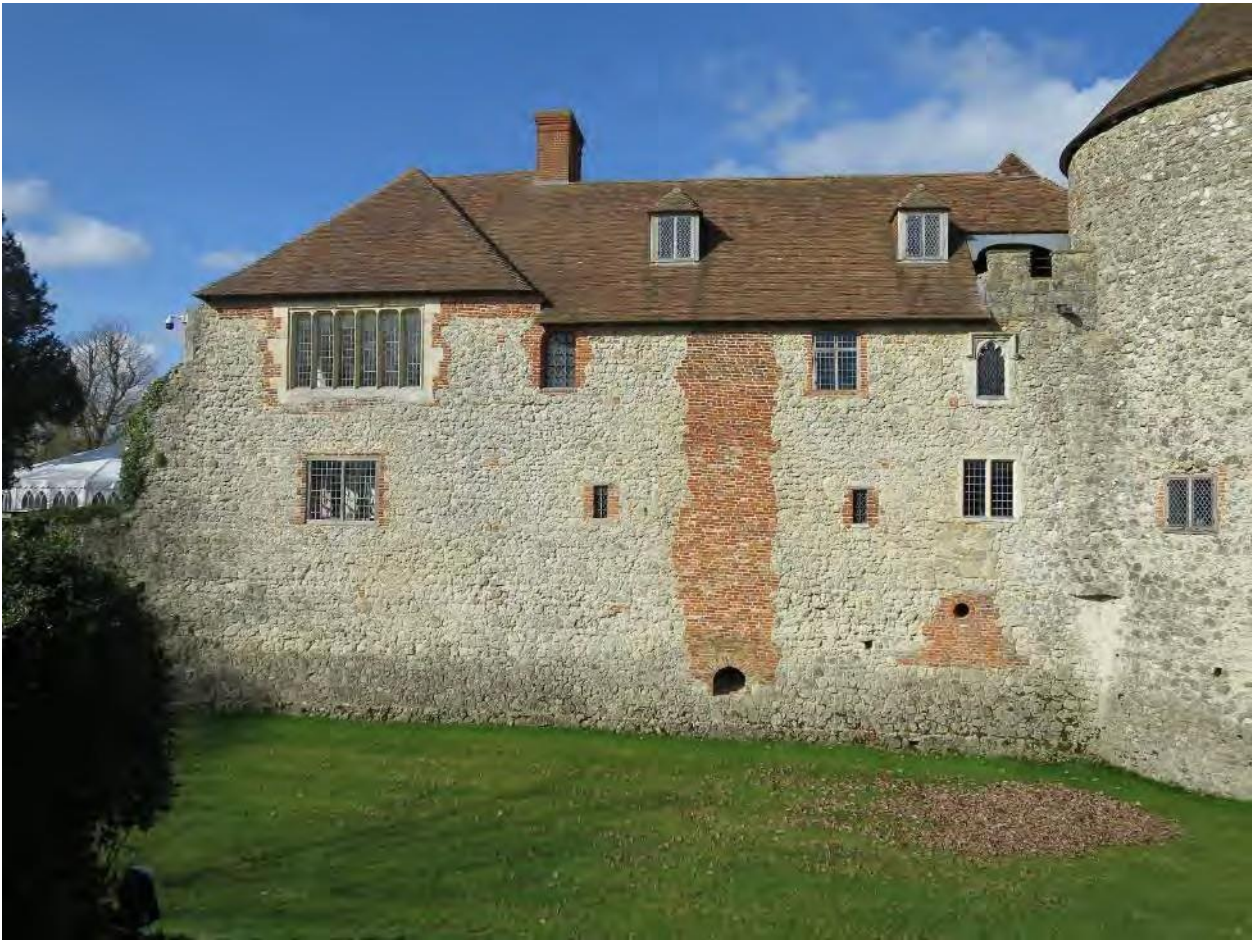
Plate 8: East-facing façade of the Castle and Manor House showing phasing

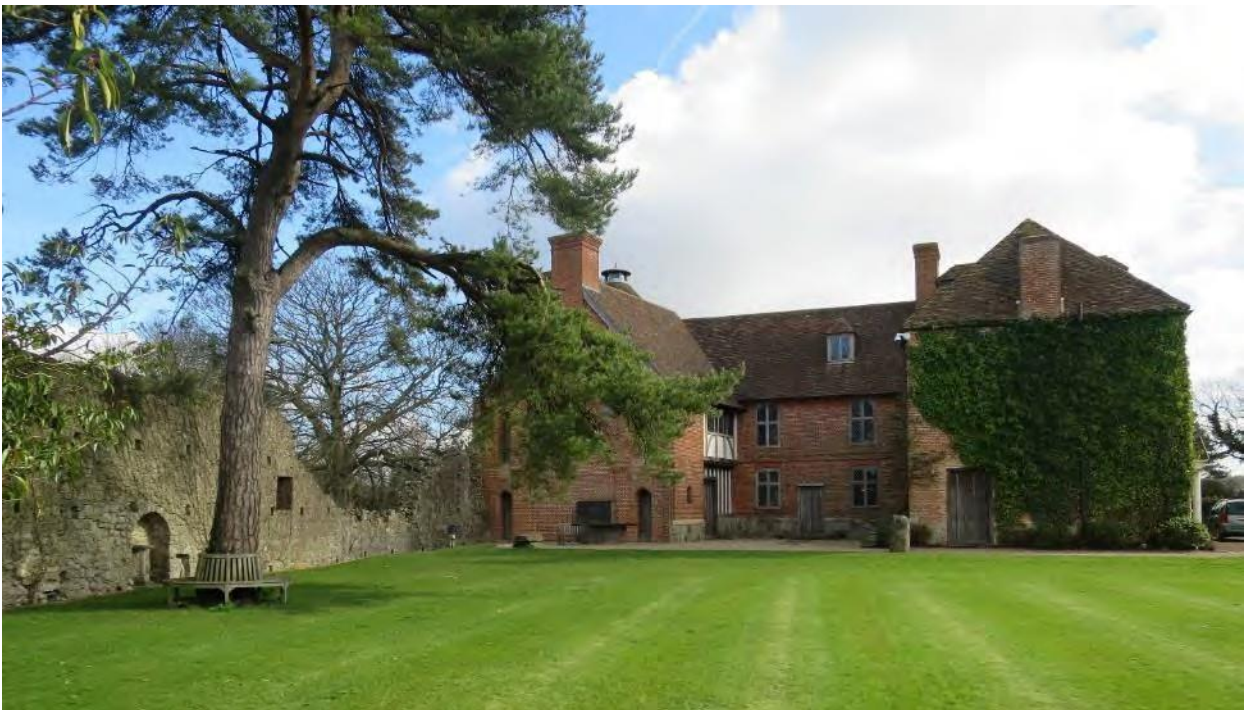
Plate 10: Interior of Castle complex, view east

3.3.6. The Manor House comprises three ranges, north, south and east, the north of which was constructed by the current owner in close consultation with Historic England, following the footprint of an earlier north range and in the same style as the remainder of the Manor House (Plates 10 and 11). All ranges are constructed in redbrick, over a stone sill-wall, and display a variety of window types. In addition to which a large window behind the stairs of the south range has been infilled and two arch-headed lights have been added over the stairs. The new north range includes a timbered surround to the doorway and the pitched roof of the Manor House comprises ceramic tiles.

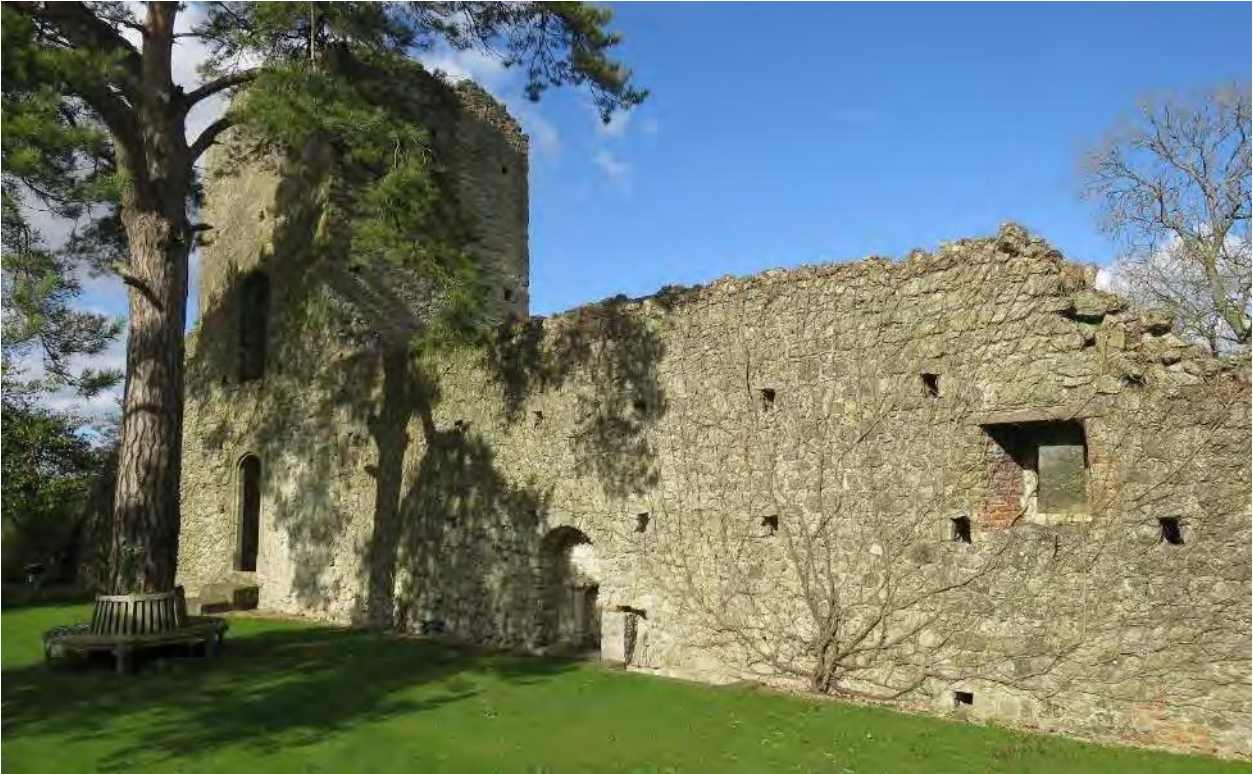
Plate 12: Rosamund's Tower and adjoining Castle wall, view north-west from the Manor House

- 3.3.7. Rosamund's Tower stands on the north side of the castle complex, central within the north castle wall. It comprises a square tower of rubble stone construction with ragstone dressings matching the build of the castle wall (Plates 12-14). Both the tower and wall display put log-holes (used for scaffolding boards when the castle was built or repaired) and the walls have lost their tops. The tower is currently roofless. There are little indicators of alteration, which are limited to areas of brickwork within the tower and an embrasure (angled aperture) within the wall.

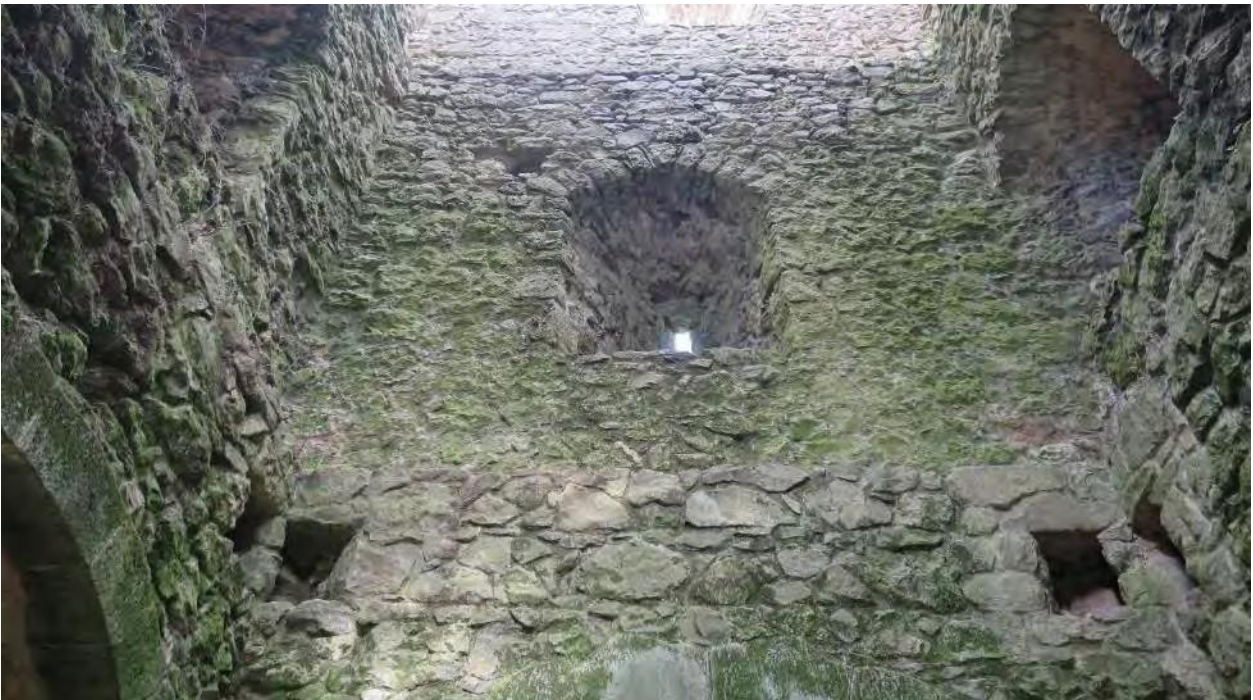
Plate 13: Interior of Rosamund's Tower, showing signs of water-ingress

- 3.3.8. The exterior of the tower and wall section are in good condition, reflecting recent conservation works. The only indicators of possible deterioration are within the tower where the walls are greening from water-ingress from the open roof and along the top of the wall where there is no coping (Plate 13). Both the tops of the tower and wall have been consolidated as part of restoration, which should afford them adequate protection for the foreseeable future.

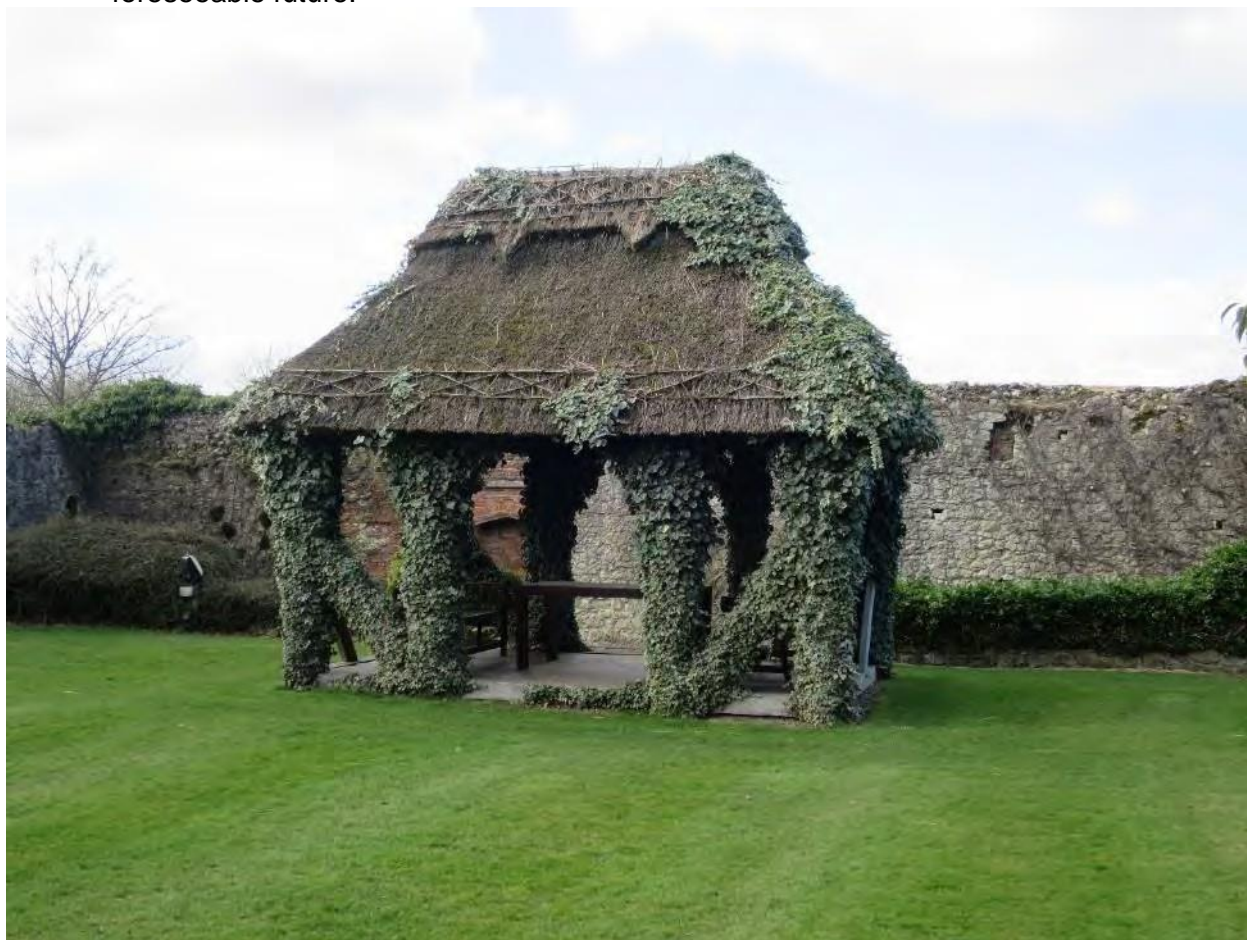
Plate 15: The Wedding Pavilion

- 3.3.9. The wedding pavilion is a new addition to Westenhanger Castle, located at the western side of the complex and comprises a thatched-roof over a timber-frame, which is clad in ivy. This temporary structure makes a neutral contribution to the castle complex and appears to be in good condition (Plate 15).

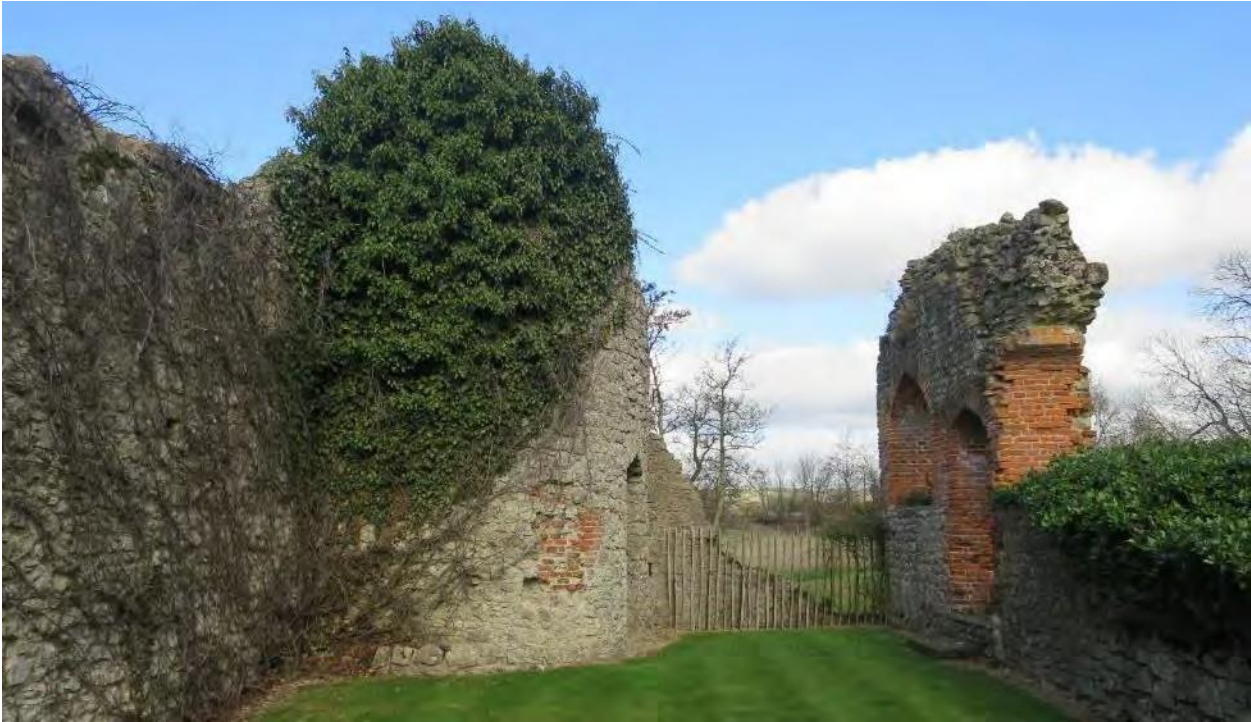
Plate 16: The former chapel and north-west tower view north

- 3.3.11. The north-west tower and the walls of the possible former chapel have recently been consolidated by the owner using a Historic England grant. The vegetation growth has been to develop for aesthetic reasons by the owner. Neither the tower nor wall sections retain their wall-tops but despite some signs of water-ingress and ivy growing around the exterior of the tower they are in a stable condition.

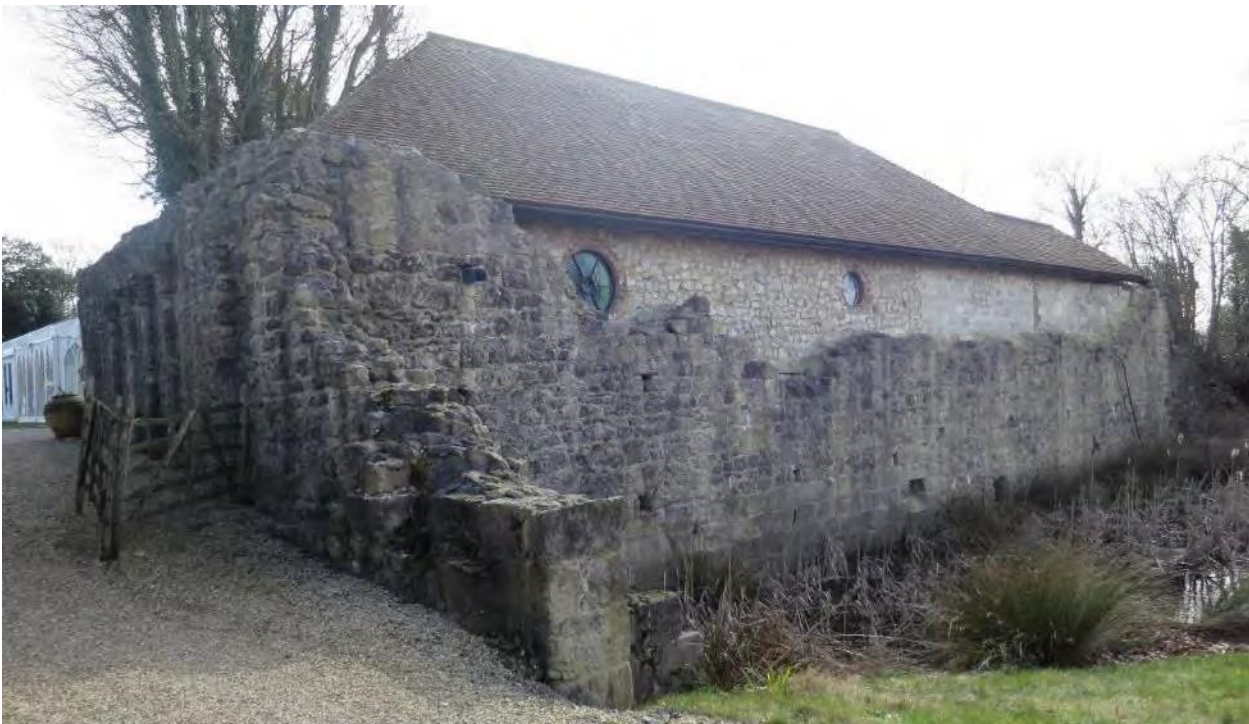
Plate 18: Entrance to Castle complex: the gatehouse and exterior wall, view south-east

3.3.12. The entrance to the castle complex from the west is via a ruinous gatehouse constructed in rubble stone with ashlar dressings (Plate 18). The adjoining wall to the south displays a lower course of ashlar or cut blockwork, which may indicate an earlier phase in the castle's construction. The adjoining building in the south-west corner of the castle complex (Plate 18) is of recent construction in a lighter stone with round windows and a tile roof, making a defined contrast with the gatehouse and adjoining wall. Pilasters with capitals are present along the north wall of the entrance (Plates 18 and 19). There is evidence for a portcullis in front of the gate and a drawbridge over the moat.

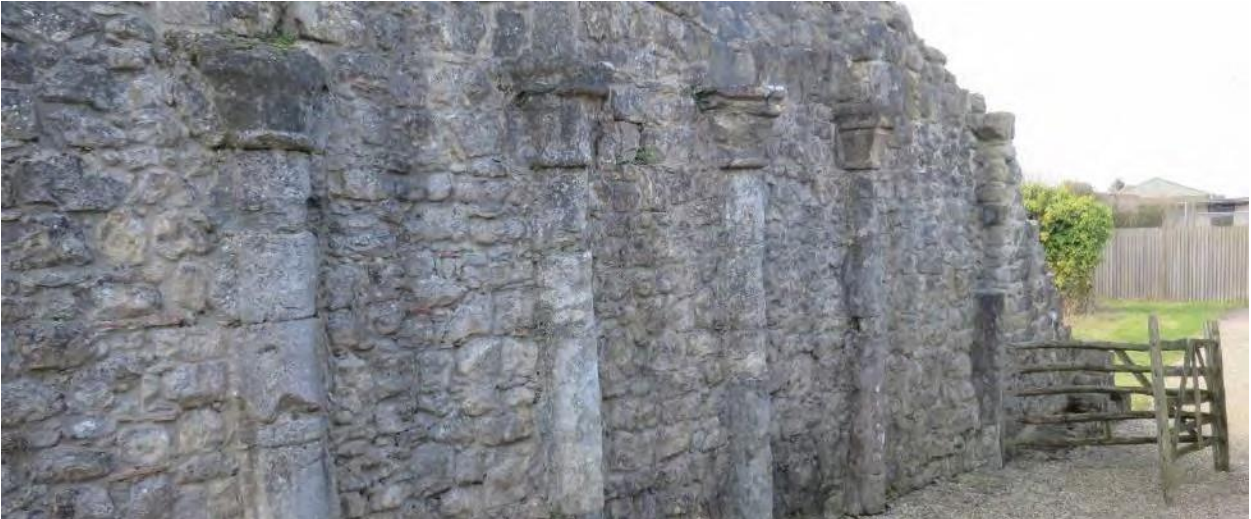
Plate 19: Pilasters at entrance to gatehouse, view south-west

4.3.9. The main access was from the south, via a bridge over the moat and through the gatehouse on the western side of the curtain wall (Plates 18,19 and 27). A pivot hole for a drawbridge and grooves for a portcullis are evident in the gatehouse. All that remains of the gatehouse is the entrance passage and front wall but excavations in 2000 revealed foundations of the northern and eastern walls (Martin and Martin 2001, 5). The passage would originally have been vaulted, as evidenced by supporting semi-octagonal wall shafts along the wall. A groove for a portcullis can be seen in front of the gate. The very different character of the gatehouse stone work from the rest of the castle walls strongly suggest that this was once free standing at a time when the moated site possibly had an earthwork or timber defensive surround.

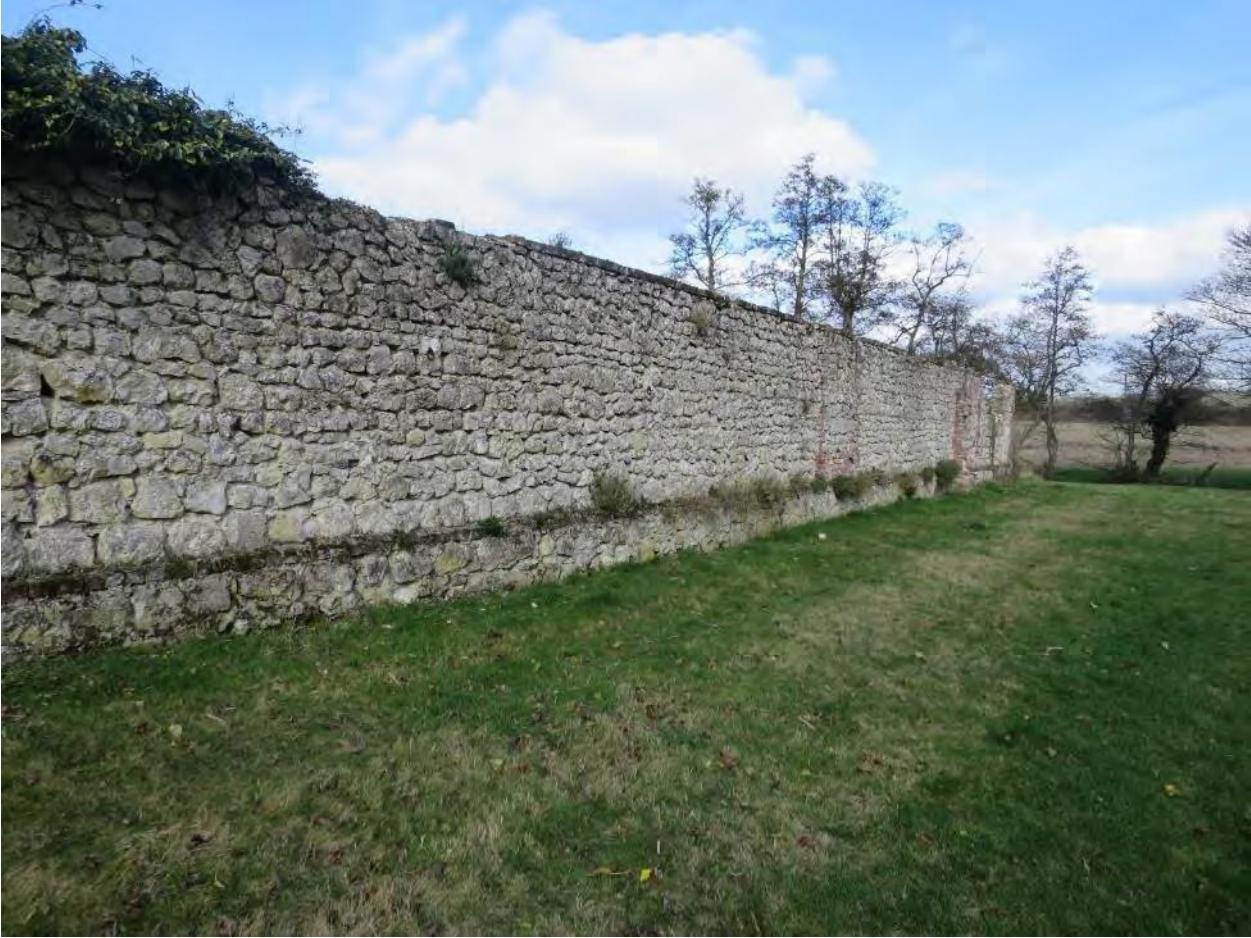
Plate 21: Perimeter wall to outbuildings (barns)

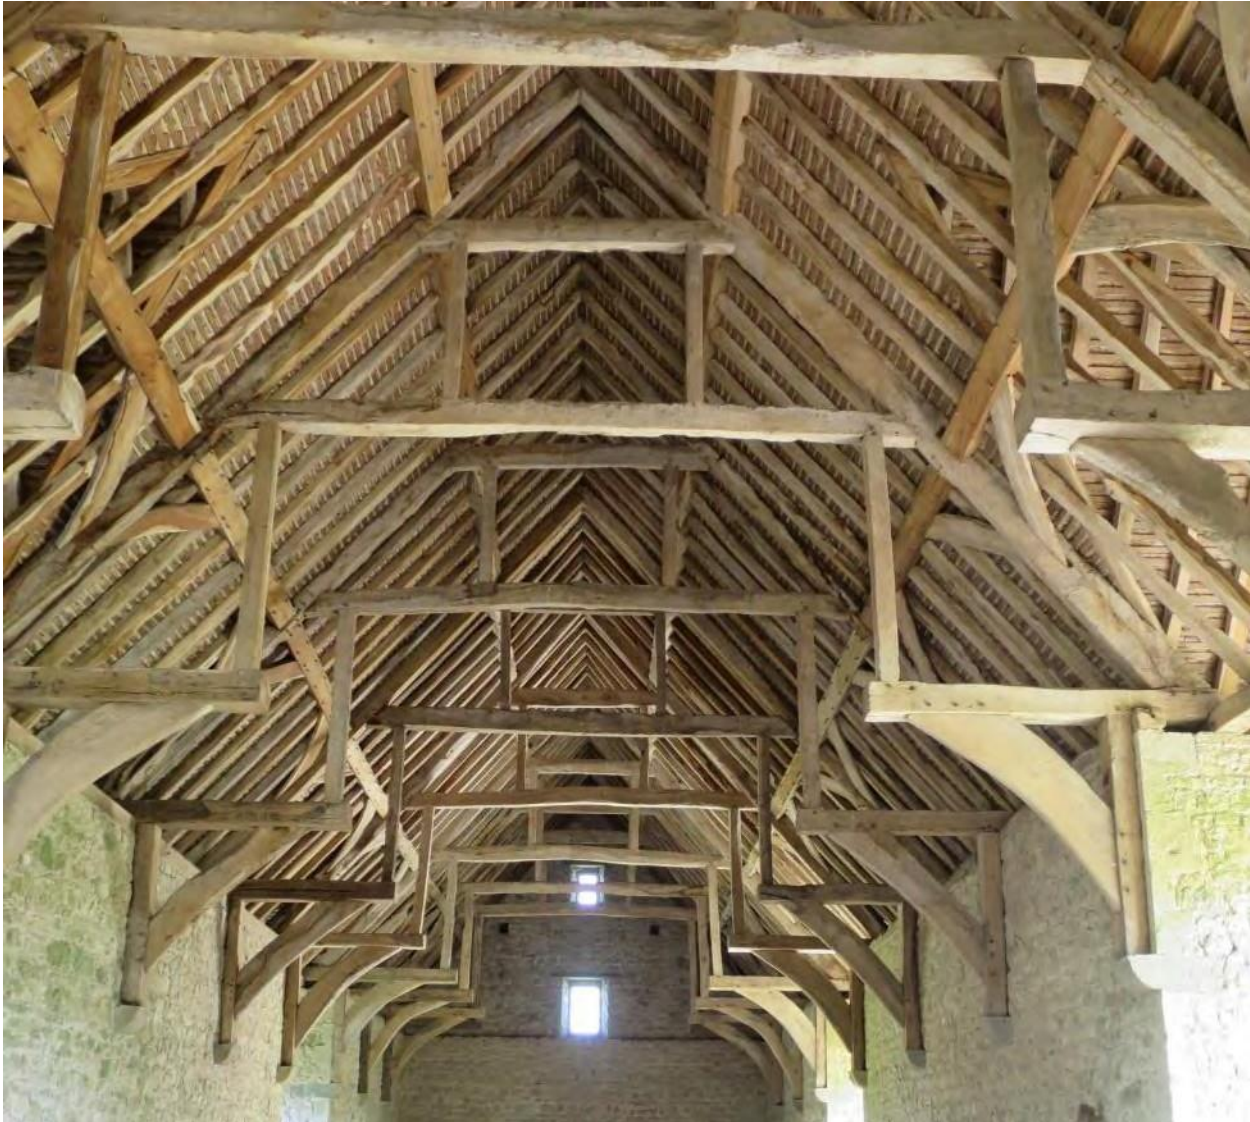
Plate 22: The north-south range of barns with hammer-beam roof

- 3.3.15. At the exterior on the northern side of this barn there is an unusual arched vault which allows the river to pass under the barn.
- 3.3.16. The north-south range of the barn has recently been restored and is consequently in a good state of repair.

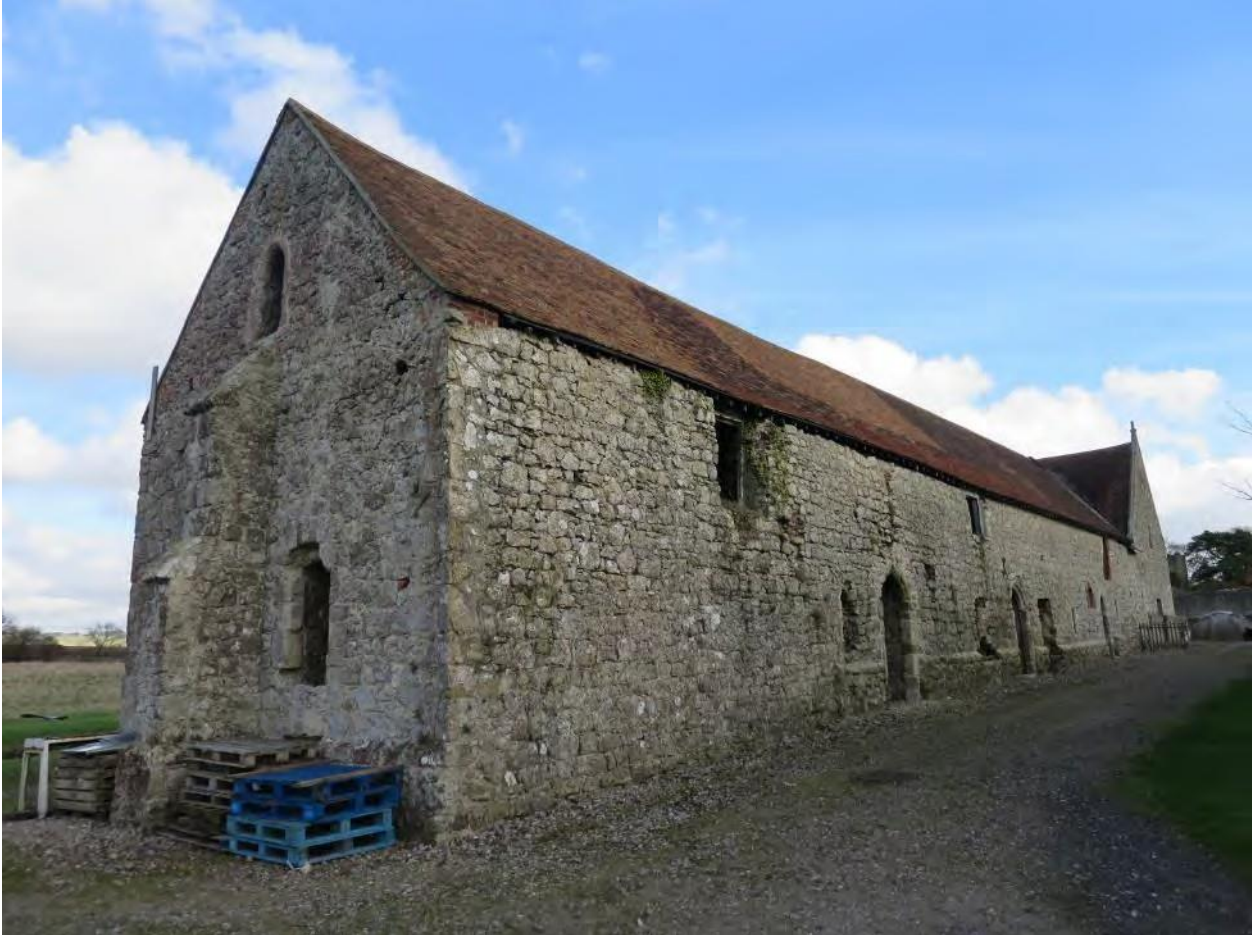
Plate 23: East-west range of the barn

- 3.3.19. The east-west range was not included in the recent renovation of its counterpart and exhibits signs of water-ingress and deteriorating mortar jointing at several points. There are also areas of vegetation taking root around some of the doors and windows.

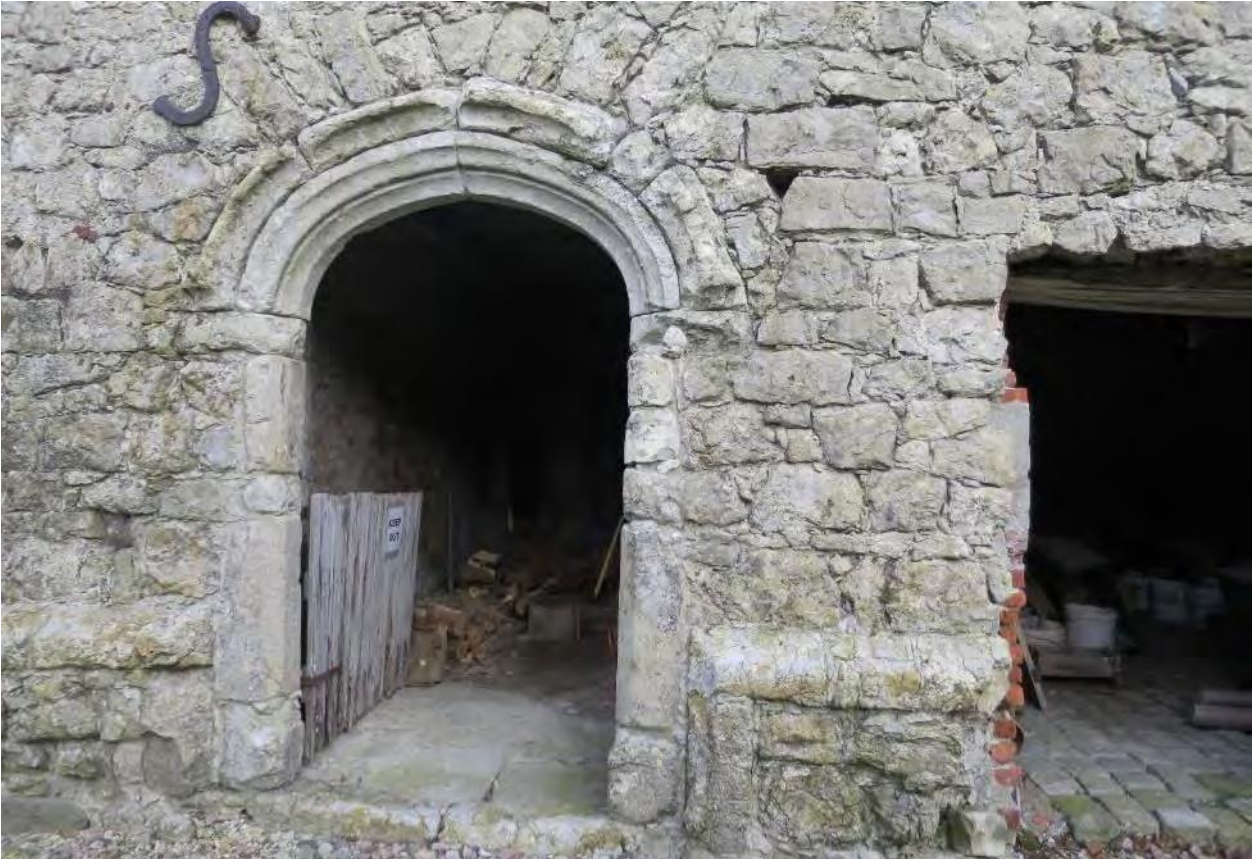
Plate 24: Moulded door surround one of two in south façade of east-west barn

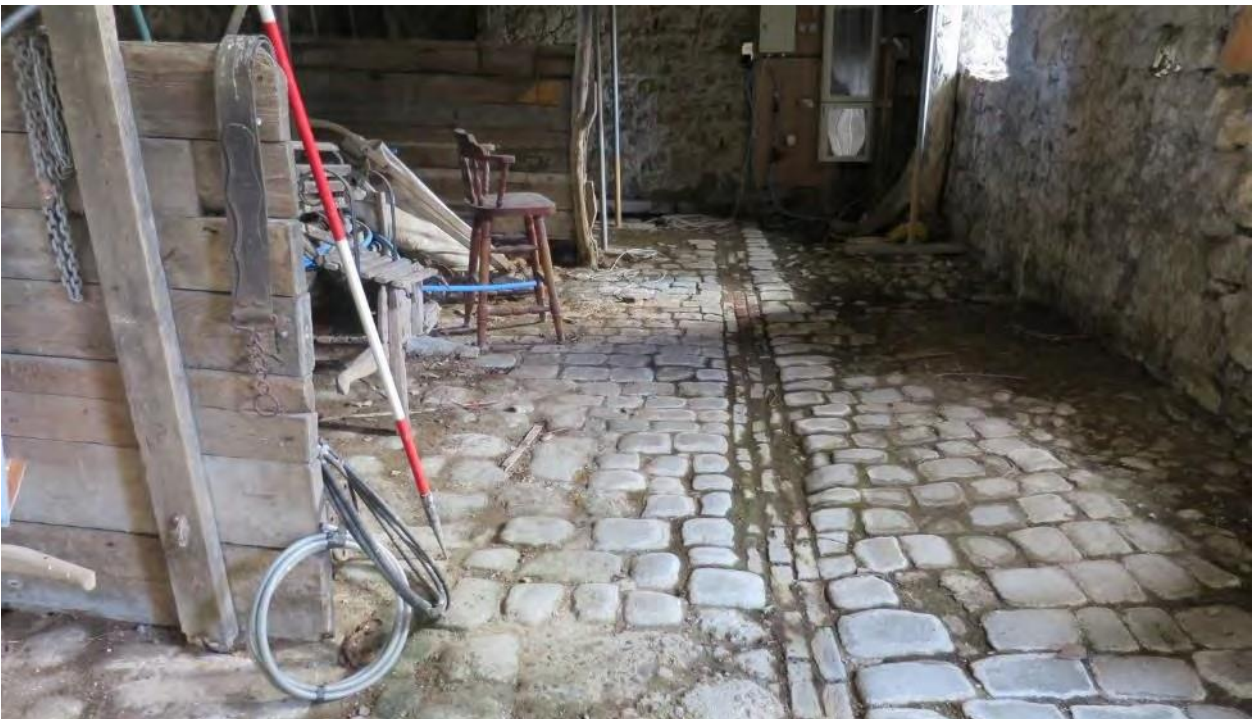
- 3.3.18. Internally, much of the roof-structure has been altered, following damage during the hurricane of 1987 (Forge Pers Comm) meaning that there is little to date the construction from surviving elements. The floor and walls of the building provide clear indications of having housed livestock in the form of a gutter and marks indicating partitioning for stalls (Plate 25).

Plate 25: Gutter and partitioning in the east- west barn

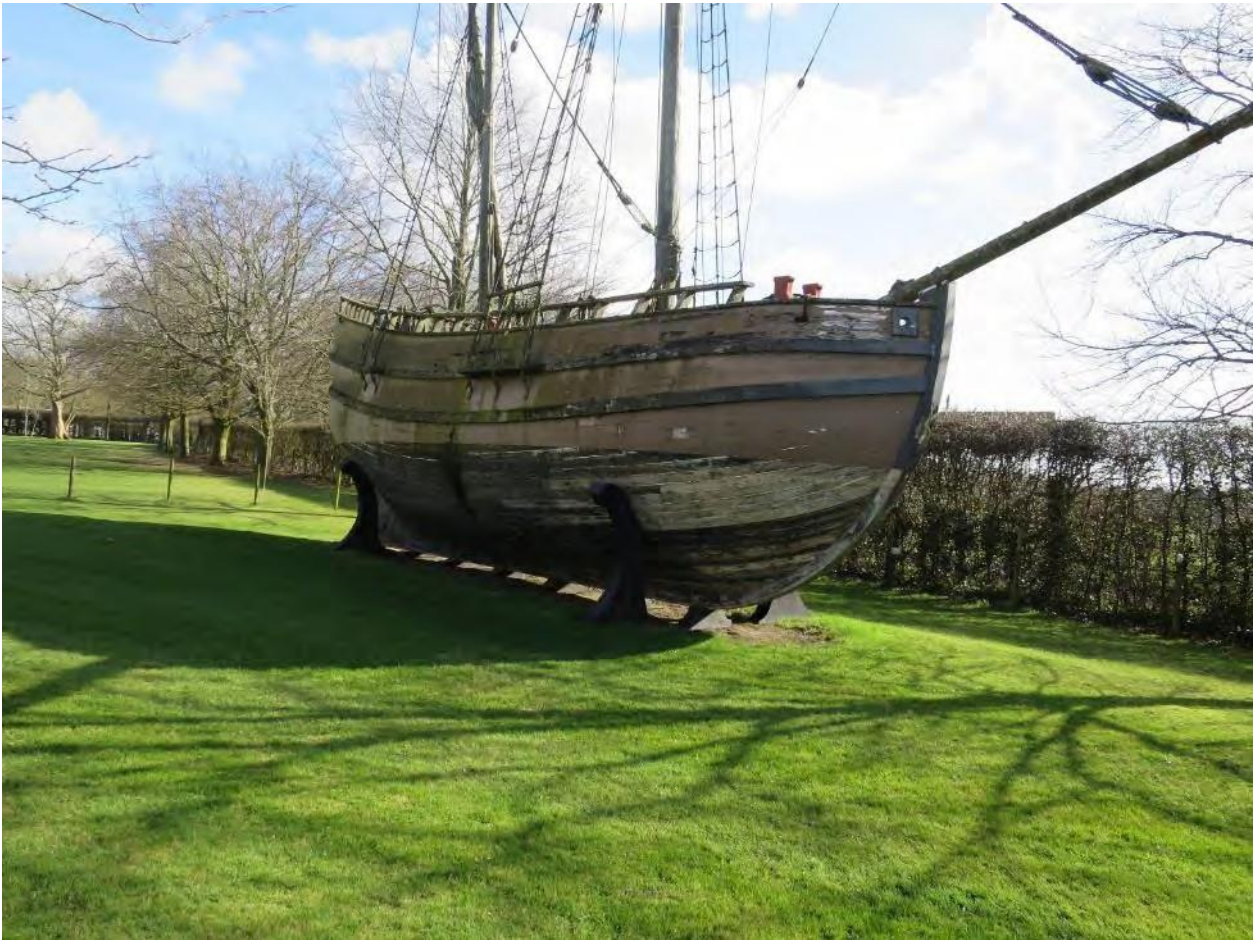
Plate 26: The replica of 'the Discovery'

- 3.3.20. A modern constructed wooden boat stands to the east of the castle complex adjacent to the access lane. The boat is a replica of a small vessel complete with rigging and masts, which was owned by one of the former owners of Westenhanger Castle (Plate 26).
- 3.3.21. The boat is an incongruous feature of the castle but it does no physical harm and is neutral for appreciation of the significance of the buildings/ruins.
- 3.3.22. The paint of the boat is peeling and there are clear signs of wetting and drying of the hull planking, which is beginning to deteriorate in places.

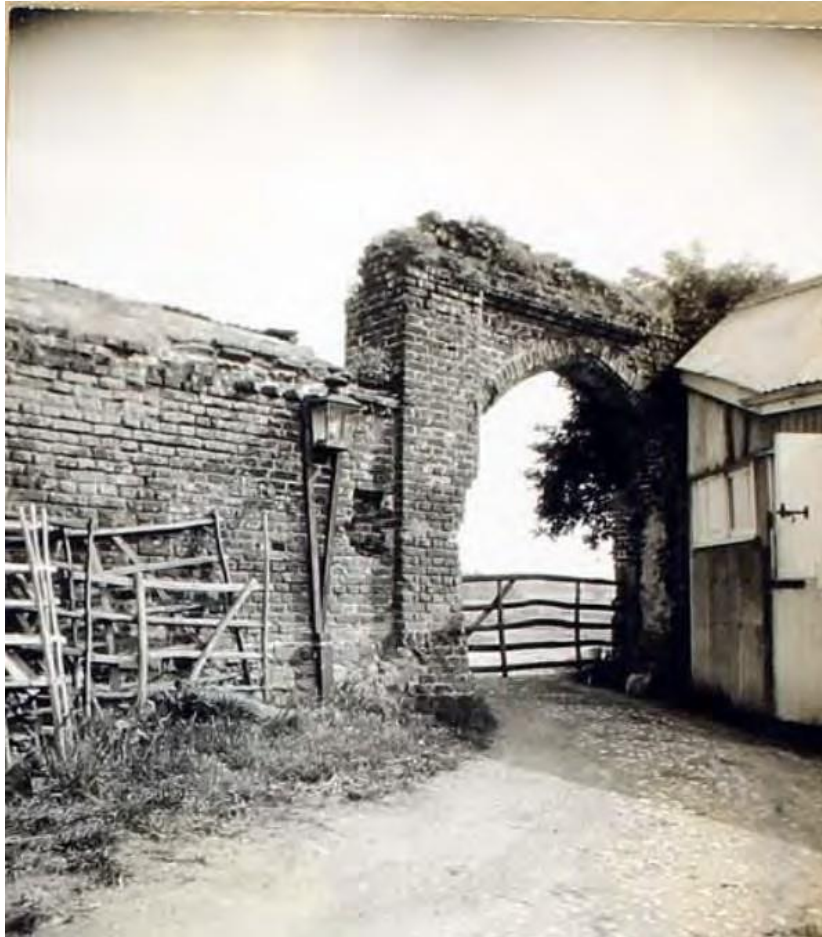
Plate 28 Photograph of the now demolished Tudor gateway possibly located in the outer courtyard, from the Historic England Archive

- 4.3.27. The now lost Tudor gateway could have occupied this part of the site (Plate 28). This photograph shows a high brick boundary wall with a well-constructed gateway of typical Tudor style. From its height it is designed to allow loaded wagons through it.

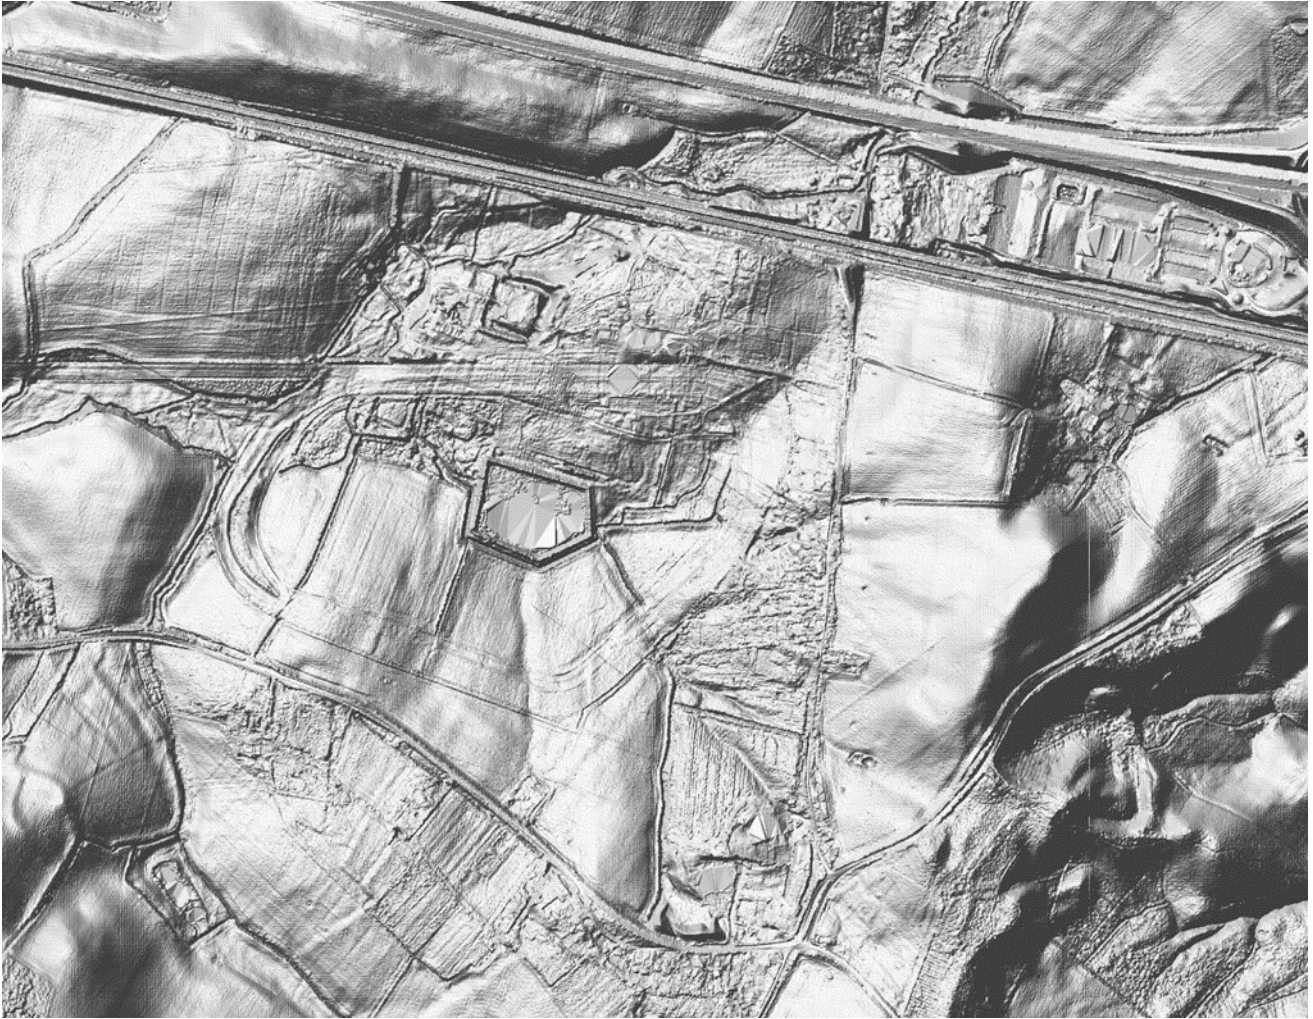
Plate 31 LiDAR (1m resolution) showing Westenhanger Castle, its landscape features and the racecourse
