OTTERPOOL PARK

Environmental Statement Appendix 9.6 Westenhanger
Castle Statement of Significance Addendum, 2022

OTTERPOOL PARK ENVIRONMENTAL STATEMENT

Appendix 9.6 Westenhanger Castle Statement of
Significance, 2018

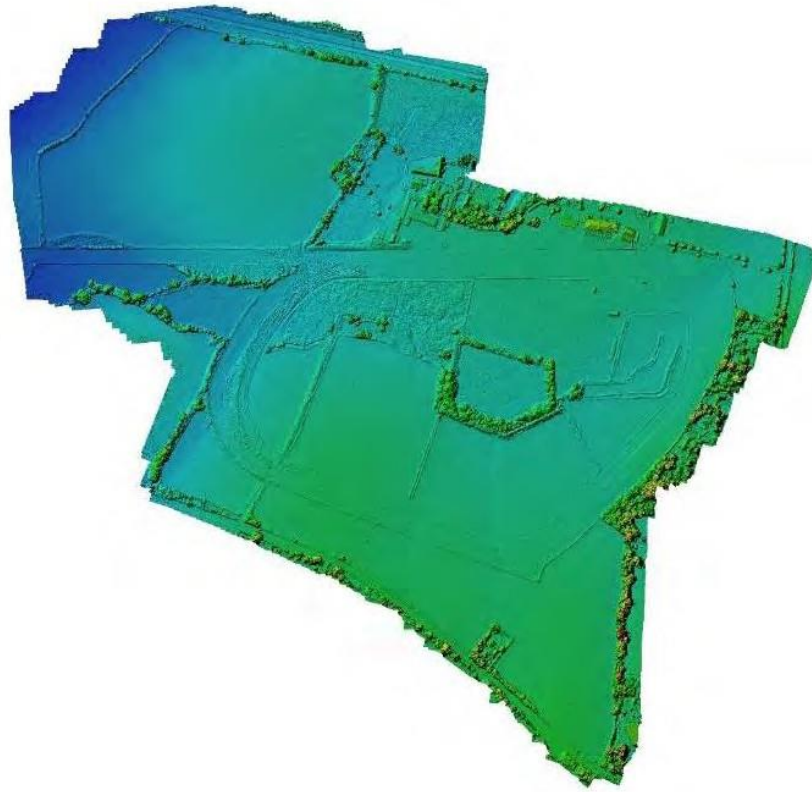
Plate 32 Digital Elevation Model of the Castle and racecourse area, taken by a Drone 2018

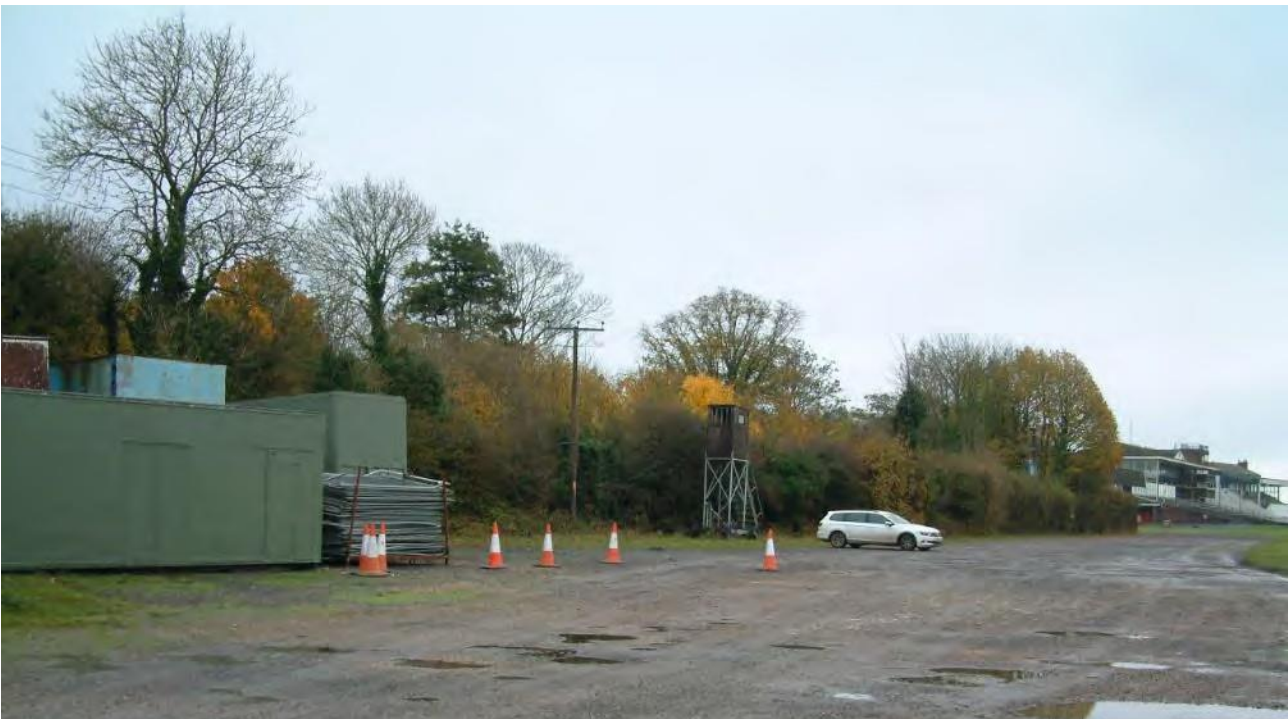
Plate 36: Tree screening between the racecourse and the castle, view ENE

3.2.2. As a group, the scheduled area and its buildings are semi-screened from the racecourse by trees, vegetation and the intervening form of the 20th century stable buildings (Plates 3 and 36). Within this the southern façade and roof of the Grade I listed Manor House are visible and elsewhere there are limited glimpses of structures at the western side of the castle. This screening continues along the eastern side of the castle in the form of a high hedge. Given that survey was carried out in February it is anticipated that the image below (Plate 3) represents a low level of coverage, within which deciduous trees are present. It is likely that this screening is associated with the development of the racecourse (opened in 1898) over the past century given that it does not appear on earlier Ordnance Survey mapping. In addition to the screening to the south of the castle trees to the north are visible in views forming a background.
