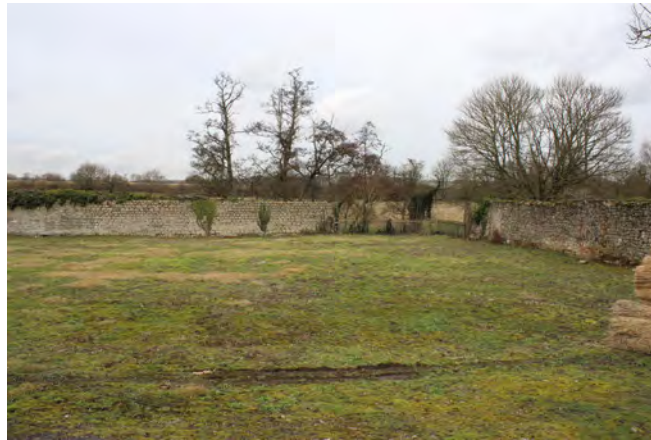
The land in Outer Court to the east of the barns features grass lawn, overgrown with weeds, and an L-shaped masonry boundary wall to the north and north-east. The area was formerly occupied by the medieval parish church and its associated cemetery, before it went out of use in 1542. There are no above grounds remains but high potential for buried remains.

Figure 113: View looking north across the site of the former medieval church

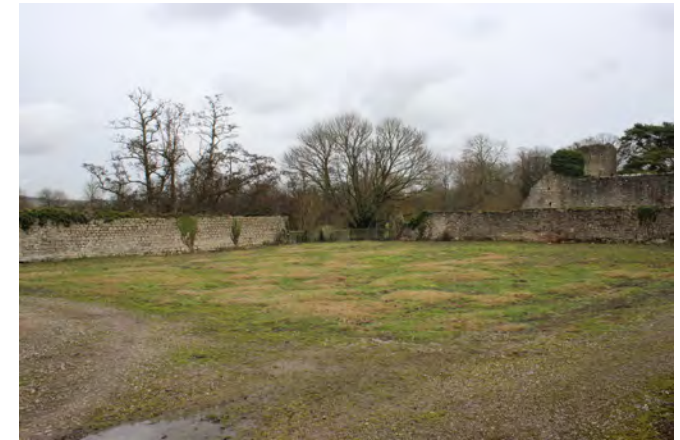
Figure 114: View looking north-east across the site of the former medieval church

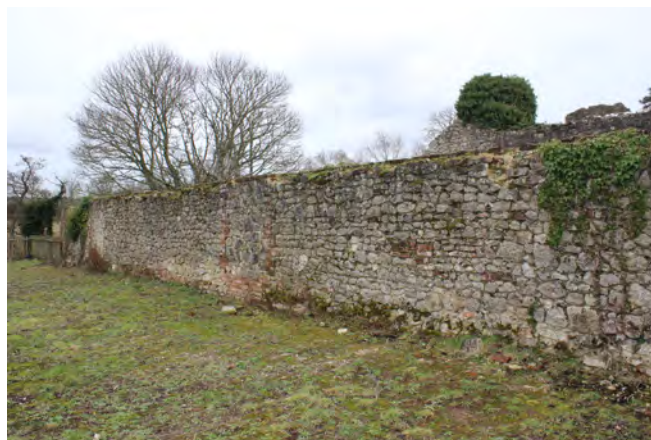
The stone boundary wall comprises two separate arms (north and east) joined by a section of later timber fencing. The walls, which are galetted like the stonework to the adjacent north-south barn, formerly served as elevations to buildings that are no longer extant as indicated by the infilled openings and iron rings fixed to the stonework (likely for tethering horses).

Figure 115: Detail of stone wall bounding the east side of the area to the east of the barns showing evidence of infilled openings

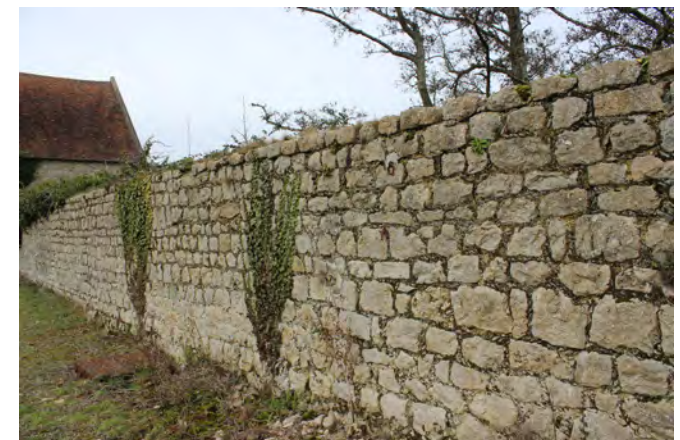
Figure 116: Detail of stone wall bounding the north side of the area to the east of the barns

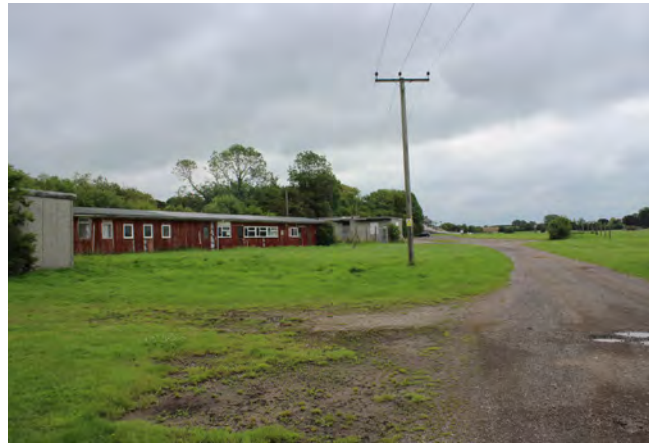
Figure 117: View of the modern stabling associated with the former racecourse to the south of the barns and the racecourse grandstands in the background

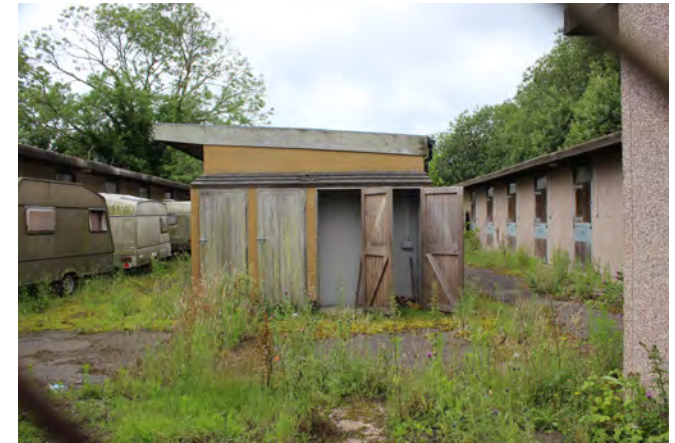
A complex of 20th century stables and barns lie to the south of the barns within the historic Outer Court. These buildings, comprising pre-cast pebbledash panels with corrugated roofs, were associated with the former Folkestone Racecourse and now lie redundant and derelict. They are surrounded by high-security fencing and gates with barbed wire and their landscape setting is overgrown and unkempt. Piles of salvaged stone associated with the historic buildings on the site can be found amongst these modern buildings.

Figure 119: Modern stabling to the south of the barns

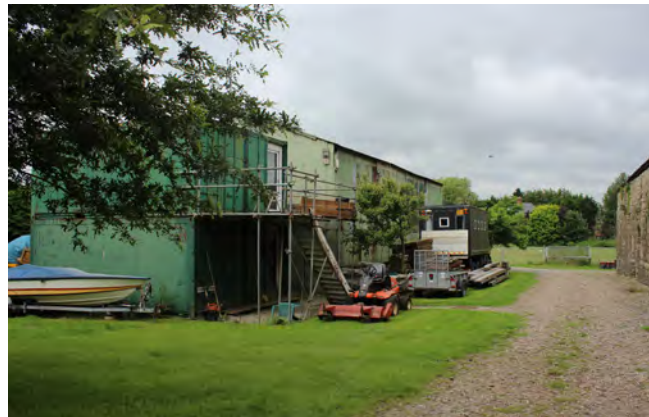
Figure 118: Modern stables and semi-permanent buildings to the south of east-west barn

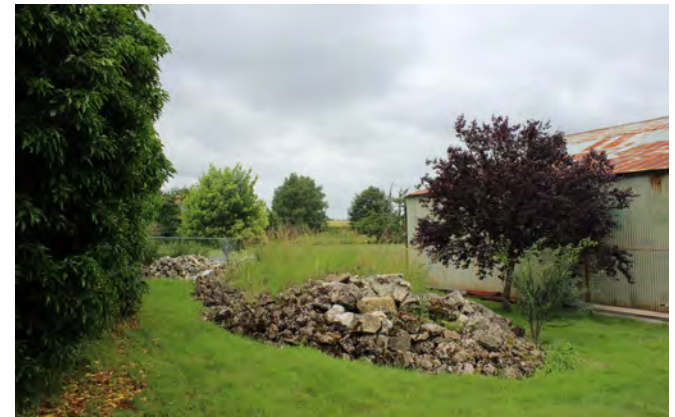
Figure 120: Piles of salvaged stone behind the modern barn to the south of east-west barn

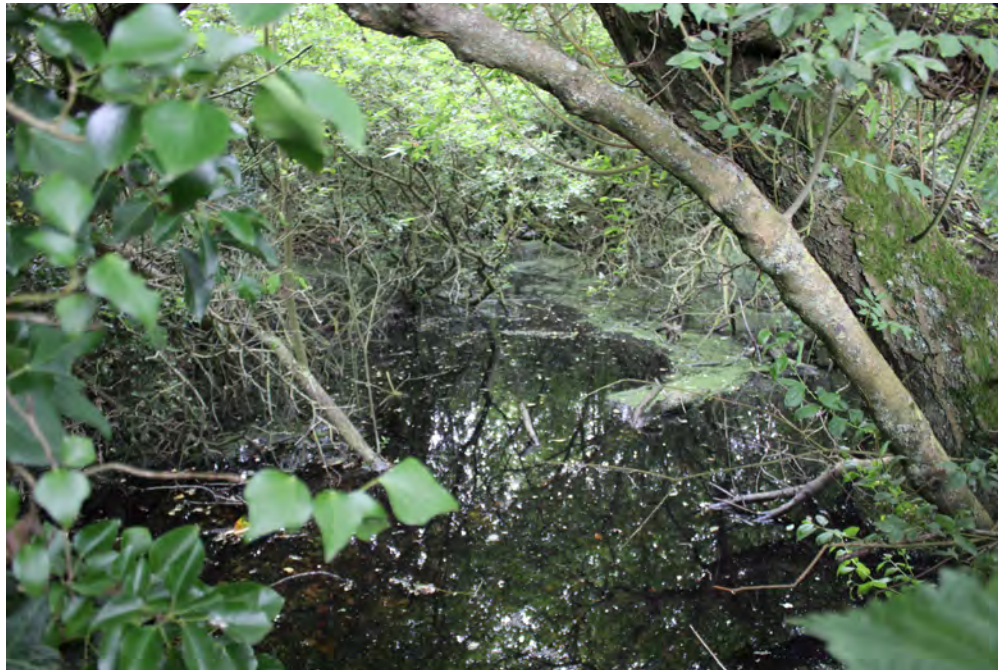
The modern stables are arranged around an overgrown historic pond, which may once have been connected to the moat and historically had a close relationship with the principal causeway approach.

Figure 121: View of the pond, which sits at the centre of the modern stable arrangement, and is well-screened by trees and shrubbery

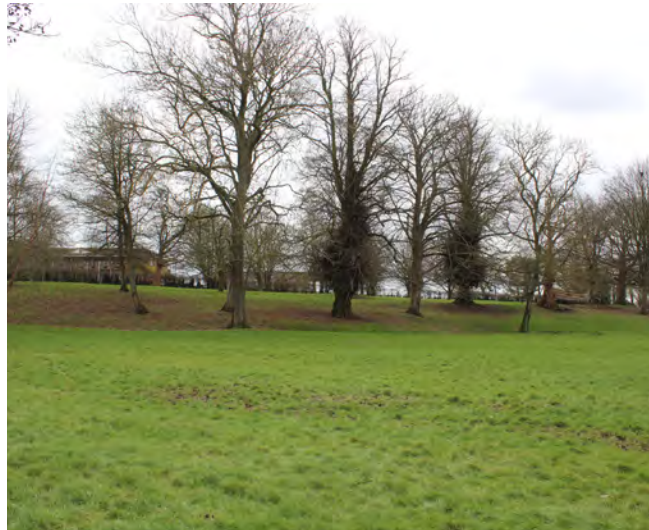
Figure 122: View of the earthen bank of the former park pale to the north-east of Inner Court

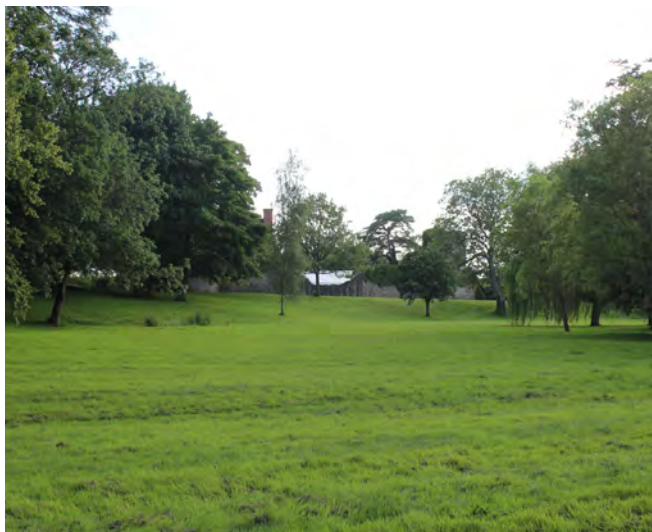
Figure 123: View across the area to the north-east of Inner Court showing the undulating terrain in the setting of the castle

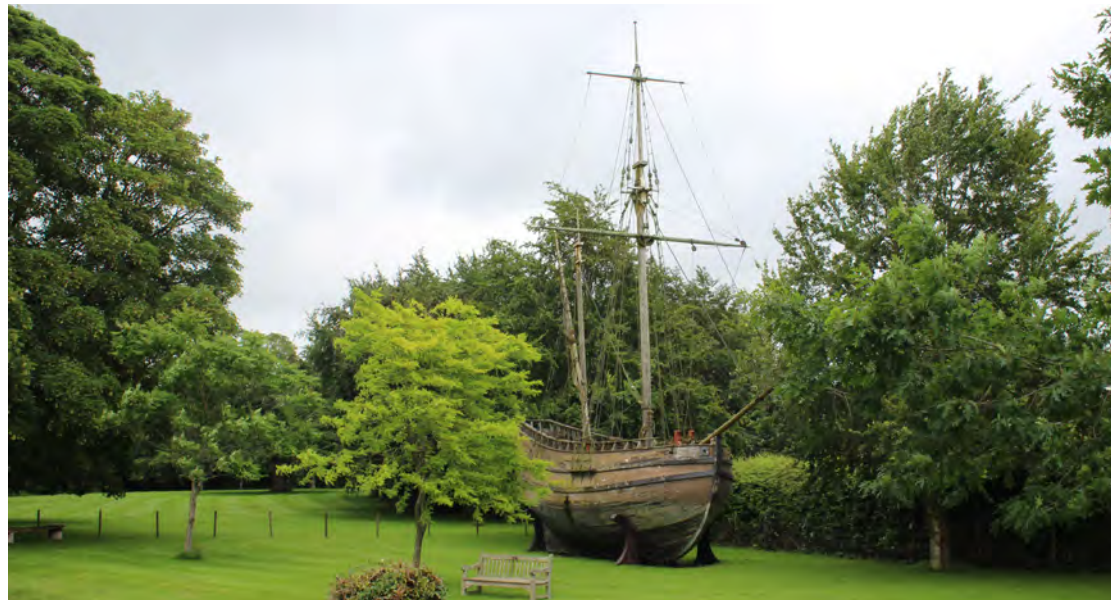
The east landscape setting, adjacent to the east arm of the moat, comprises a mown lawn featuring young and mature trees and a replica of the 'Discovery'. The 'Discovery' was one of the ships that founded Jamestown in Virginia (an expedition funded by a former Westenhanger owner, Sir Thomas Smythe). The replica of the ship is complete with rigging and masts. The paint of the boat is peeling, leaving sections of timber exposed, and the hull planking is beginning to deteriorate in places.

Figure 126: Landscape setting to the east of Inner Court showing the mown lawn, young and mature tree planting and the full-size replica of the 'Discovery'

In 2008, the replica of 'The Discovery', from the 1607 expedition to Virginia, was brought to the site. The original was commissioned by Sir Thomas Smythe, son of the earlier Thomas Smythe, for the East India Company. He led an expedition to Virginia and the boat was one of three that sailed into Chesapeake Bay in 1607 resulting in the foundation of a permanent English-speaking settlement in the Americas.

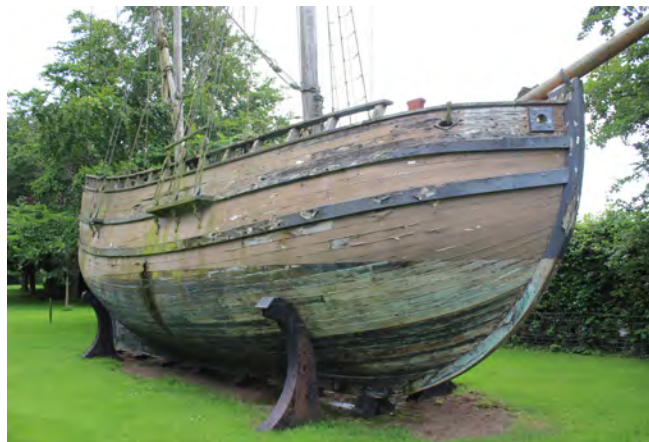
Figure 127: The hull of the 'Discovery' showing peeling paintwork

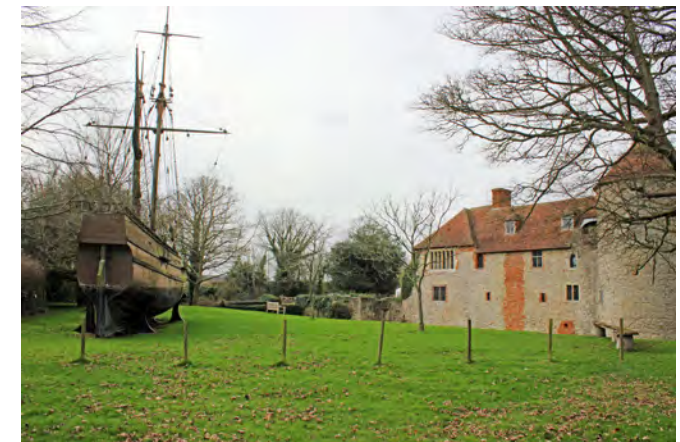
Figure 128: Landscape setting to the east of Inner Court showing timber bollards and benches in the setting of the replica ship

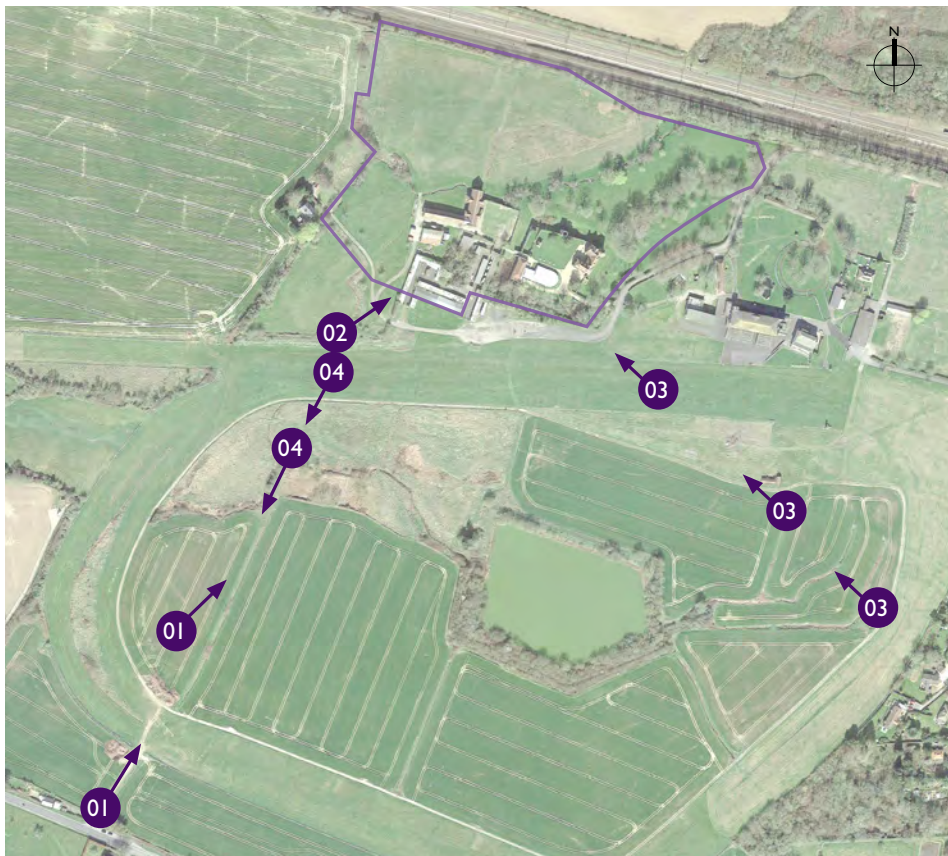
Figure 134: Views outside the Scheduled Monument

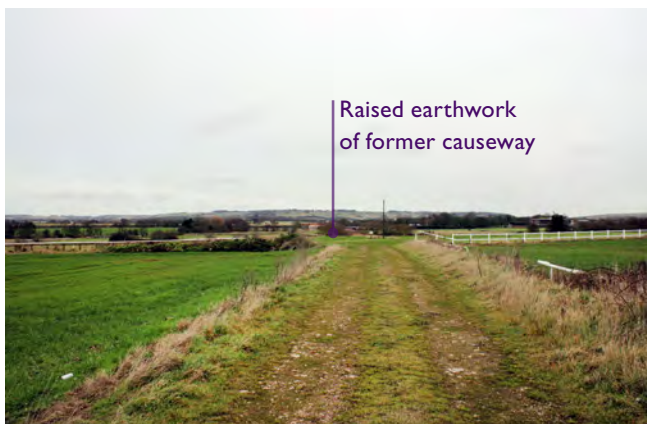
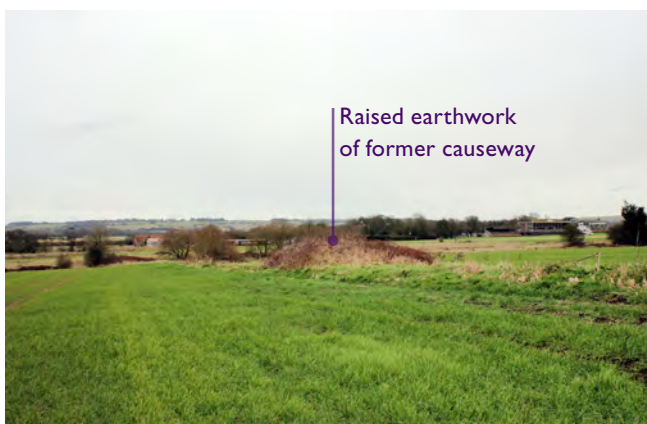
Long-range kinetic views to the south of the Westenhanger Scheduled Monument looking north across the racecourse, along the extant southern section of the Scheduled causeway, accessed off the Ashford Road (A20), and towards Westenhanger.

The view captures the landscape setting to the south of the Scheduled Monument at Westenhanger, which has historic significance as a former Tudor deer park with royal associations. The views are significant in that they include the visibly raised, southern section of the historic causeway approach to Westenhanger, which is scheduled separately and remained the principal approach to the site until the 18th century. The views include glimpse views of the Grade I listed, east-west barn and the conical dovecote roof to the north-east tower, also Grade I listed as part of the Manor House. However, the visibility towards the site, and therefore the significance of the view, has been negatively impacted by the racecourse, associated infrastructure, modern stabling and trees screening the manor house.

Raised earthwork of former causeway

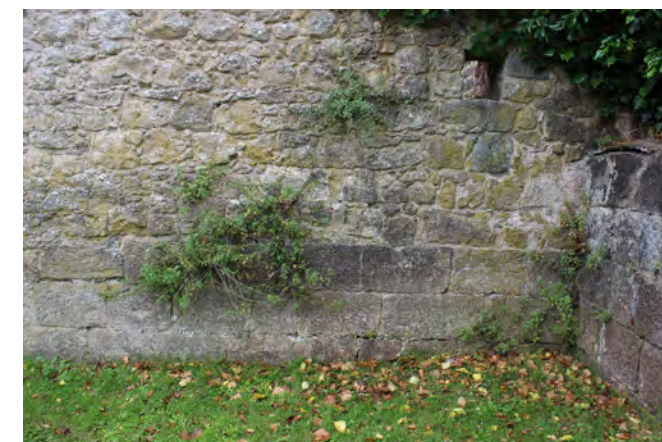
Figure 136: Early dressed ragstone ashlar blocks, found at the lower courses of the curtain wall near the base of the gatehouse, which pre-date the 14th century

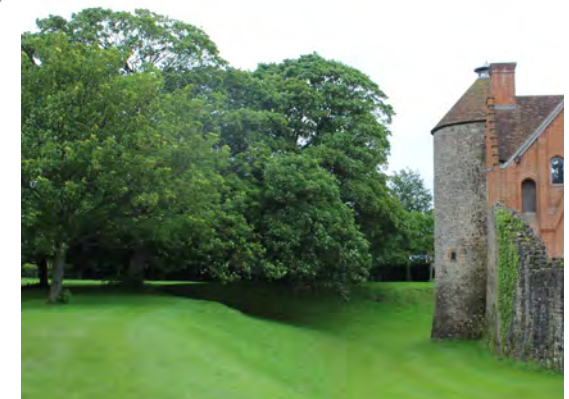
Figure 138: The shadowed dip in the bank of the moat is the remains of an inlet leat, which fed the moat from the River East Stour

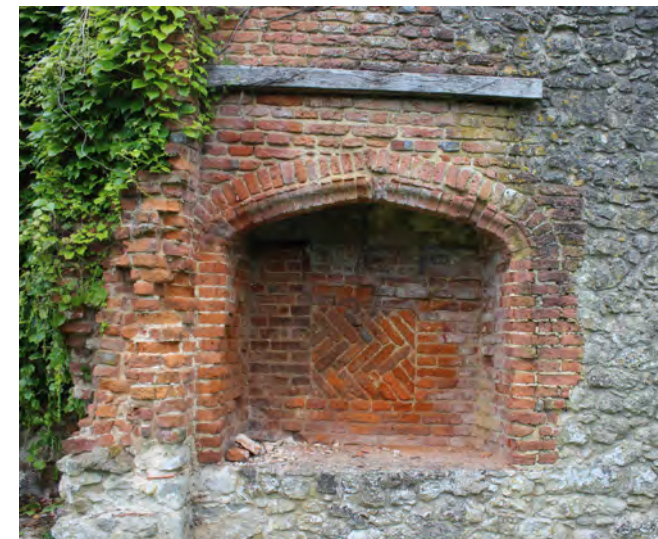
Figure 140: Red brick Tudor fireplace in the west range

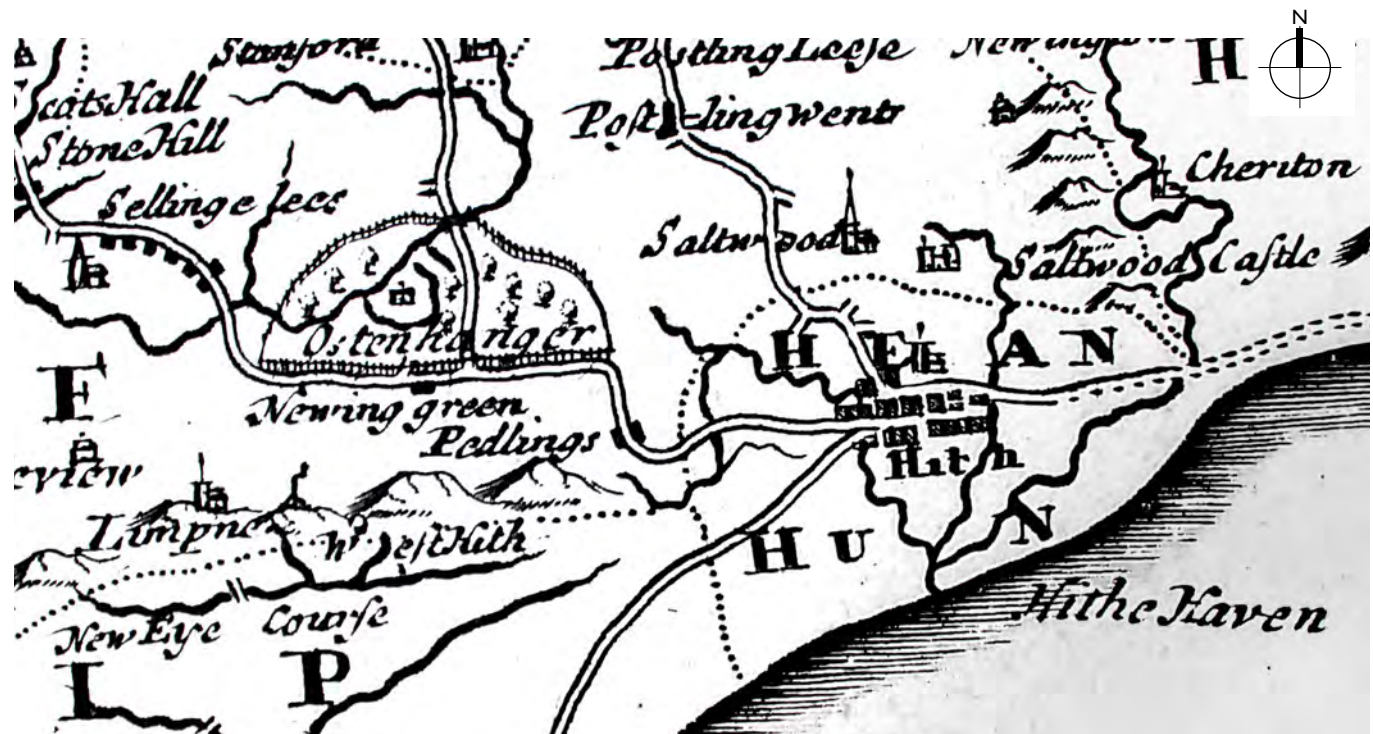
Figure 144: Robert Morden, Map of Kent, 1695, showing 'Ostenhanger' surrounded by a moat, set within the deer park.

and a number of chambers.¹⁹ Many of these latter, ancillary rooms would have been located in Outer Court. Robert Morden's Map of 1695 shows the Manor House, here referred to as 'Ostenhanger', encircled by the moat sitting within the deer park bounded by a fence boundary or park pale. The map was the first to reference the presence of the causeway approach, depicting a gap in the southern boundary of the deer park corresponding with the causeway's southern end.

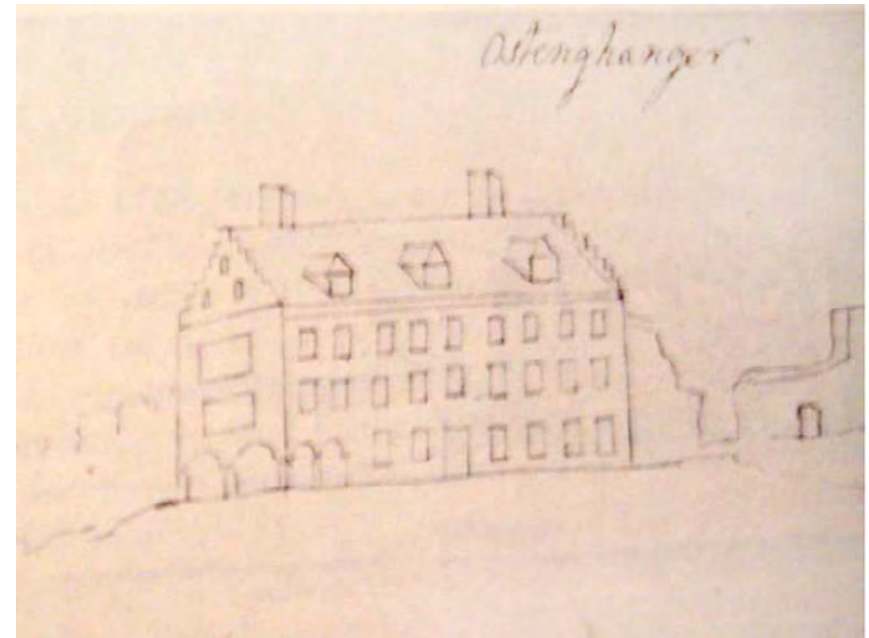
Figure 145: Sketch of Ostenhanger by Hasted, c.1760-1770, after drawing by John Warburton dating to c.1725 (British Library)

Hasted's drawing of 'Ostenhanger' dating to c.1760/ 1770 but copied from an earlier sketch by John Warburton (c.1725), shows that prior to the 18th century alterations the house, namely the north cross-wing, was of a much larger scale. The west crow-stepped gable features three single light windows and below this two large rectangular windows or recessed panels below, which resemble the remaining panel to the rear (north) of the existing main range. Remains of the curtain wall abutting the south end of the Manor House give an insight into the appearance of the remains associated with the former medieval hall, which were likely demolished shortly after in line with the Georgian frontage and driveway.

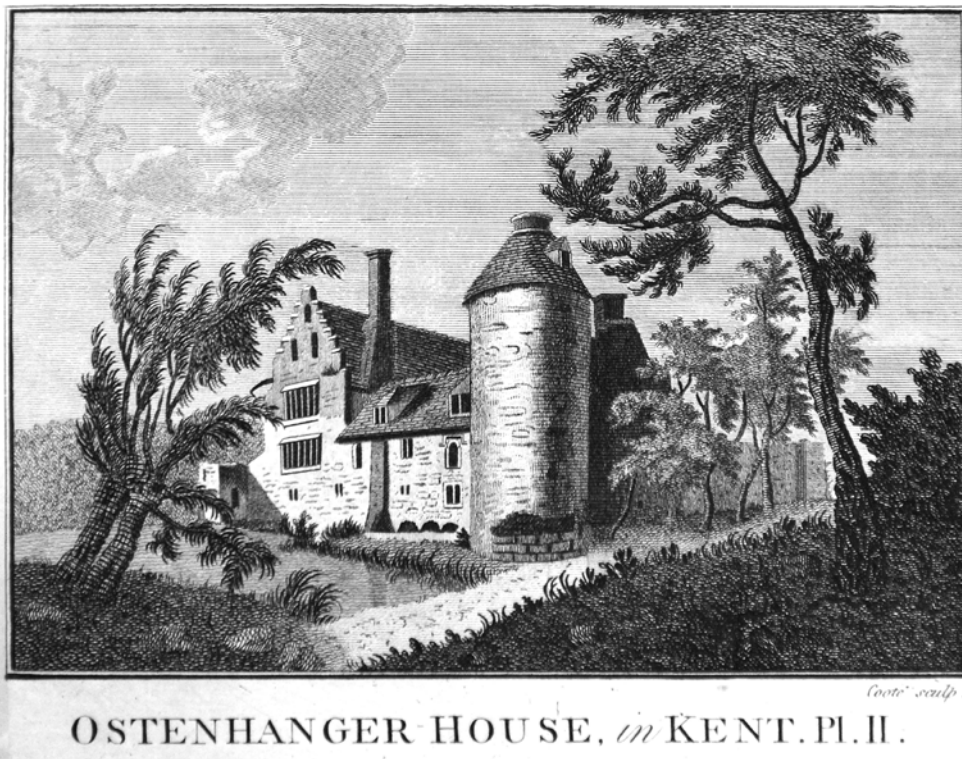
Figure 146: Ostenhanger or Westenhanger House seen from the north-east, Godfrey/ S. Hooper, c.1773

An engraving dating to c.1773 is useful in determining subsequent phases of change to the Manor House. It shows the steeply pitched Tudor crow-stepped gable at the east end of the north 16th century cross-wing with a tall chimney, indicating that the Georgian alterations had not yet taken place. The gable matches the opposite (east) gable shown on Hasted's sketch with two tiers of single light openings. The gable and the two tiers of single light openings have since been lost, as well as the upper six light mullioned window, however, the lower mullioned window remains. The moat along this range is filled meaning the visible elevation is more limited than the elevation we see today. The fenestration in the east range has been altered. To the right of the round north-east tower, the kitchen gable and chimney are visible, these have since been lost.

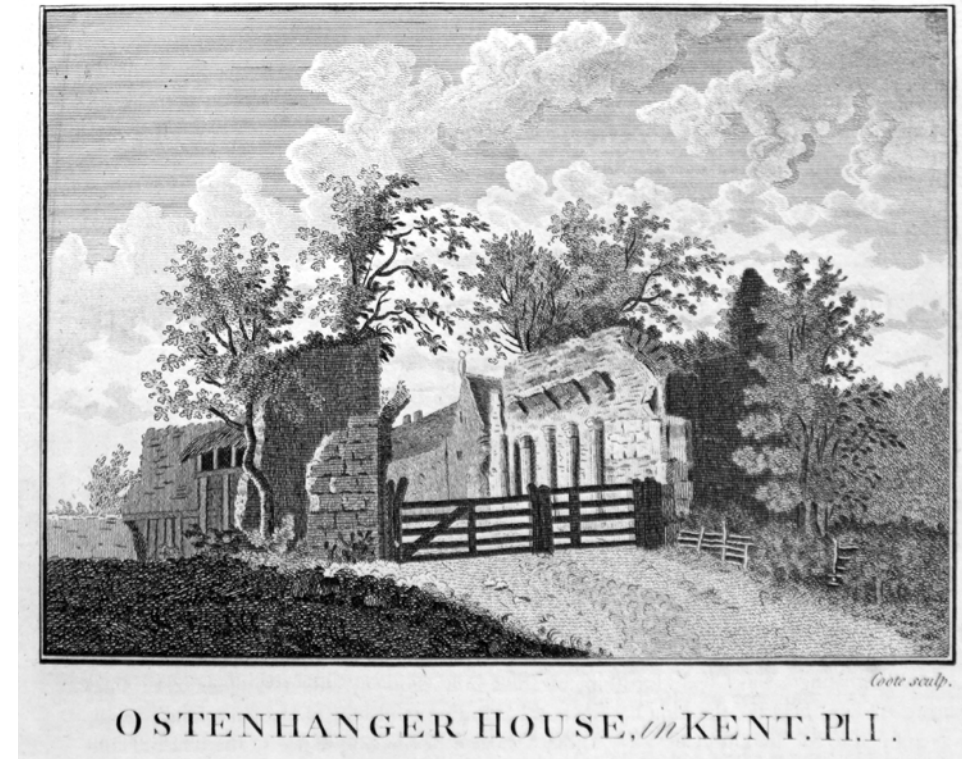
Figure 147: View looking west of the remains of the vaulted arch entrance to the gatehouse showing the barns in the background, from a sketch c.1750 or 1780 (British Library, reproduced in *Archaeologia Cantiana* Vol 31, 1915)

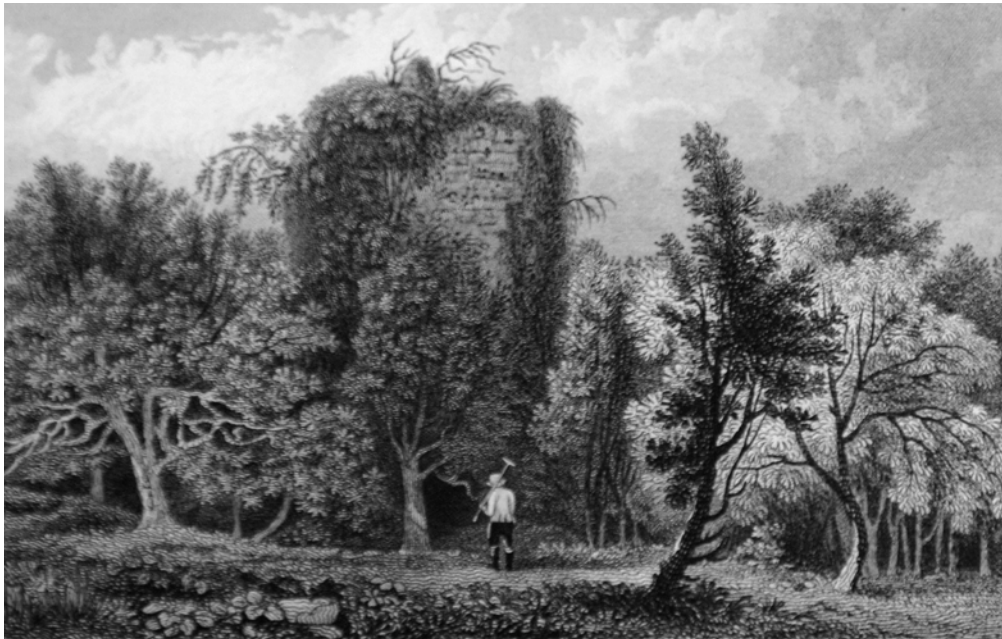
Figure 150: Print of Rosamund's tower at Westenhanger House (Folkestone Library, undated [c.early/ mid-19th century])

The two undated prints of Rosamund's tower likely date to the early/ mid-19th century and show particularly picturesque representations of the tower, engulfed in ivy and foliage with artfully placed trees framing views of the structure. Whilst their romantic renderings cannot be relied upon for their accuracy, the prints indicate the neglect of the site and the ruinous nature of the buildings during this period.

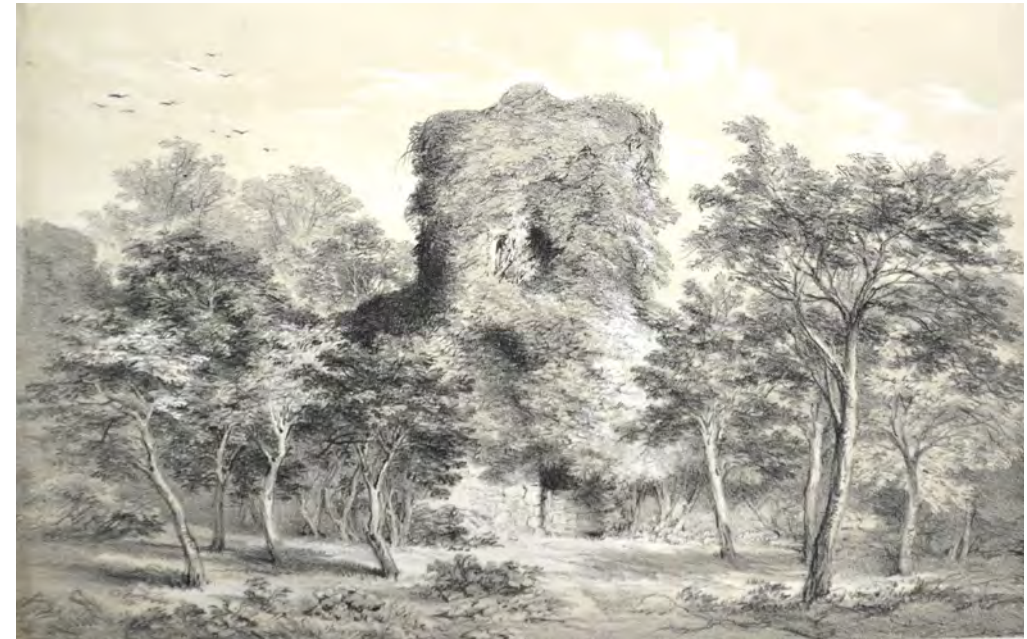
Figure 151: Print of Fair Rosamund's tower, Westenhanger (Folkestone Library, undated [c.early/ mid 19th century])

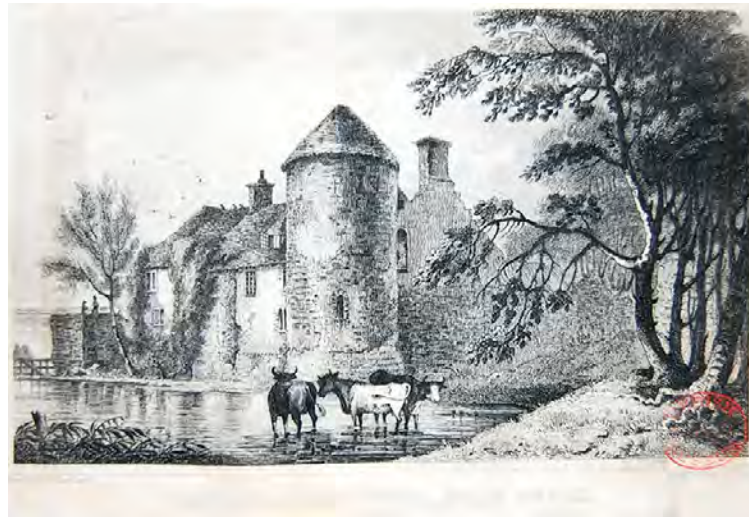
Figure 153: View of moated medieval Manor House by John Rogers after George Shepherd, c.1830 (British Library)

Mid-to late 19th century prints show the Manor House in a pastoral landscape surrounded by farmland and grazing livestock. Comparison of these images with those dating to the 1760s/1770s, illustrates the change that took place in the latter part of the 18th and the 19th century, although their picturesque quality and minor discrepancies may indicate some artistic license. The crow-stepped gable had been replaced, although the replacement roof typology varies from pitched roof to gable end. Although the fenestration represented does not seem entirely consistent, what is clear is that the upper mullioned window to the east gable of the main range had been lost. In each print the Manor House and curtain walls are shrouded in ivy. The last image depicting the Georgian south range shows two first floor windows infilled and the south-east approach to Inner Court.

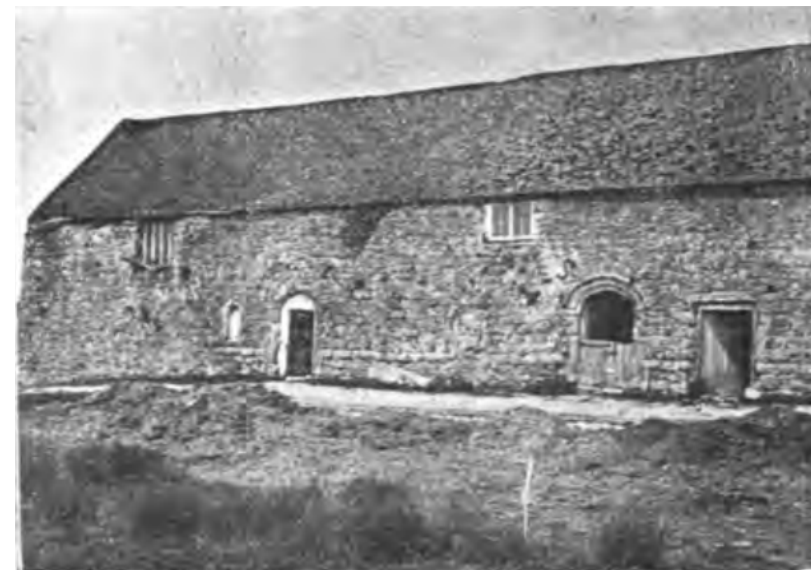
A late 19th or early 20th century photograph of east-west barn shows the building in disrepair. The different types of openings and doors visible reflects the extent of change to windows and doors.

Figure 157: Historic photograph showing the south elevation of the east-west barn (Archaeologia Cantiana, 1915)

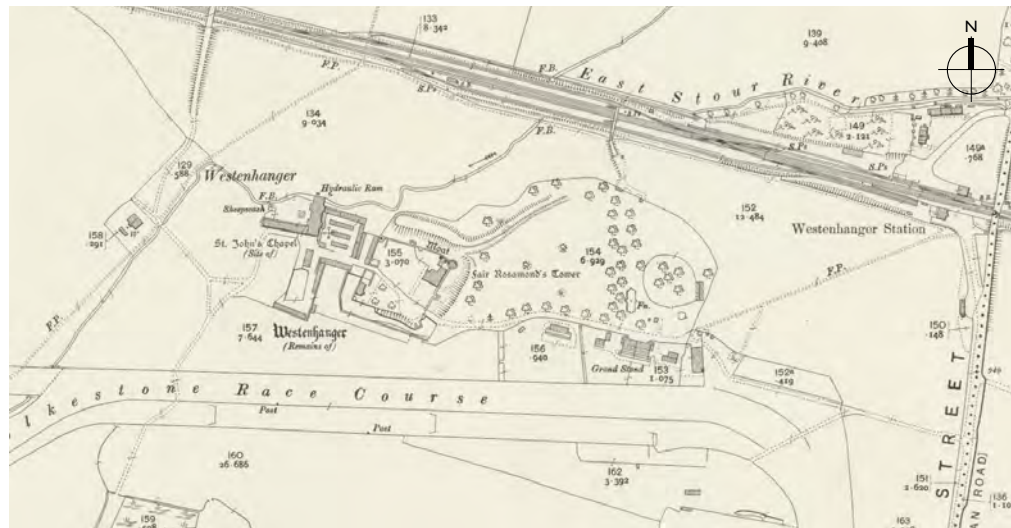
Figure 158: OS map, 1906 (National Library of Scotland)

The 1906 OS map shows the site had become increasingly hemmed in, with the arrival of Folkestone Racecourse, established in 1898, and the construction of associated infrastructure including the racecourse itself to the south of the site, the grandstand to the east and stabling built on the land to the east of the north-south barn on the site of the former medieval church. The racecourse visibly cuts across the former approaches to the south, namely the historic causeway to the south-west and the Pound House Track to the south-east. An additional building or extension had been added into Inner Court abutting the north curtain wall, to the west of the north-east tower. The only remaining filled sections of the moat were the south-east and south-west corners.

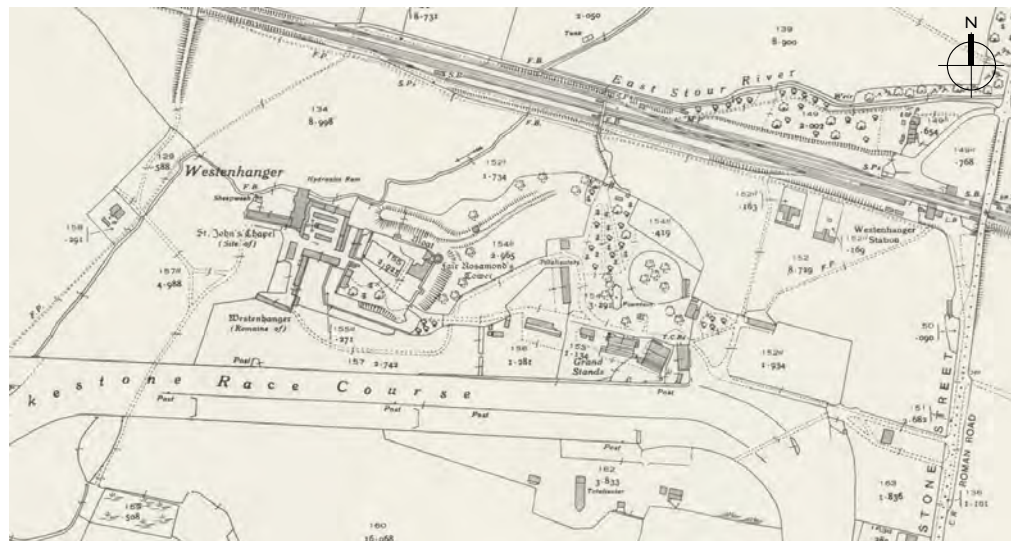
Figure 159: OS map, 1939 (National Library of Scotland)

The 1939 OS map shows the racecourse infrastructure had expanded further with new buildings erected to the east of the site. Another building had been added to the west range to the south of the gatehouse.

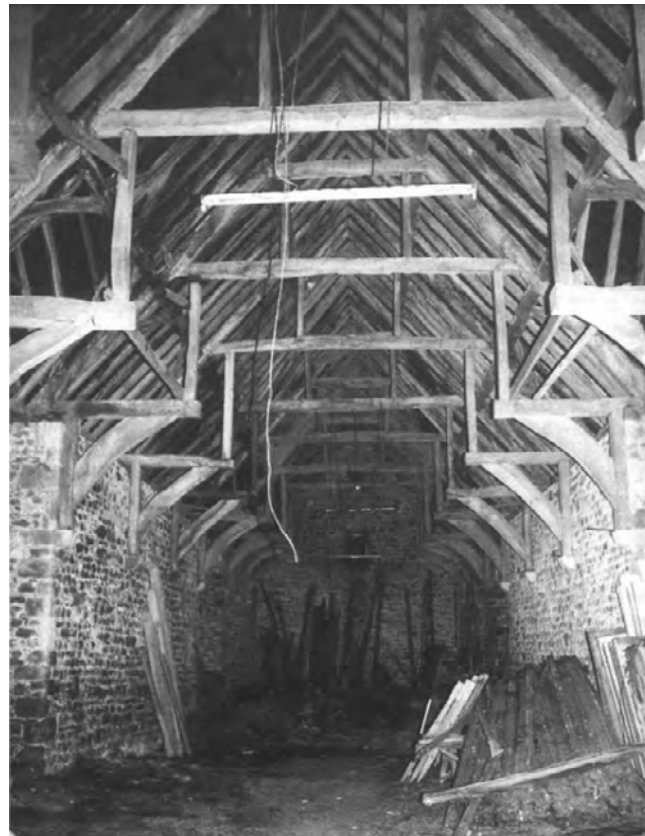
Figure 160: Interior of the north-south barn looking north showing the barn prior to restoration (Archaeologia Cantiana, 2001)

In 2002, the Forge family acquired the barns from the owners of the racecourse and began significant repairs, with advice and grants from English Heritage.
