OTTERPOOL PARK

Environmental Statement Appendix 16: Collision Analysis Technical Note

MARCH 2022

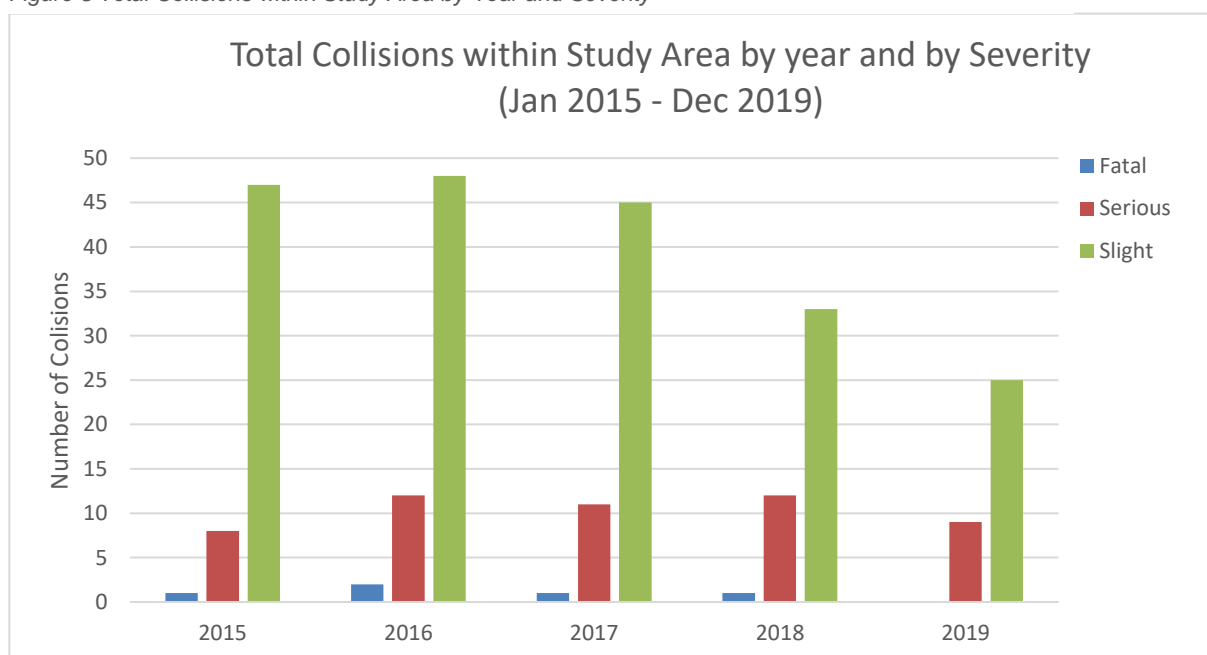
Figure 3 Total Collisions within Study Area by Year and Severity

1.2.5 Figure 3 shows that total collisions per year peaked in 2016 but then generally declined during the remaining period.

1.2.4 A summary of the total collisions over the five-year period by year and severity is provided in Table 4 and the yearly distribution of collisions by severity is presented in Figure 3.

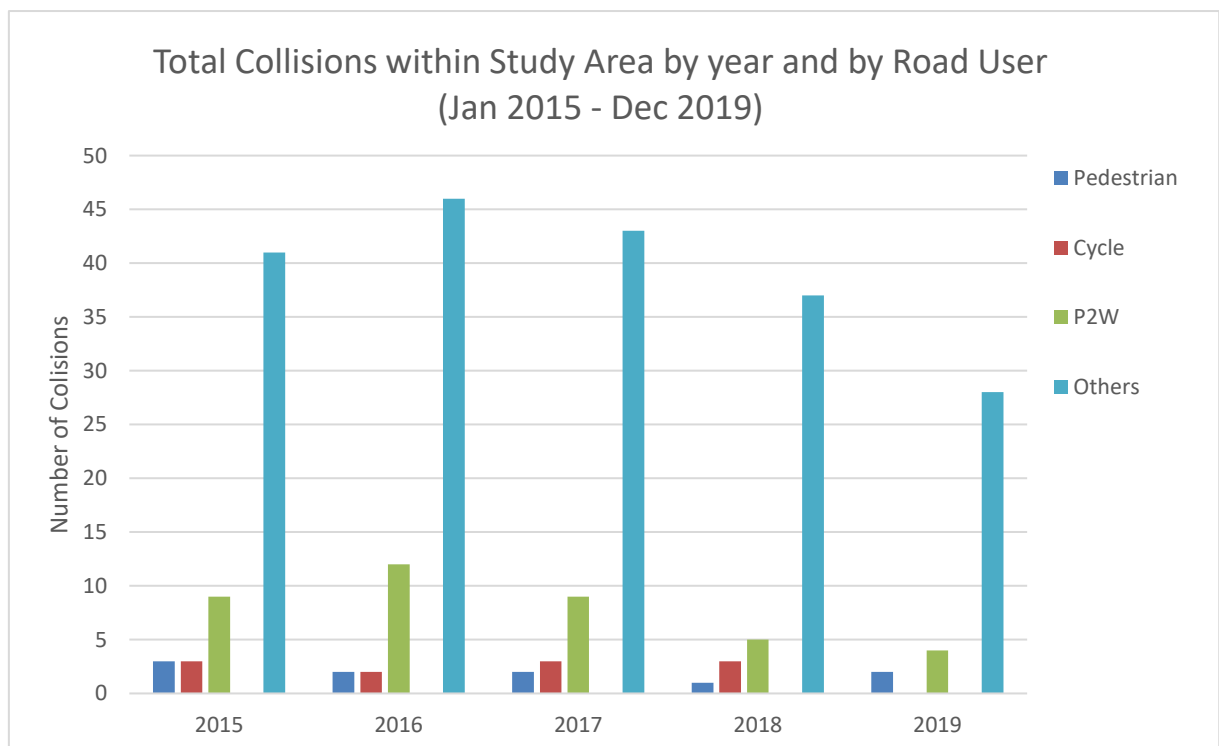
Figure 4 Total Collisions within Study Area by Year and by Road User

1.3.1 In terms of injuries to vulnerable road users, a total of 10 collisions resulted in injuries to pedestrians (4%), 11 collisions (4%) resulted in injuries to pedal cyclists and 39 collisions (15%) resulted in injuries to motorcyclists.

1.3.2 A summary of total collisions within the study area over the five-year period by year and road user is provided in Table 5 Total Collisions within Study Area by Year by Road User and shown in Figure 4.

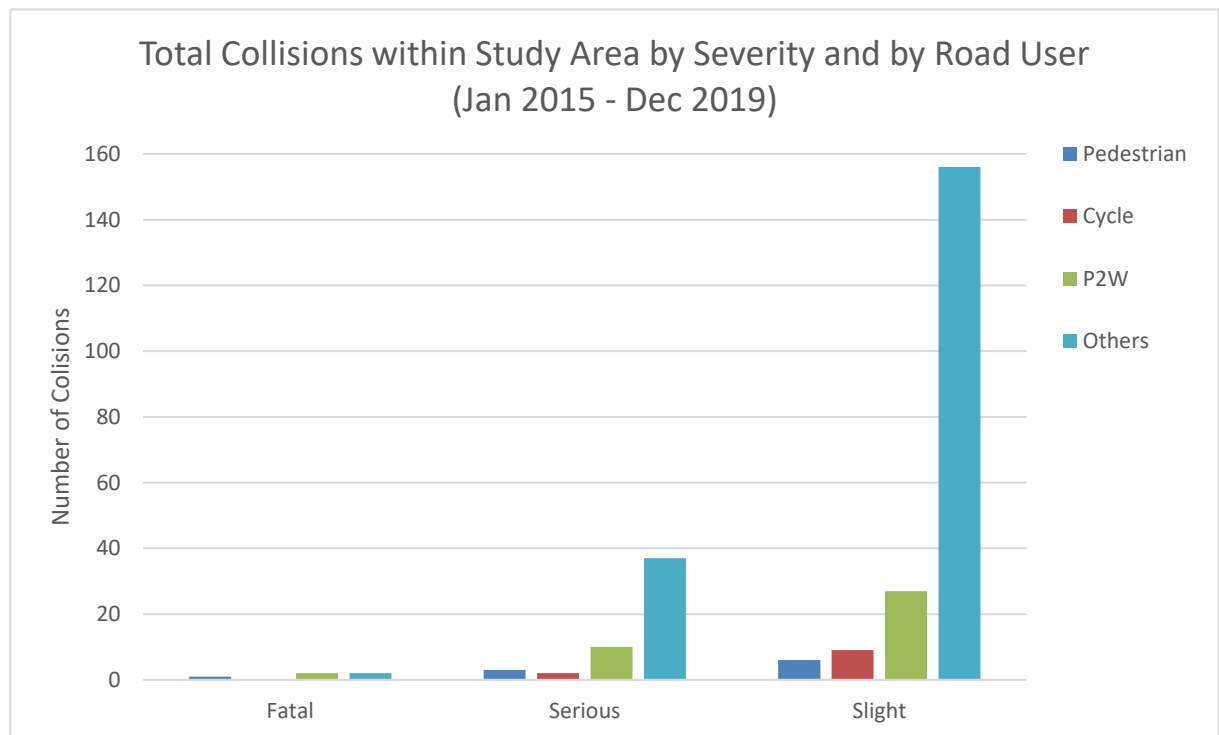
Figure 5 Total Collisions within Study Area by Severity and by Road User

1.4.1 Table 6 Total Collisions within Study Area by Severity and by Road User shows total collisions within the study area by severity and by road user for the five-year period and this is summarised in Figure 5.

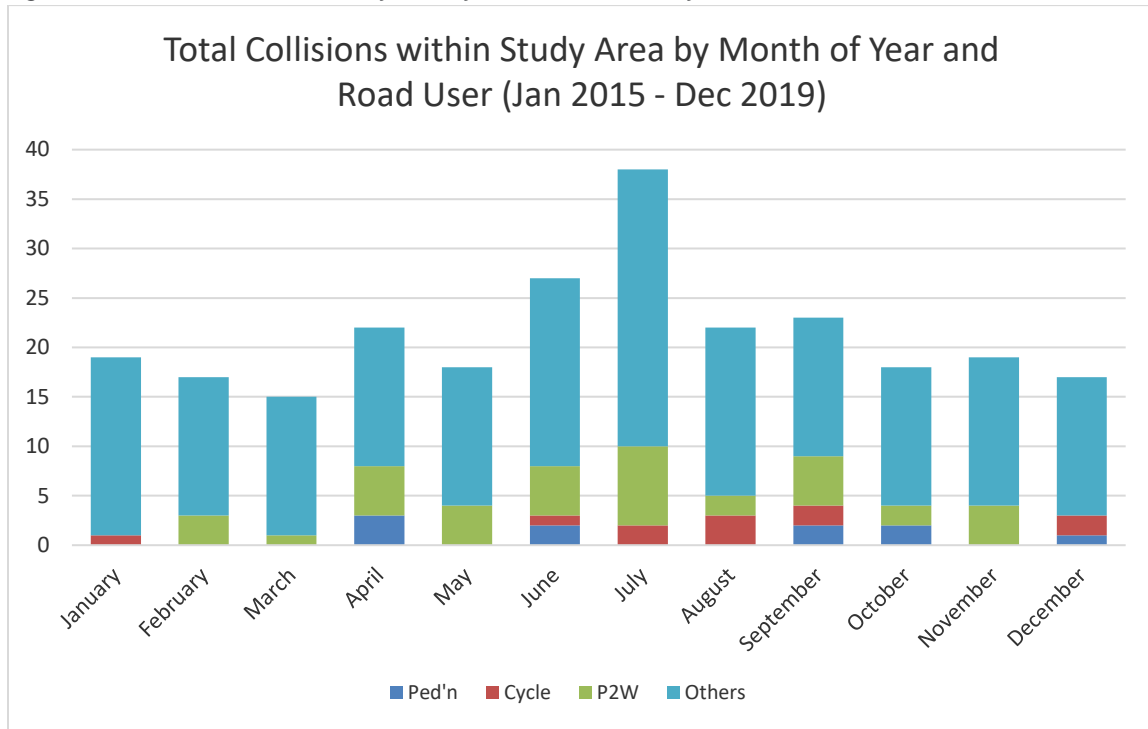
Figure 10 Total Collisions within Study Area by Month of Year and by Road User

1.7.1 Figure 10 highlights the distribution of total collisions by month of the year and by road user.

1.7.2 The number of collisions over each month is fairly consistent. However, the highest number of collisions along the Study Area occurred in July (38 collisions - 15%), followed by June (27 collisions - 11%). The least number of collisions occurred in March (15 collisions - 6%).

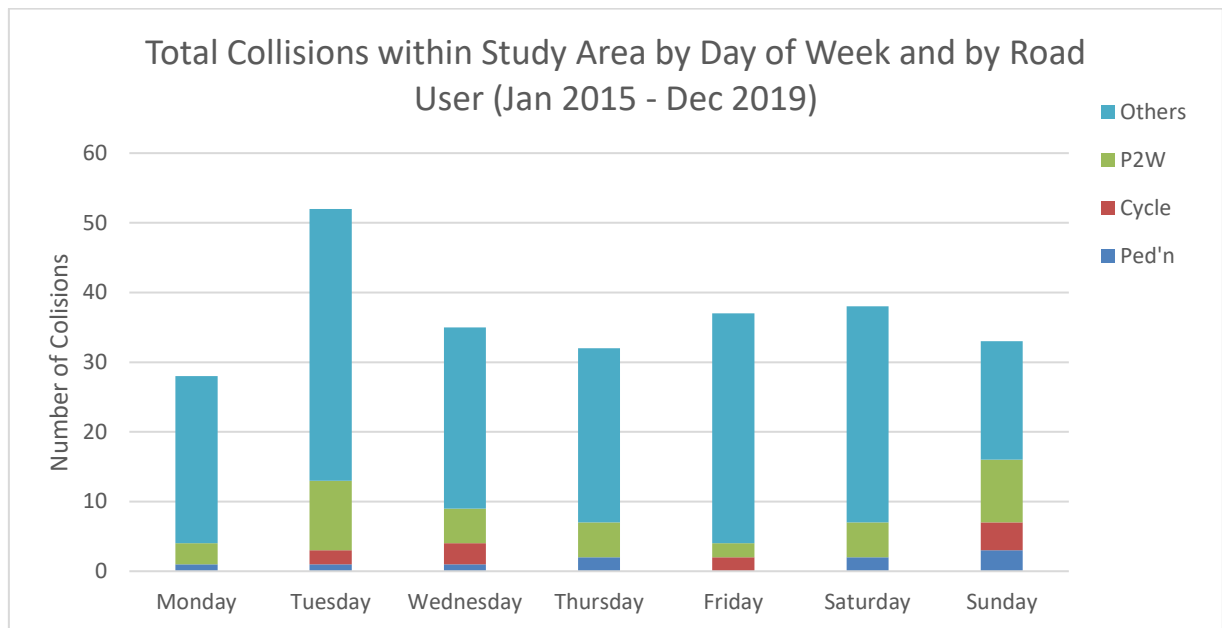
Figure 11 Total Collisions within Study Area by Day of Week and by Road User

- 1.8.1 Figure 11 highlights the distribution of total collisions during the day of the week by road user.
- 1.8.2 In general, collisions occur fairly evenly throughout the week. However, the greatest number of collisions was recorded on a Tuesday (52 collisions, 20%) and the least number of collisions was recorded on a Monday (28 collisions, 11%).

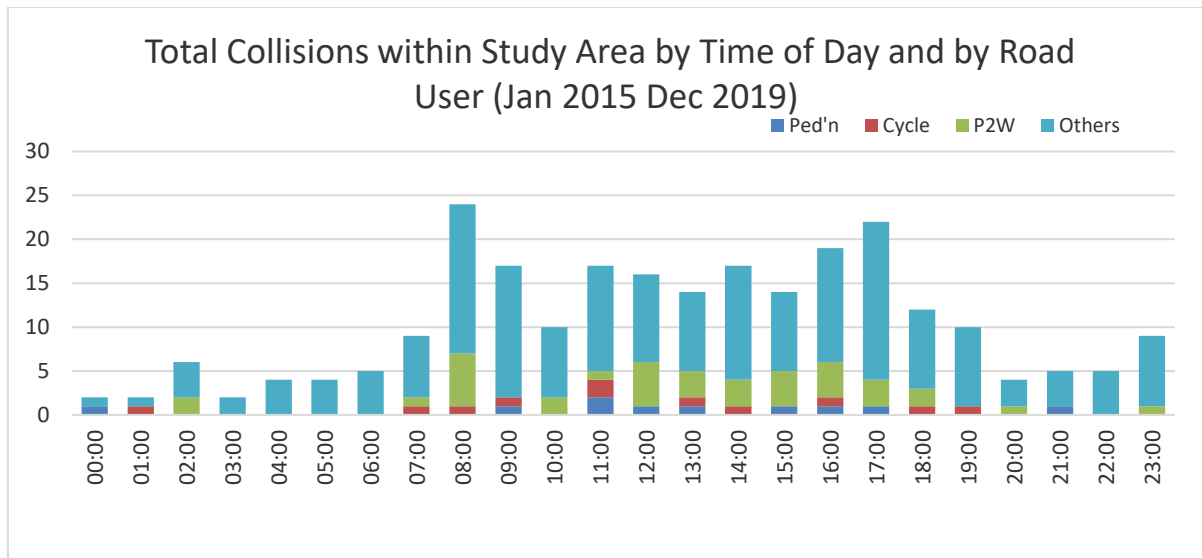
Figure 12 Total Collisions within Study Area by Time of Day and by Road User

- 1.9.1 Figure 12 highlights the distribution of total collisions by time of day and by road user.
- 1.9.2 Generally the highest number of collisions occurred during the AM and PM peak hour period (08:00-08:59 & 17:00-17:59).

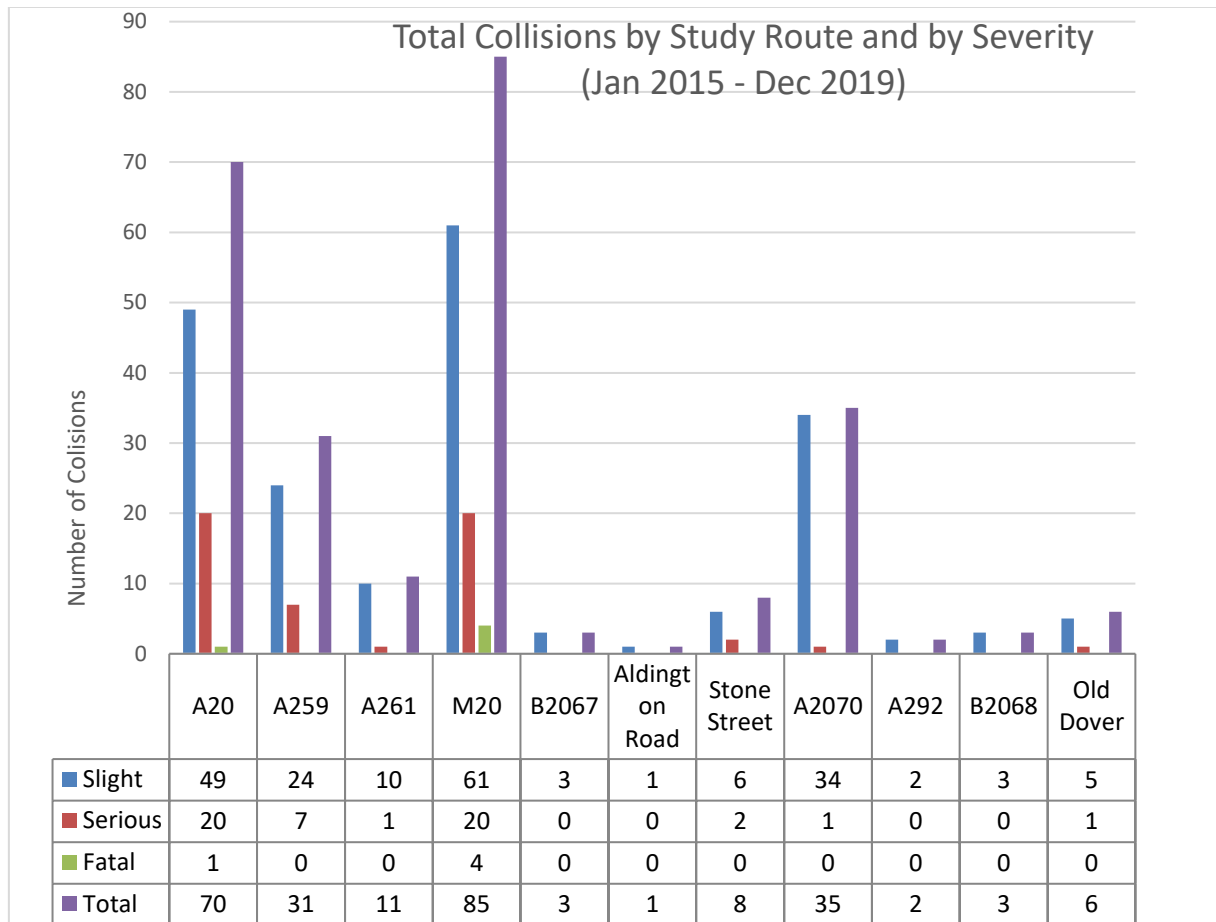
Figure 13 Total Collisions by Study Route and Severity

- 1.10.1 Collision severity totals per study route and by severity are provided in Figure 13.
- 1.10.2 The majority of collisions occurred along the M20 Corridor (Junction 9 - Junction 11 [excluding Junction 10A]) with 85 collisions (34% of total collisions).

- 1.10.3 This was followed by notable collision totals experienced along A20 (Barrow Hill, Ashford Road & Hythe Road with 70 collisions – 28% of total collisions), A2070 (Bad Munstereifel Road & Lacton Interchange with 35 collisions – 14% of total collisions) and A259 (Dymchurch Road & Seabrook Road with 31 collisions – 12% of total collisions).

- 1.10.5 Four out of five of the fatal collisions occurred along the M20 motorway, while most serious collisions (20) were recorded equally along the M20 and A20 respectively.

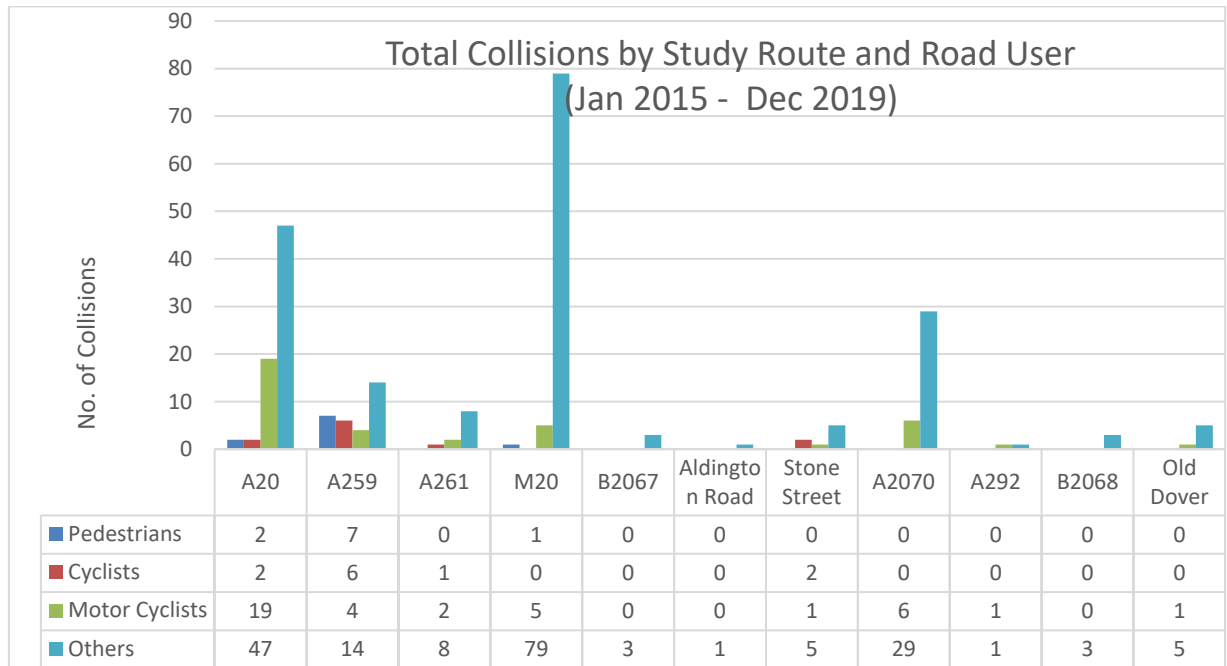
Figure 14 Total Collisions by Study Route and Road User

1.11.1 Figure 14 shows the number of collisions by study route and by road user.

1.11.2 In terms of vulnerable road users, during the five-year period the highest number of pedestrian collisions (seven) occurred along the A259 carriageway, and 19 motorcycle collisions along the A20 carriageway.

1.11.3 The highest number of collisions involving cyclist were also recorded along the A259 carriageway and totalled six collisions.

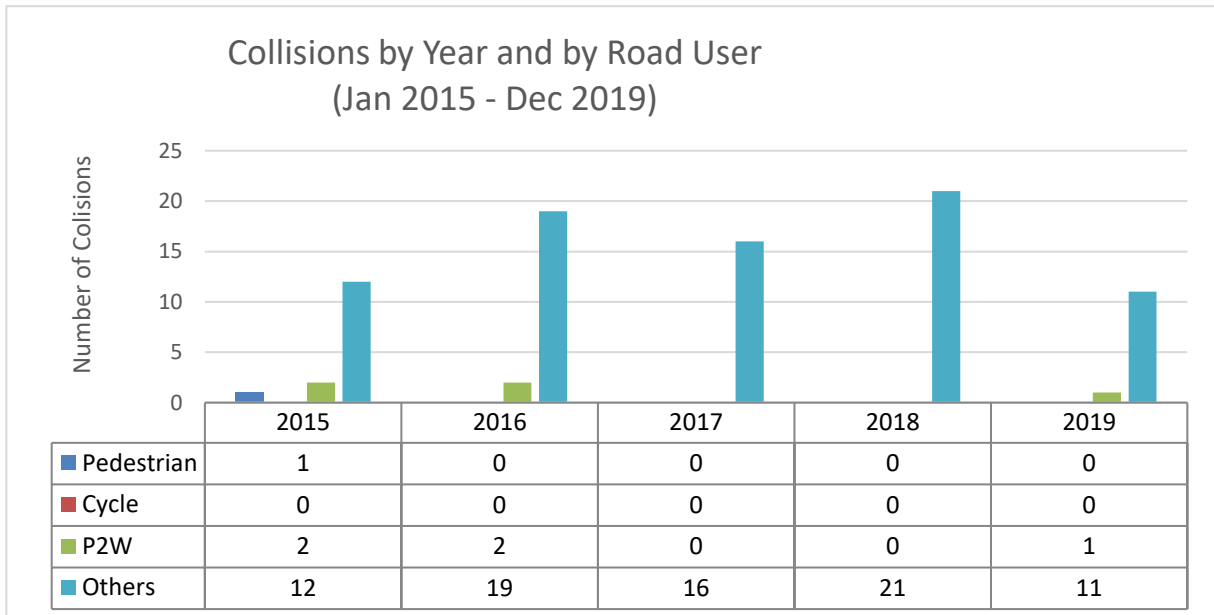
Figure 19 M20 Collisions by Year and by Road User

1.16.1 Figure 19 shows the number of collisions recorded by year and by road users along the M20 Study Route. The greatest number of collisions were recorded during the period 2016 to 2018.

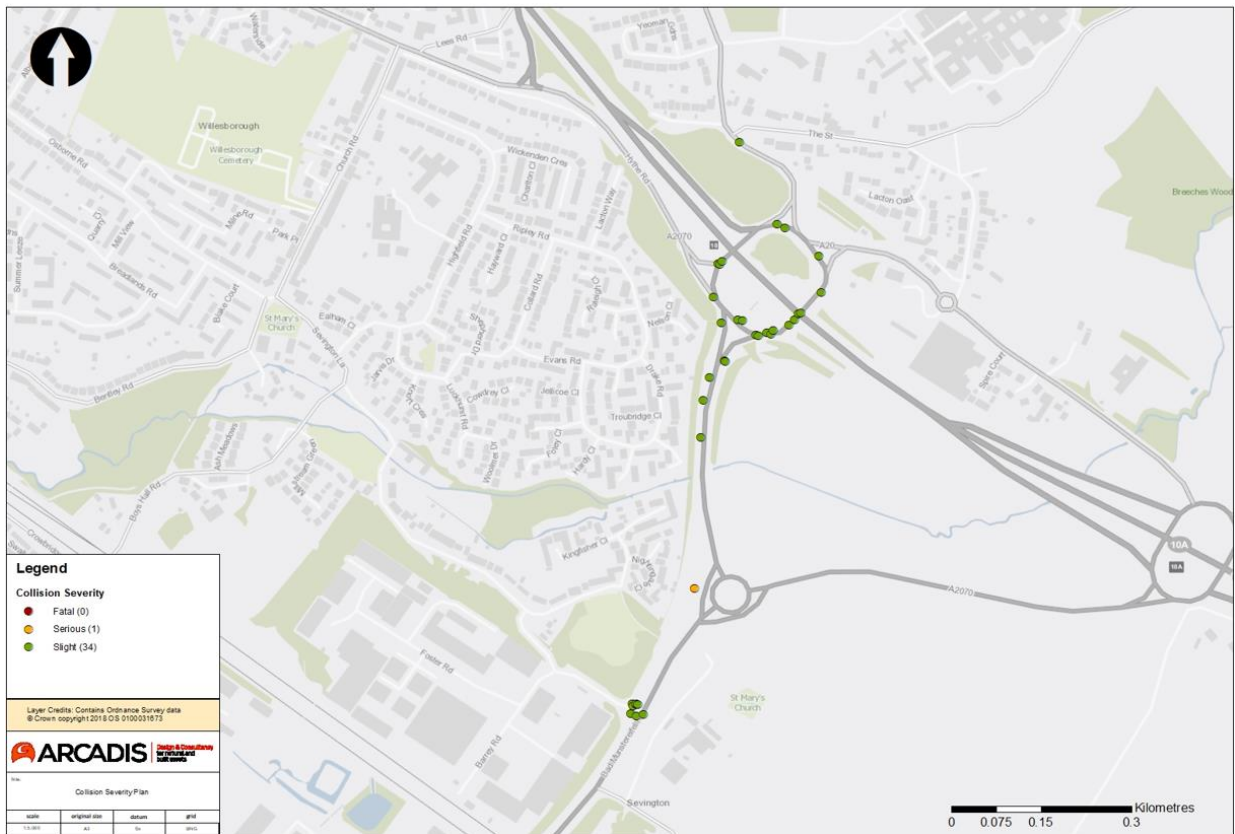
Figure 21 A2070 Collision Study Route

1.18.1 In total, 35 collisions occurred along the study route. The location of these collisions are shown in Figure 21.

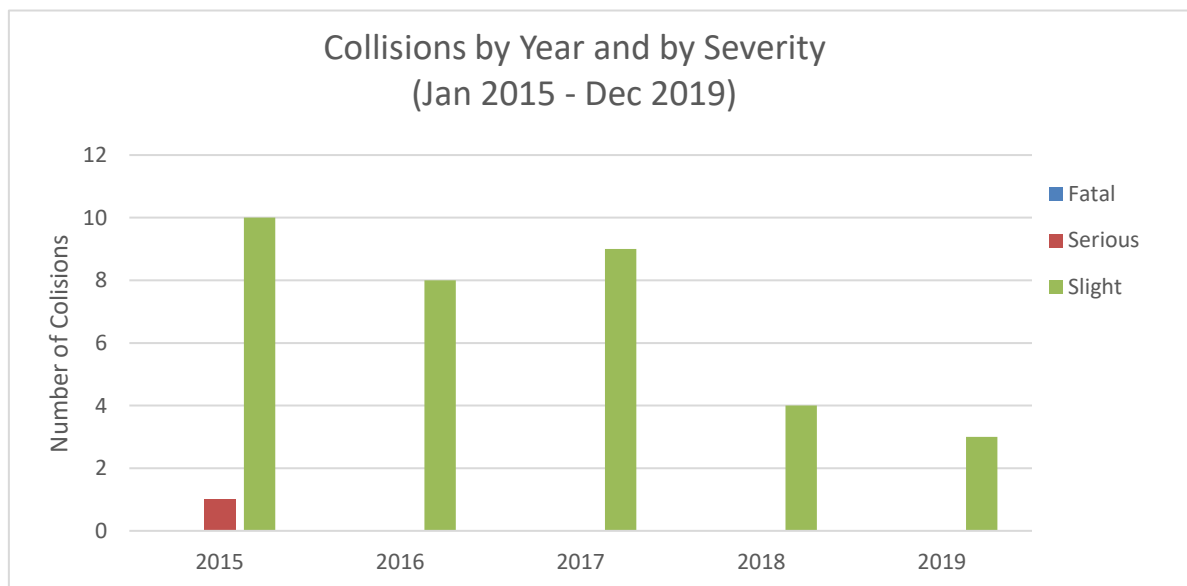
Figure 23 A2070 Collisions by Year and by Severity

1.20.1 Figure 23 shows the number of collisions recorded each year by severity along A2070 Study Route. There was a general decline in the number of collisions over the five-year period.

1.20.2 It is noted that most collisions along the study route resulted in slight collisions.

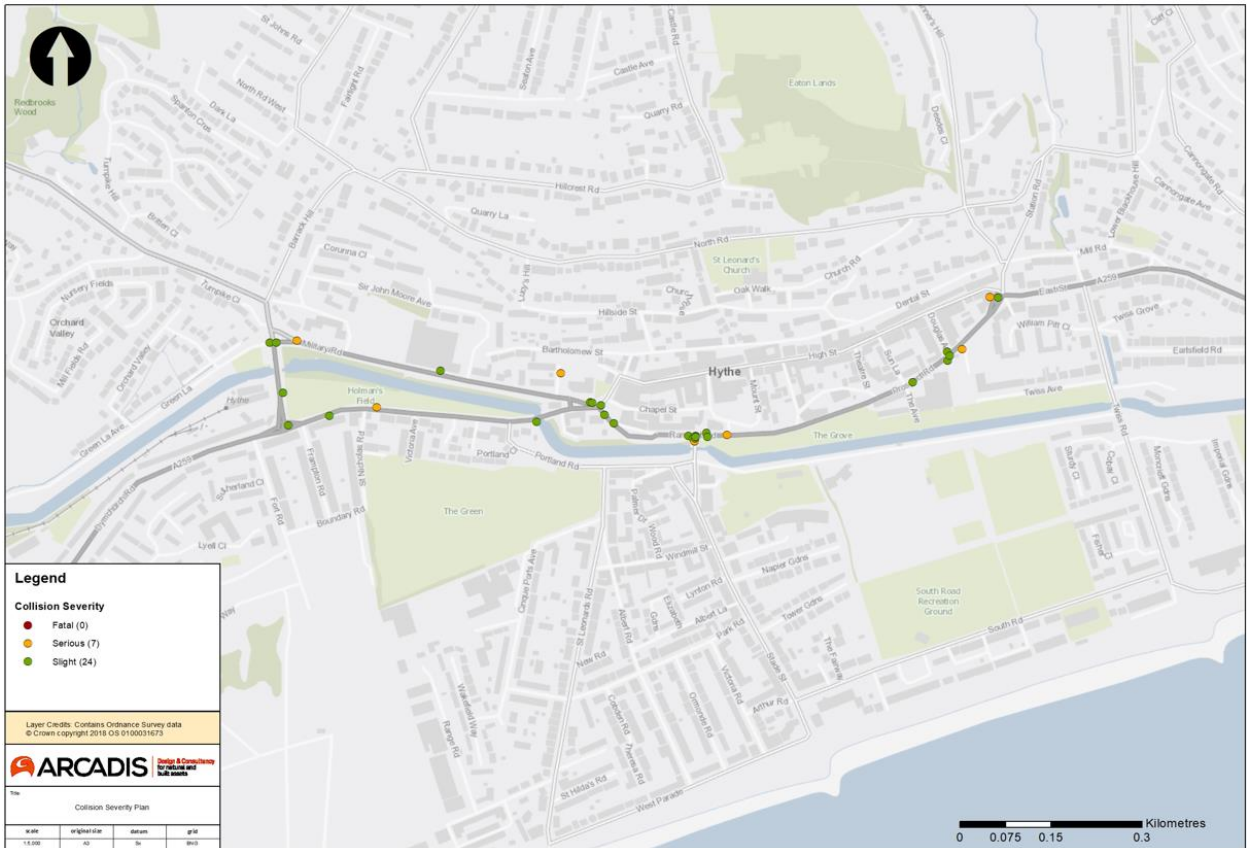
Figure 24 A259 Collision Study Route

1.21.1 In total, 31 collisions occurred along the A259 Study Route. The location of these collisions are shown in Figure 24.

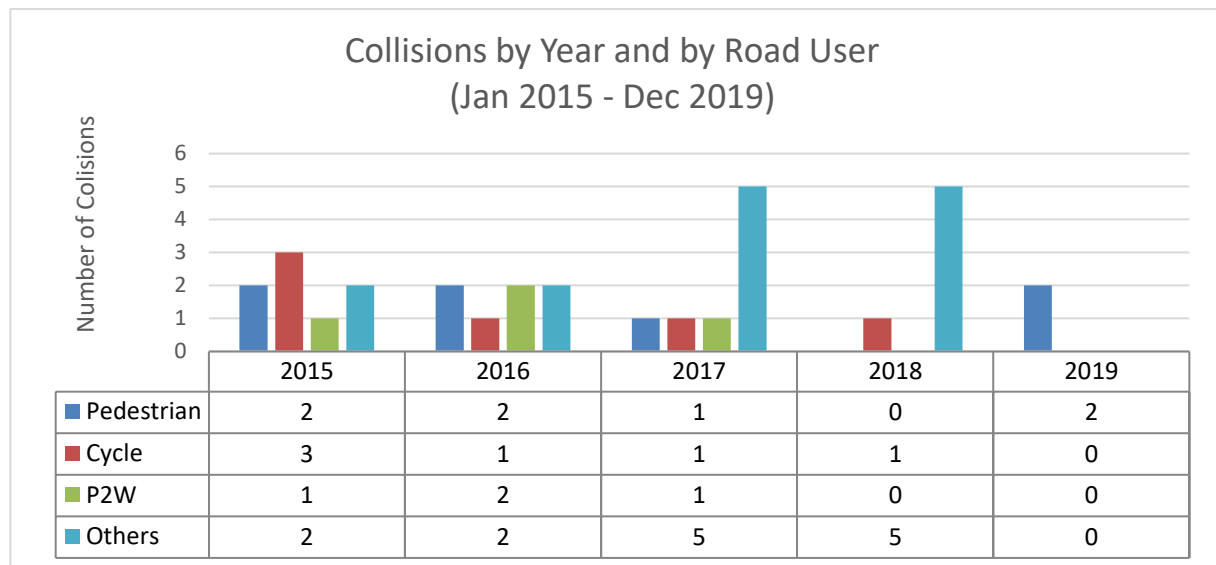
Figure 25 A259 Collisions by Year and by Road User

1.22.1 Figure 25 shows the number of collisions recorded each year by road users along the A259 Study Route. In general, the number of collisions that occurred each year was fairly consistent between 2015 to 2018, with a notable decrease in collisions recorded during 2019. It can also be seen that over 50% of total collisions along the study route involved vulnerable road users.

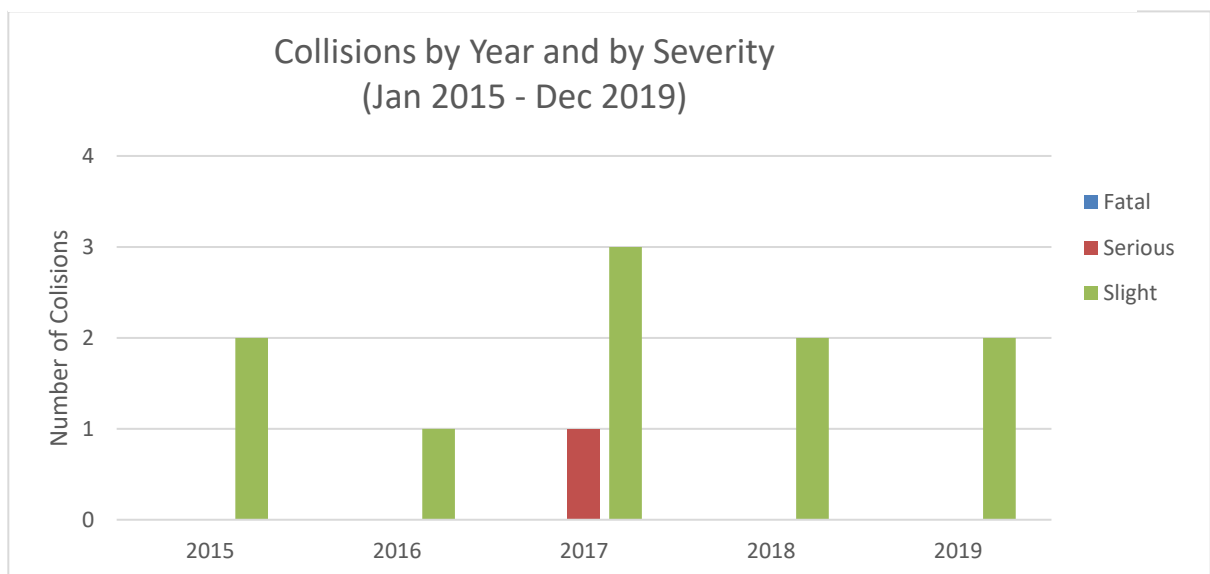
Figure 29 A261 Collisions by Year and by Severity

1.26.1 Figure 29 shows the number of collisions recorded by year and severity along the A261 Study Route. Collisions notably peaked during 2017 with four collisions.

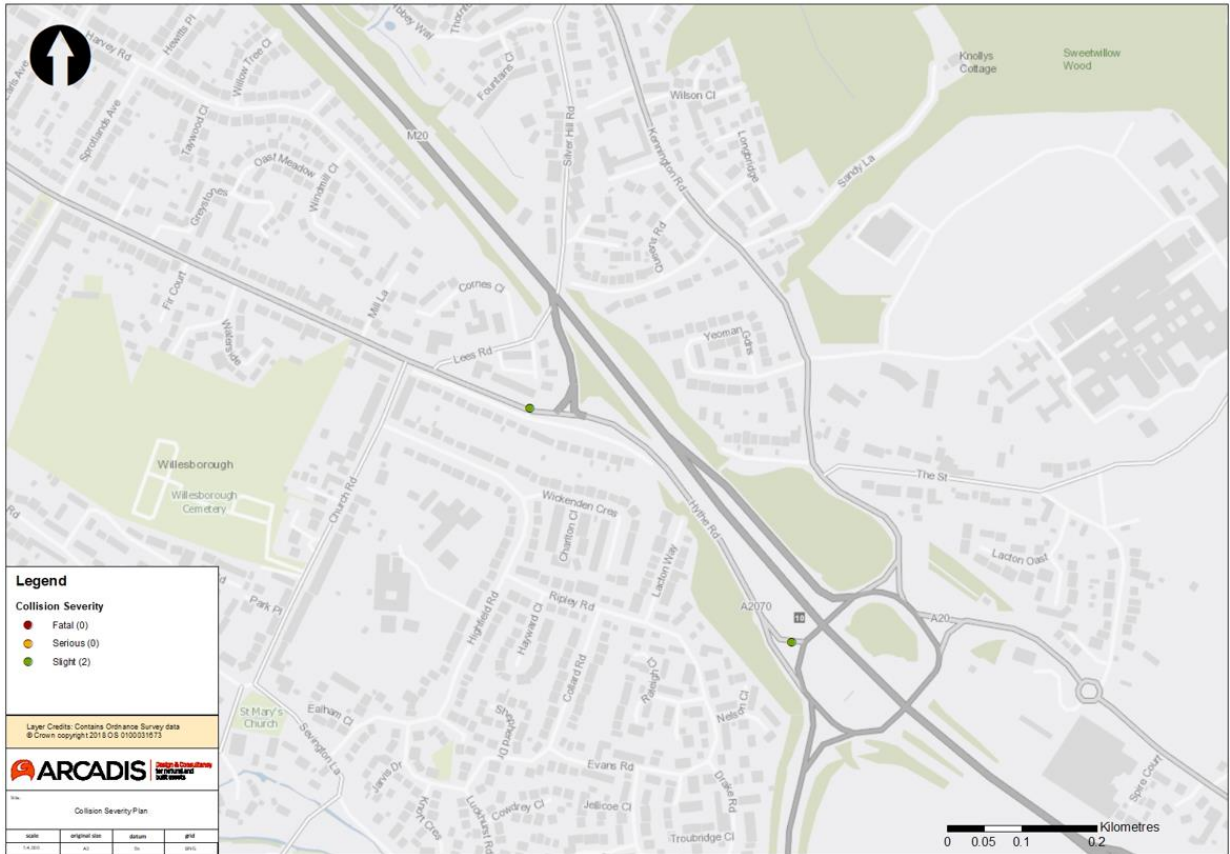
Figure 39 A292 Collision Study Route

1.36.1 In total, 2 collisions occurred along A292 Study Route. The location of all collisions are shown in Figure 39.
