Proposed Leisure Centre and  
Mixed-Use Development at  
Princes Parade  
Hythe

Environmental Statement  
**Technical Annex 5**  
Geo-Environment

GEO-ENVIRONMENTAL ASSESSMENT  
PRINCES PARADE  
HYTHE, KENT  
SHEPWAY DISTRICT COUNCIL  
GEA-17436AI-15-193  
MAY 2017

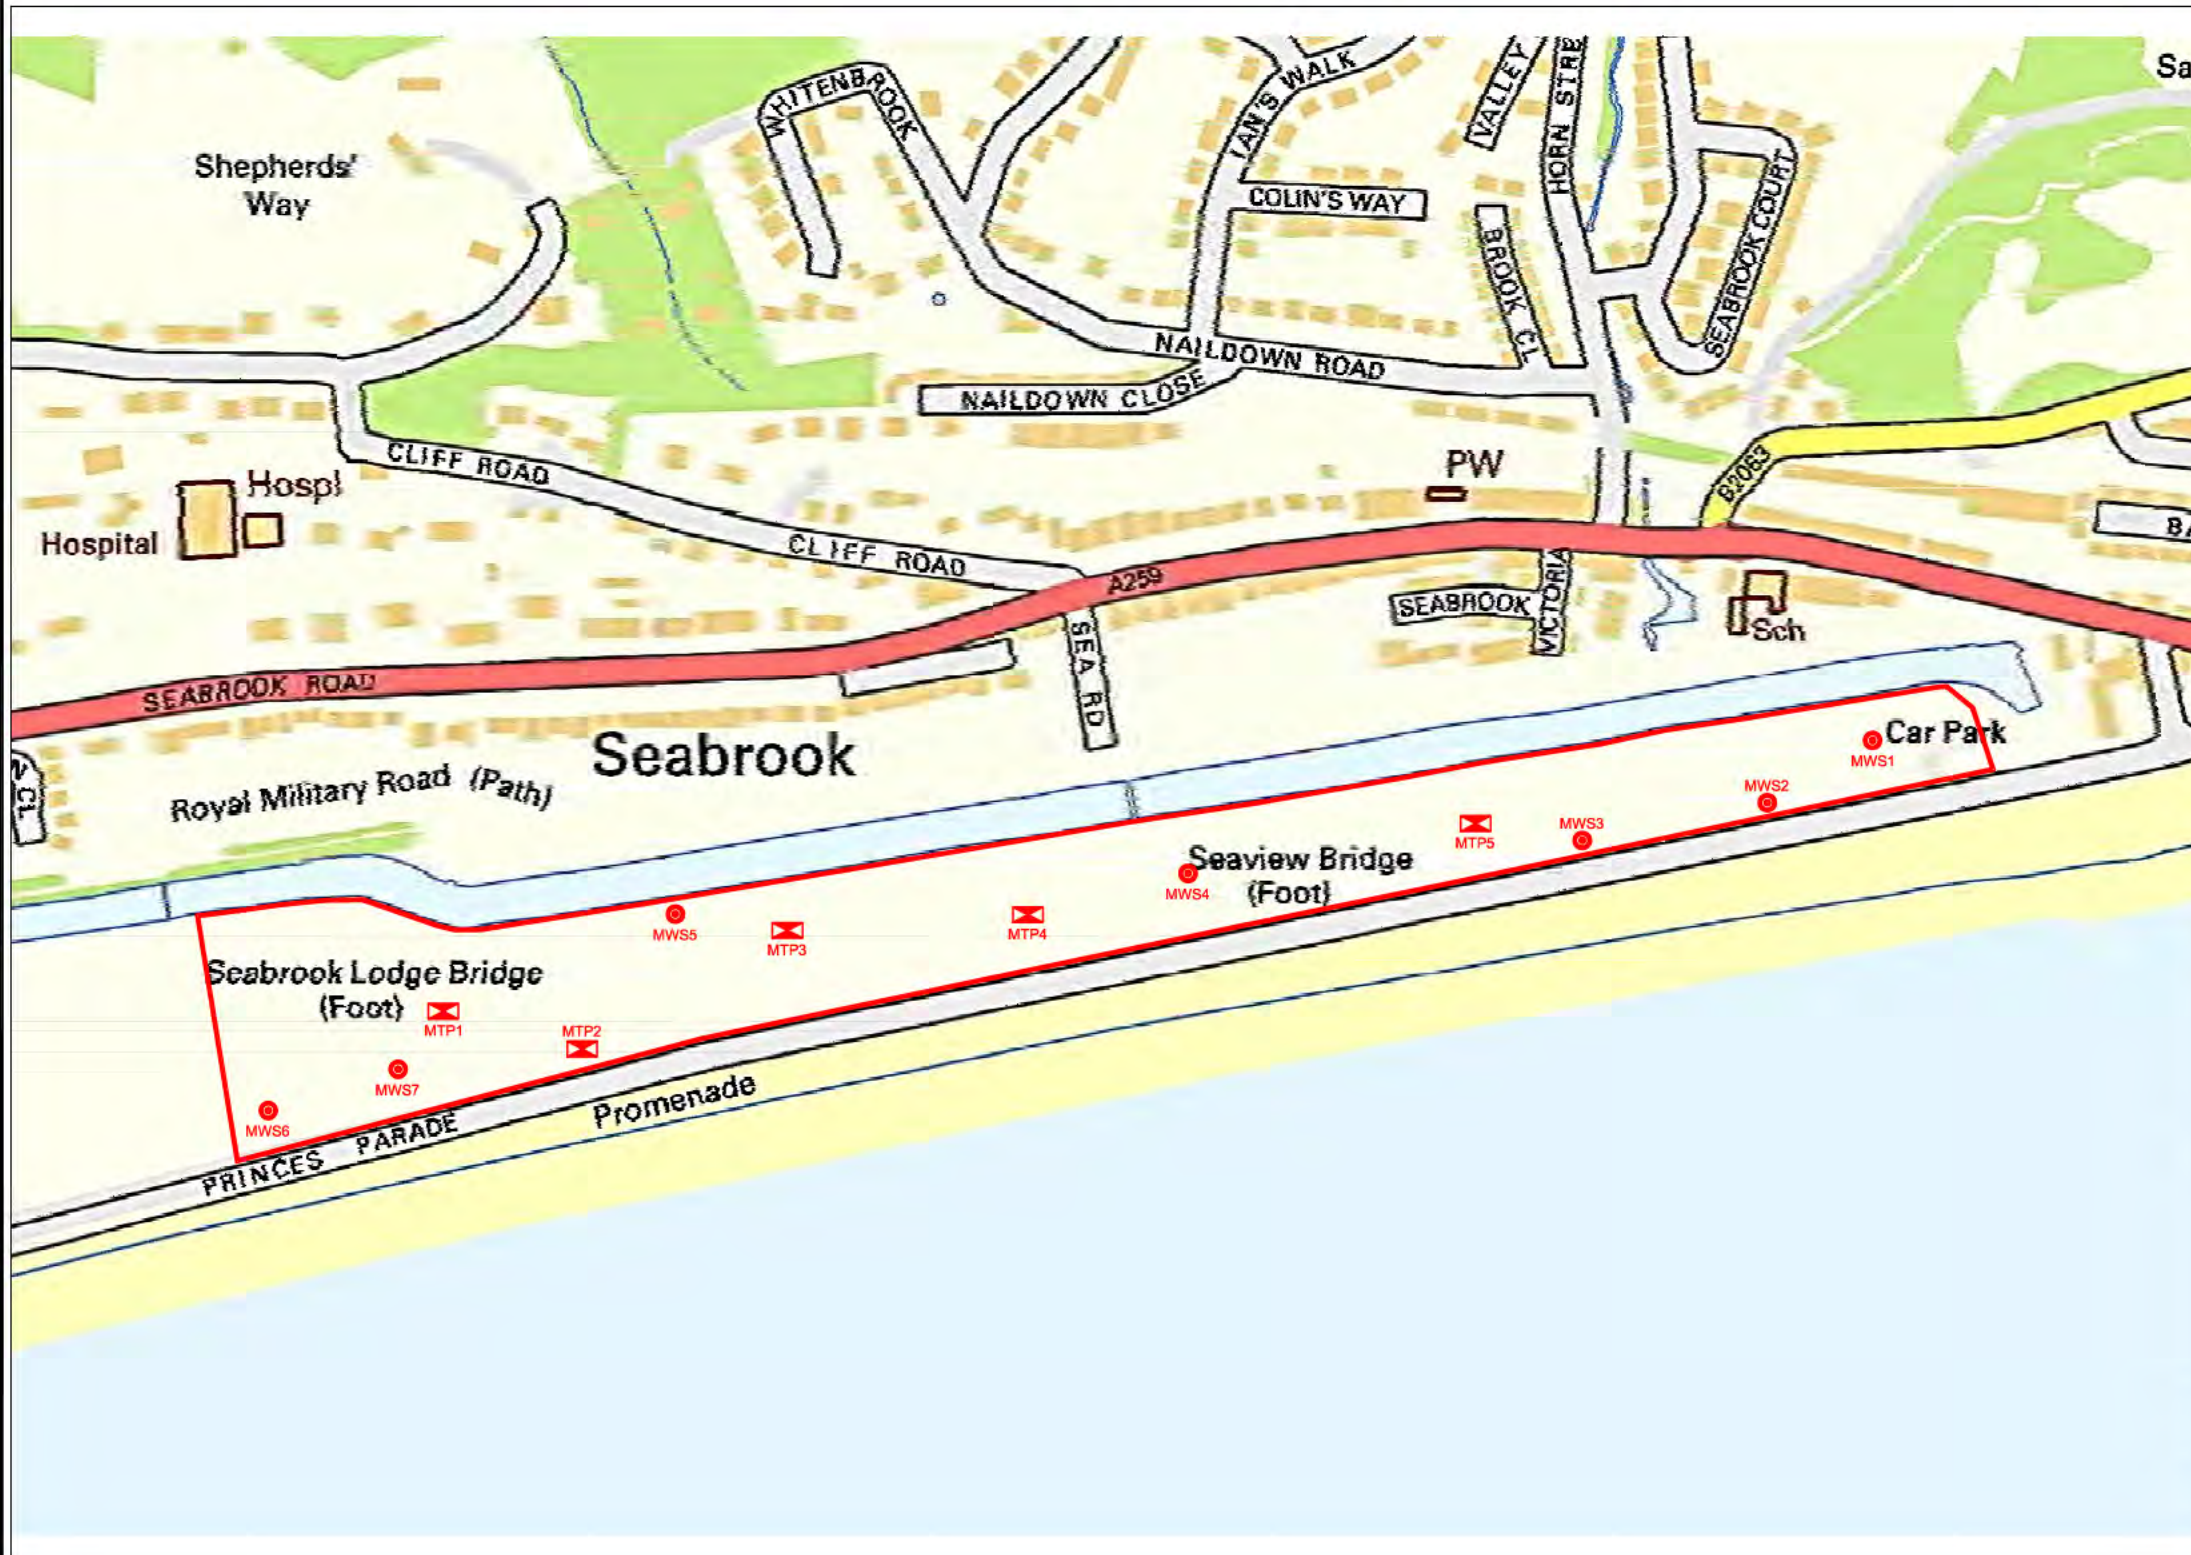
- Site boundary
- ✕ MTPref Merebrook trial pit with location reference
- MWSref Merebrook window sample with location reference

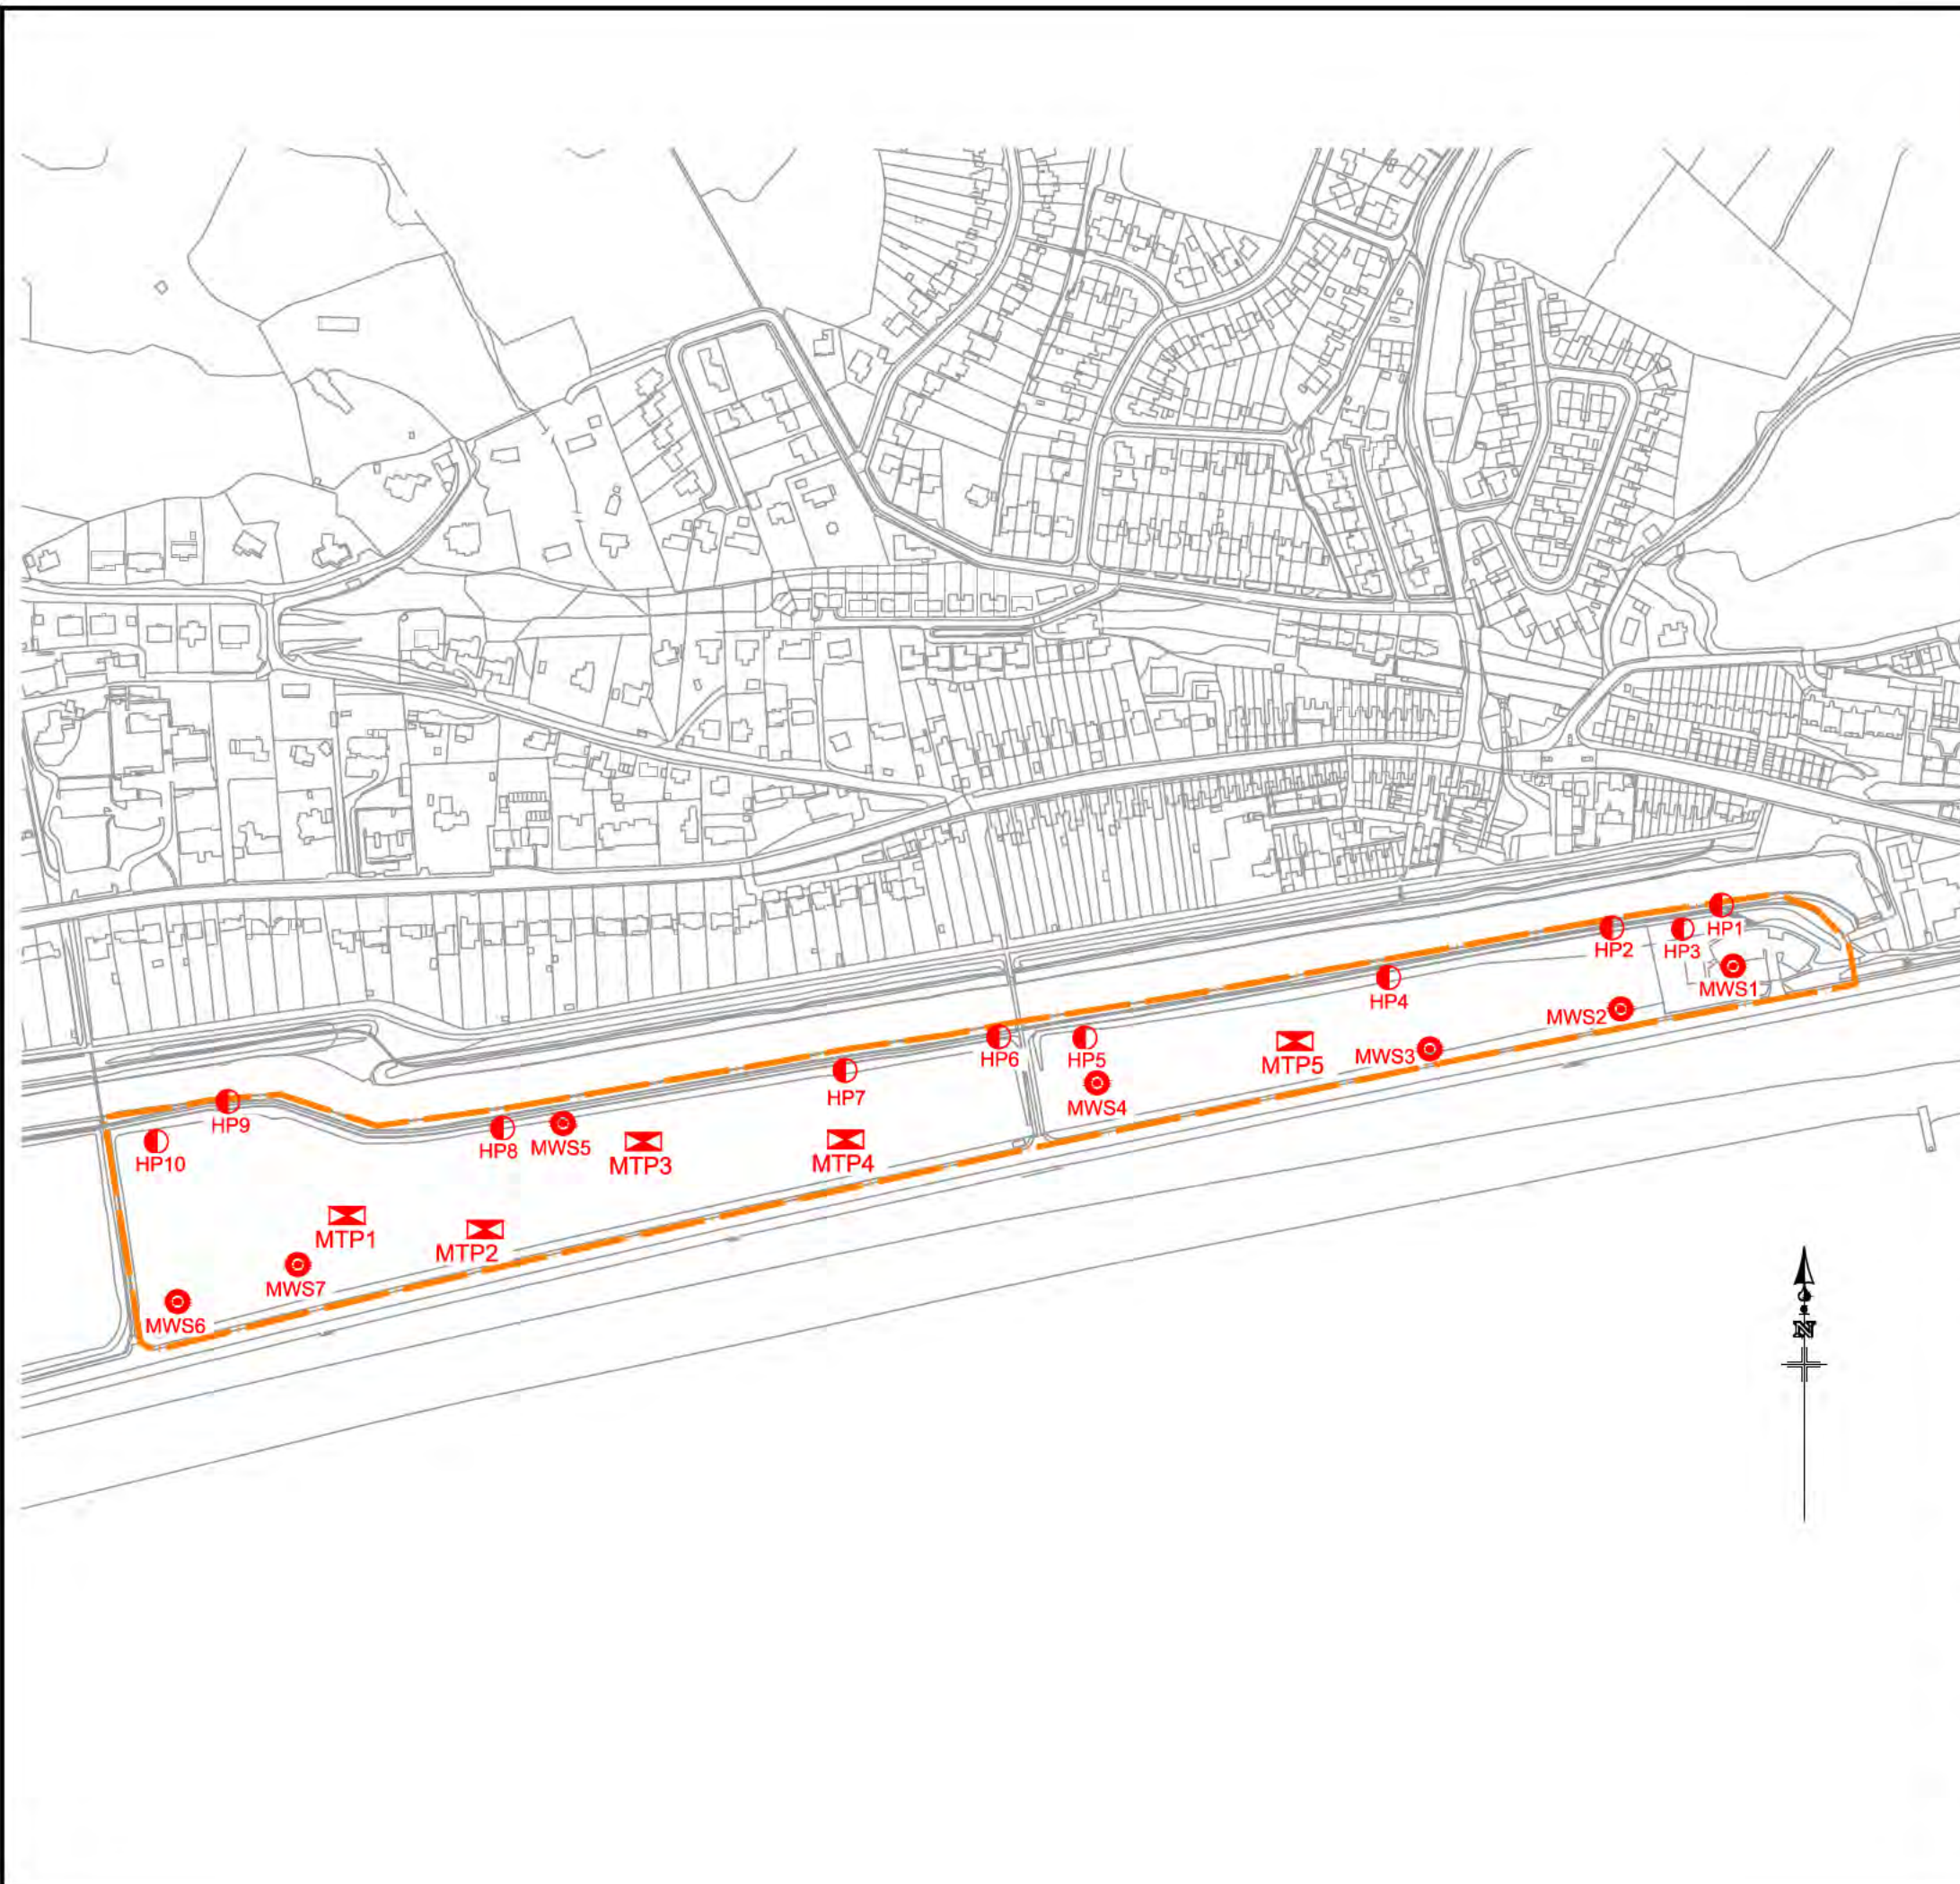
- Legend**
- - - Approximate Site Boundary
  - Approximate Merebrook hand auger location with reference (Feb 2017)
  - Approximate Merebrook window sample location with reference (July 2015)
  - ⊠ Approximate Merebrook trial pit location with reference (July 2015)
