# OTTERPOOL PARK

# ENVIRONMENTAL STATEMENT

Appendix 9.5 – Historic Buildings and Structures Appraisal,  
Addendum 2022

Appendix 9.5 – Otterpool Park Historic Buildings and  
Structures Appraisal, 2017

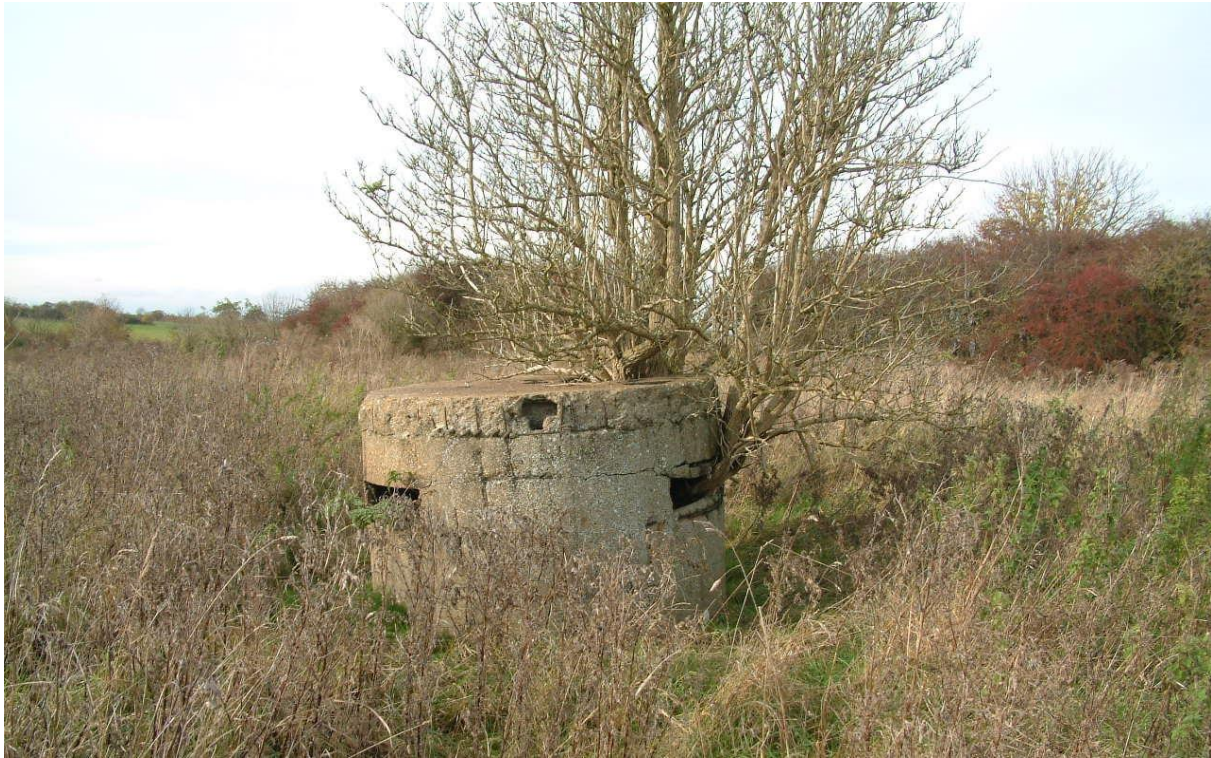
Plate 1: Pickett Hamilton Fort **32**, west of Lympne Industrial Estate

- 4.1.5 The Pickett Hamilton Fort (**32**) has a tree growing through it which has caused some damage. It was not possible to access the interior of the fort to assess the presence or condition of the internal mechanisms but should they survive then it would increase the forts suitability for listing.

- 4.1.7 The Pickett Hamilton Fort (**32**) **is recommended** as likely to meet the listing screening criteria based on its national rarity and significance in the development of defence technologies. The fort is also locally significant due to its links to the New Kent Construction Company and Lympe Airfield.
- 4.1.8 The significance of this asset would increase if the mechanisms and moving parts within the structure remain but this would require further investigation to establish and there is no evidence currently available to suggest they are present. Any recording of this asset should follow the guidance for a **Level 3** survey as recommended by Historic England in *Understanding Historic Buildings: A Guide to Good Recording Practice* (2016).

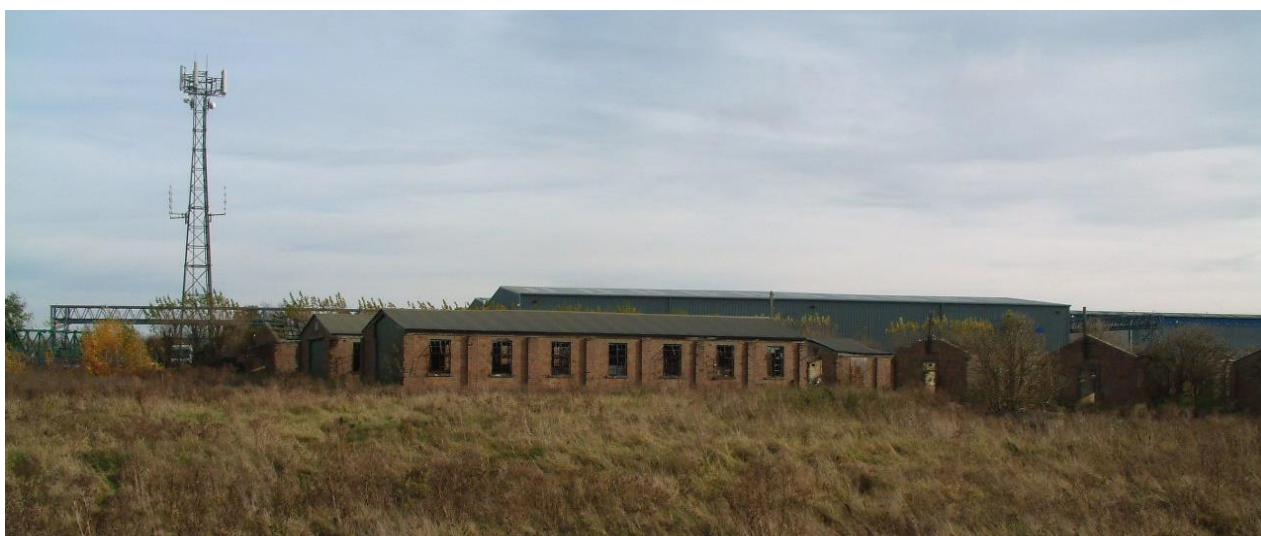
*Plate 2: Huts at Port Lympe looking east.*

- 4.1.11 The huts (**35**) are built of redbrick with a standardised in design and layout with original doors and windows remaining in some of the huts (**Plates 2 and 3**). The windows are metal-framed with small square panes held by a metal lattice and the doors and frames are wooden, some original glass survives. The roofs of the huts are constructed of corrugated sheeting which may be concrete or asbestos, some huts have been re-roofed. Some original fittings and fixtures survive such as the supports and insulators for the power supply to each hut (**Plate 3**). Some huts appear to have a small extension to the rear which may represent a privy. The huts are in various stages of dereliction with some near intact whilst others are highly degraded.

- 4.1.19 The huts west of Otterpool Lane are of value to the area based on their links to a key period within the history of an airfield of national importance during WWII and their group value with other structures, including the Pickett Hamilton Fort. They represent some of the last evidence of the RAF airfield within the area but are built to a standard design, finding parallels at Shorncliffe Barracks, Folkestone, Fort Halstead and other military sites in Kent. As such they are **not recommended** as likely to meet the listing screening criteria.

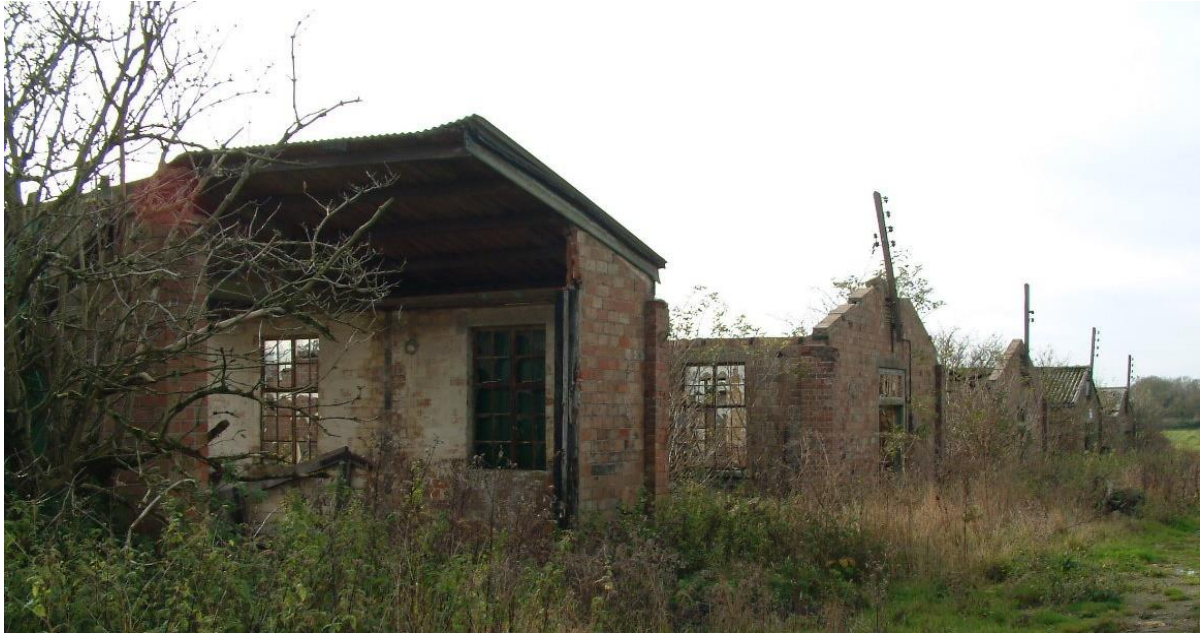
*Plate 3: Surviving fixtures at RAF huts west of Otterpool Lane.*

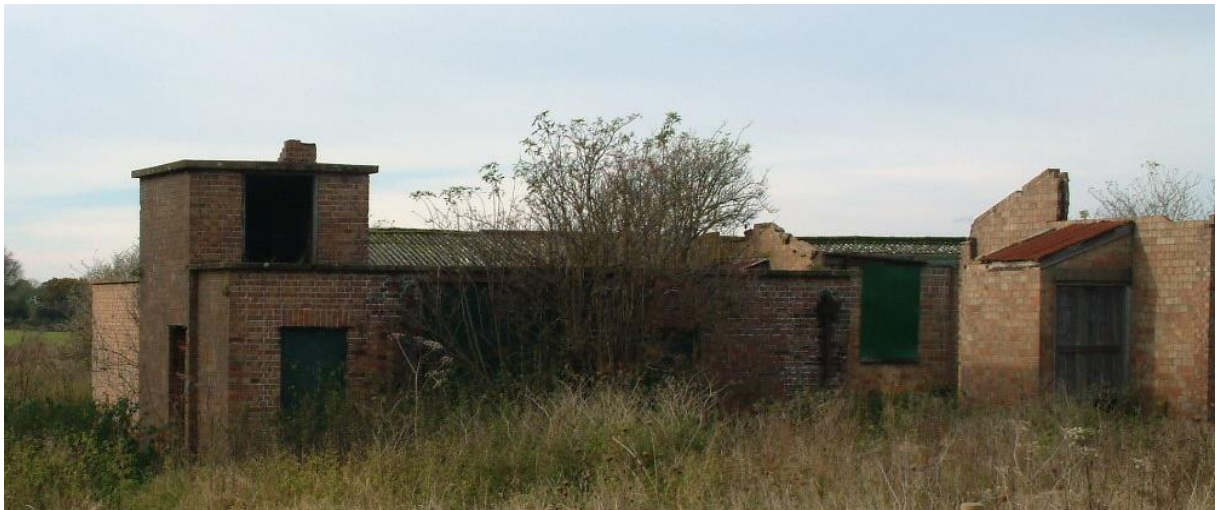
4.1.12 In addition to the eight surviving brick huts (**35**) there is one flat roofed building on the site which may be the gas decontamination unit referred to in the KHER (**30**). This structure is also built of red brick and is of a consistent style with the other extant structures in the group. The roof appears to be covered with Asphalt or similar material and the doors and surrounds are wooden. The structure is mainly on one level but has a central 'tower' on the southern side which rises to two-storeys (**Plate 4**).

*Plate 4: 'Gas decontamination' structure west of Otterpool Lane.*

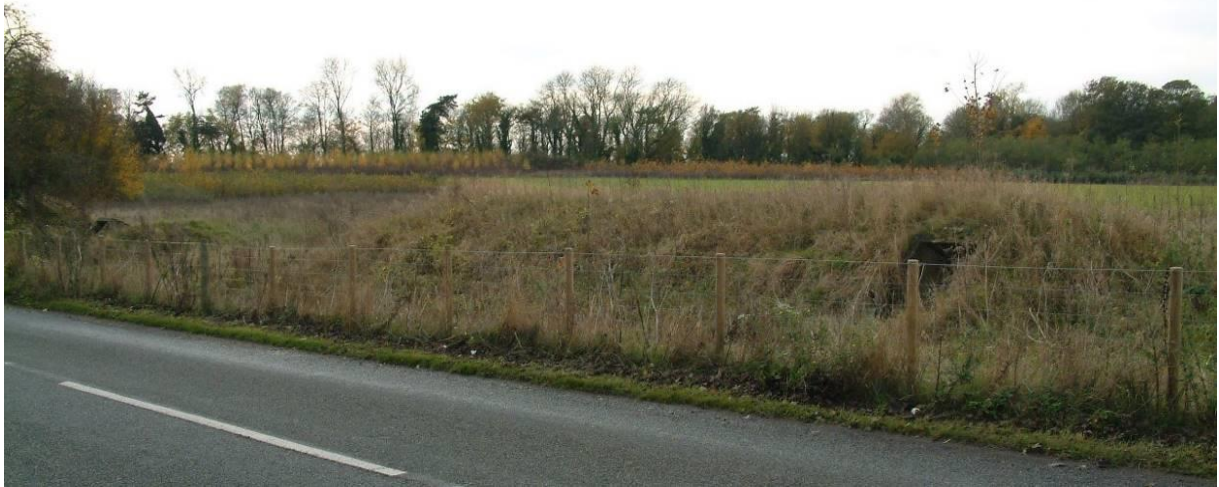
*Plate 5: Air raid shelter/bunker at Port Lympne*

4.1.13 In addition to the main group of huts there are several assets within the immediate vicinity including concrete bunkers (31) to the north of the main hut group and two wheel-washes or former weigh bridges, also concrete (Plate 6). At least eight air-raid shelters or bunkers (31) survive on or close to the huts. These appear to be earth covered structures with concrete entrances (Plate 5). The construction of the shelters beneath the earth and the general condition of the structures was not ascertained during the site visit due to access constraints and safety concerns. Externally the shelters appear in good repair as there is no sign of collapse. A bulk fuel installation mentioned on the KHER (38), to the south, was not inspected during the site-visit due to access constraints. The wheel washes/weigh bridges are of later date and relate to the animal park and the 2001 foot and mouth outbreak.

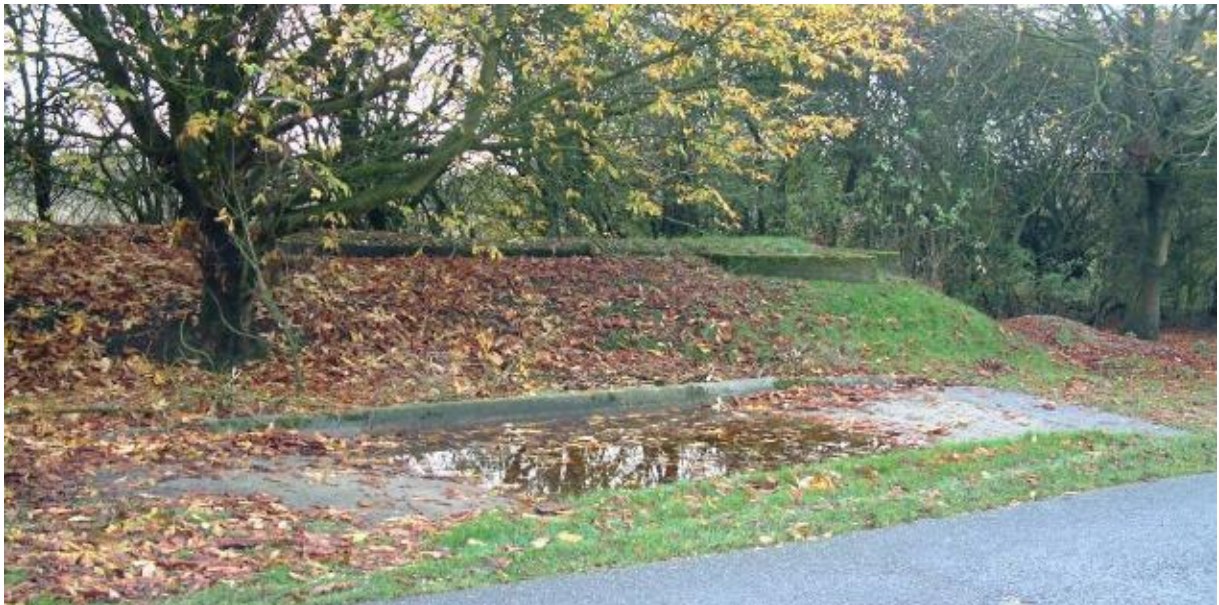
*Plate 6: Bunker and concrete wheel wash/former weigh bridge at Port Lympne*

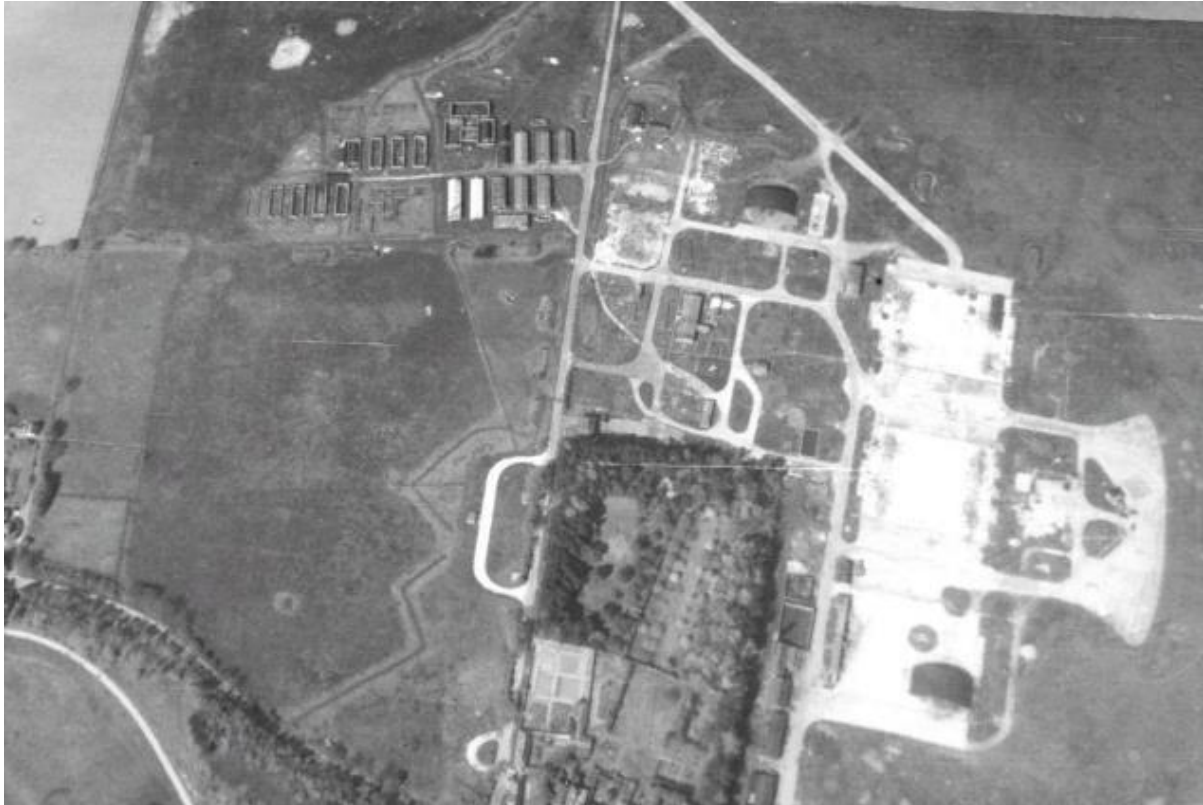
Plate 7: Lympne Airfield 1940 (Google Earth)

- 4.1.14 Ruins of further structures are still visible on Google Earth imaging and these likely relate to the structures either under construction or partially demolished shown on the 1940s aerial photography (**Plate 7**).

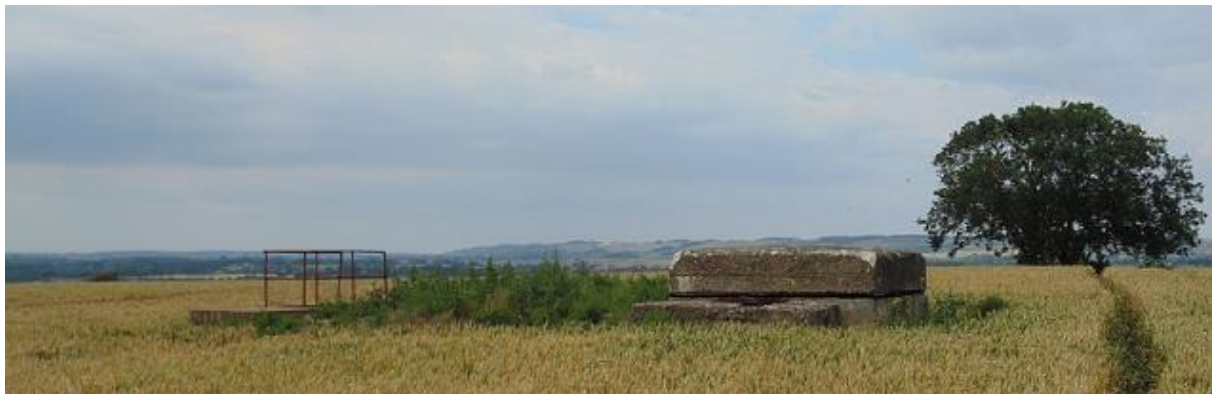
Plate 8: The Battle HQ (from *Derelict Places* 2014)

- 4.1.21 The Battle HQ comprises an underground structure which is evidenced above ground by a flat concrete hatch and a set of concrete steps surrounded by a metal guard rail on three sides (**Plate 8**). Internet sources indicate that the structure below ground is constructed of red brick with wooden fittings and that the internal condition of the structure is moderate to good (*Derelict Places* 2014).
- 4.1.22 The air raid shelter or bunker is of similar construction to those seen to the south which form part of the hut group (**31**). The structure has a concrete entrance way and is covered by earth (**Plate 9**). The interior condition or survival is not known but there are no visible signs of degradation externally.

4.1.27 The Battle HQ **is recommended** as likely to meet the listing screening criteria due to its relationship with key period of national military history and a key development phase of the airbase at Lympne. In addition, it is well-preserved and forms part of a group with the remains to the south, west of Otterpool Lane. The air-raid shelter is common to other bases and military installations of WWII date and is therefore **not recommended** as likely to meet the listing screening criteria.

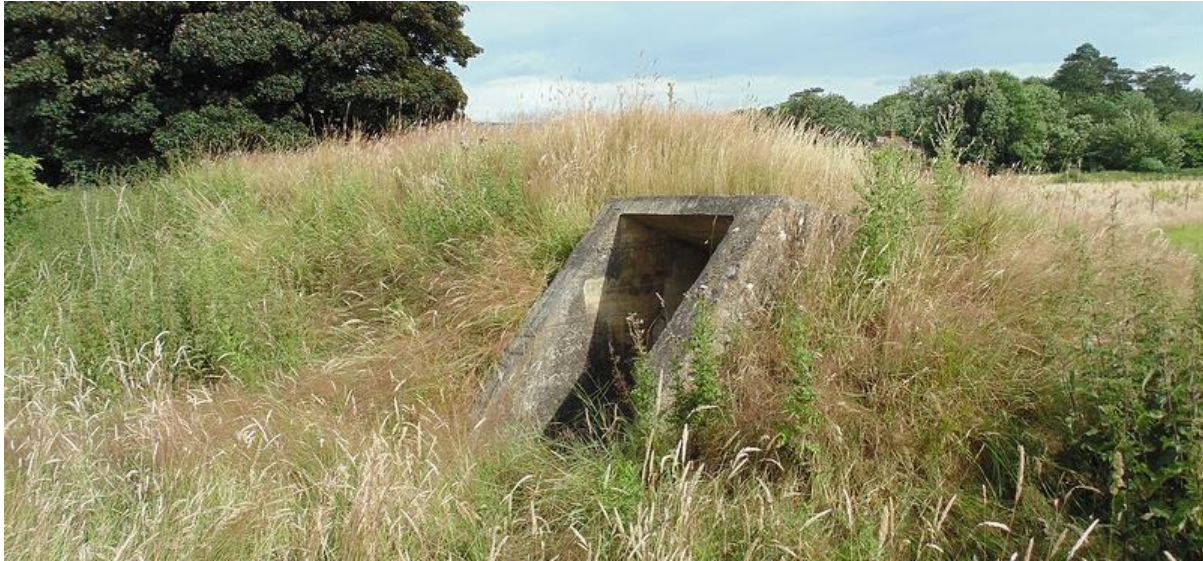
Plate 9: Image of bunker/shelter of the Battle HQ (Derelict Places 2014)

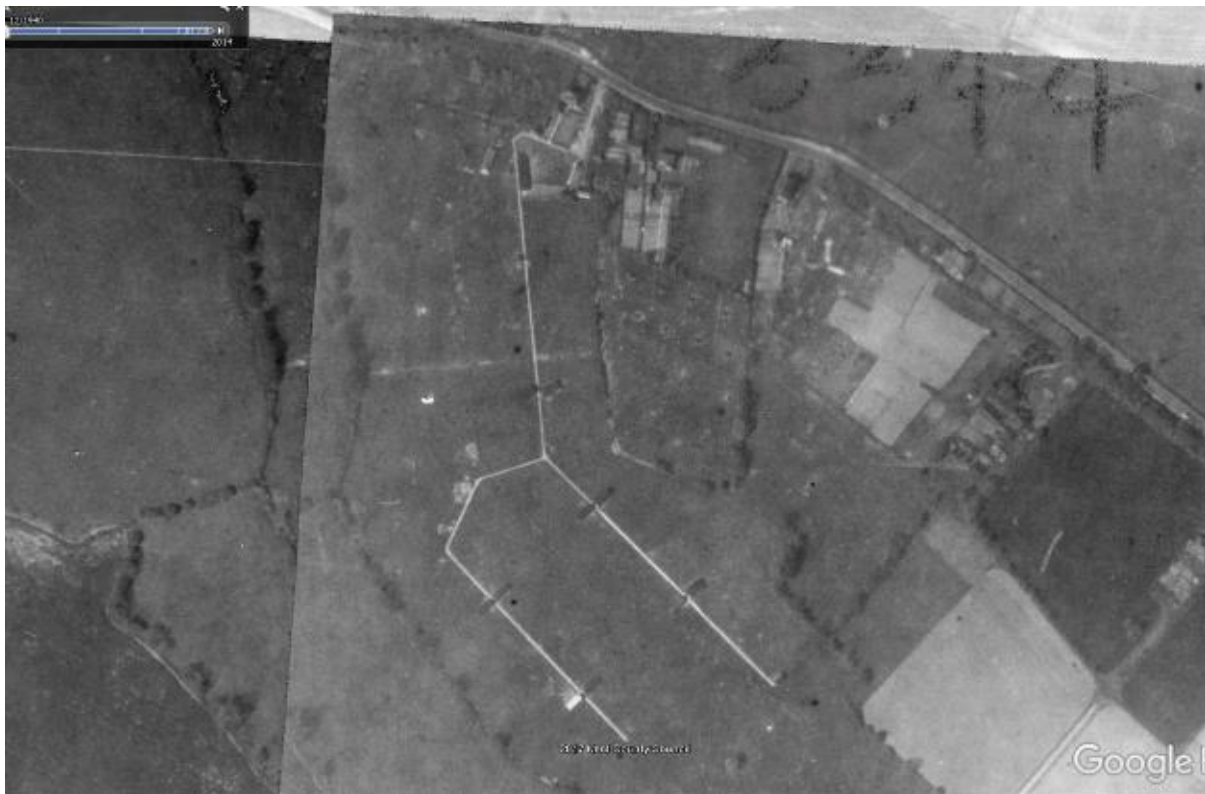
4.1.28 In the 1940s aerial photography (AP) (Google Earth) a small complex of structures and access tracks can be seen to the south of the Ashford Road close to the present Red House Farm (Zetica 2017). The complex comprised a small collection of 4-8 huts, hangers, and Nissen huts close to the Ashford Road, an access track running south and a further two access track providing access to the munitions huts. At this time the five munitions huts were located around 220m south of the Ashford Road (**Plate 10**).

Plate 10: Possible munitions store on 1940s aerial photograph (Google Earth)

4.1.37 The munitions store and associated surviving structures (**WS20**) are **not recommended** as likely to meet the listing screening criteria due to their loss of setting and context and their generally poor condition.

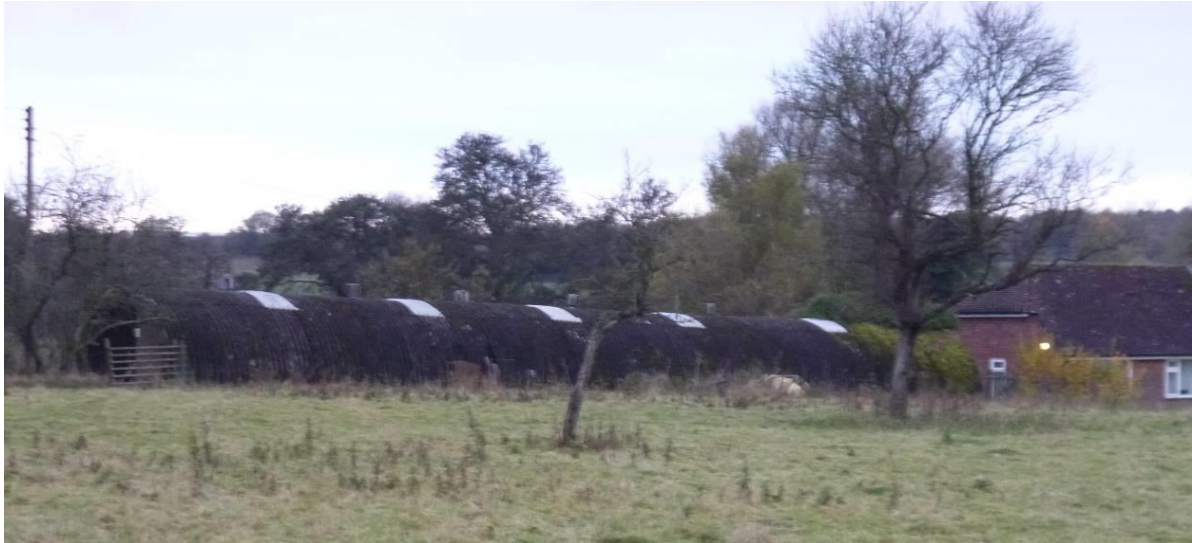
4.1.29 The munitions store has been largely lost and the original layout was no longer extant prior to the 1960s. However, some structures may survive or have been re-used in the vicinity. One of these is a Nissen hut which has been relocated close to a small modern cottage on Red House Farm 70m south of the Ashford Road (**Plate 11**). A further two structures have been identified as possible reused WWII huts, these are two workshop buildings on the Benham Business Park (**Plate 12**). These two structures are consistent in style and fabric with other military buildings of this period found on the Site and are present on the 1960s aerial photos (Google Earth) and OS maps in their present positions.

Plate 11: Re-used Nissen hut visible from the Ashford Road at Red House Farm.

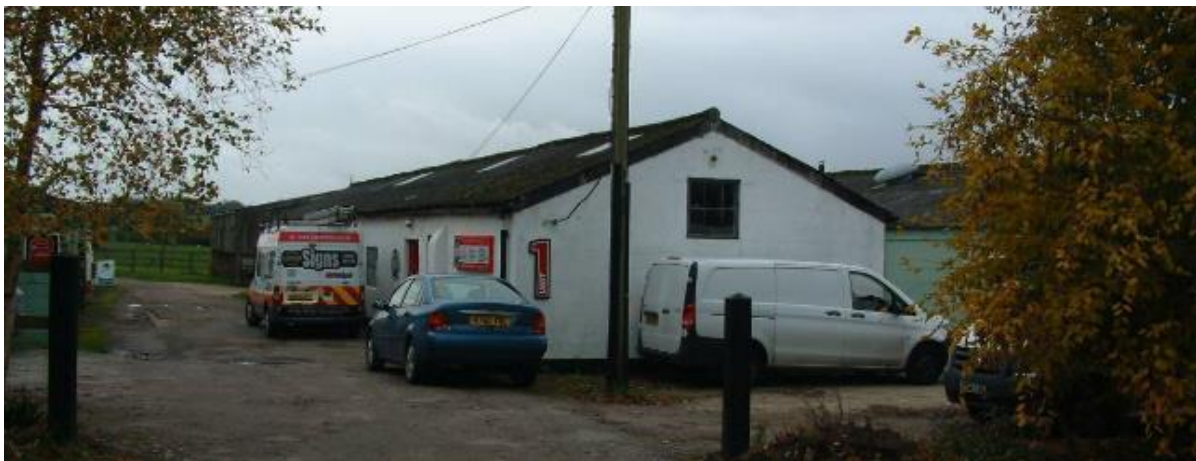
Plate 12: Possible re-used WWII hut on Benham Business Park.

- 4.1.30 Possible survivals of the WWII munitions store are two structures located close to the entrance of the business park, 30m to the south of Ashford Road. These comprise a small hut built of corrugated material on a metal frame with metal windows and modern alterations to the door, and a low red brick building which has some evidence of a corrugated roof and surviving metal framed windows (**Plate 13**).
- 4.1.31 These two structures match the locations and plans of original structures relating to the munitions store on the 1940s Air Photo image. The brick structure is also consistent with the style and character of military structures within the Site.

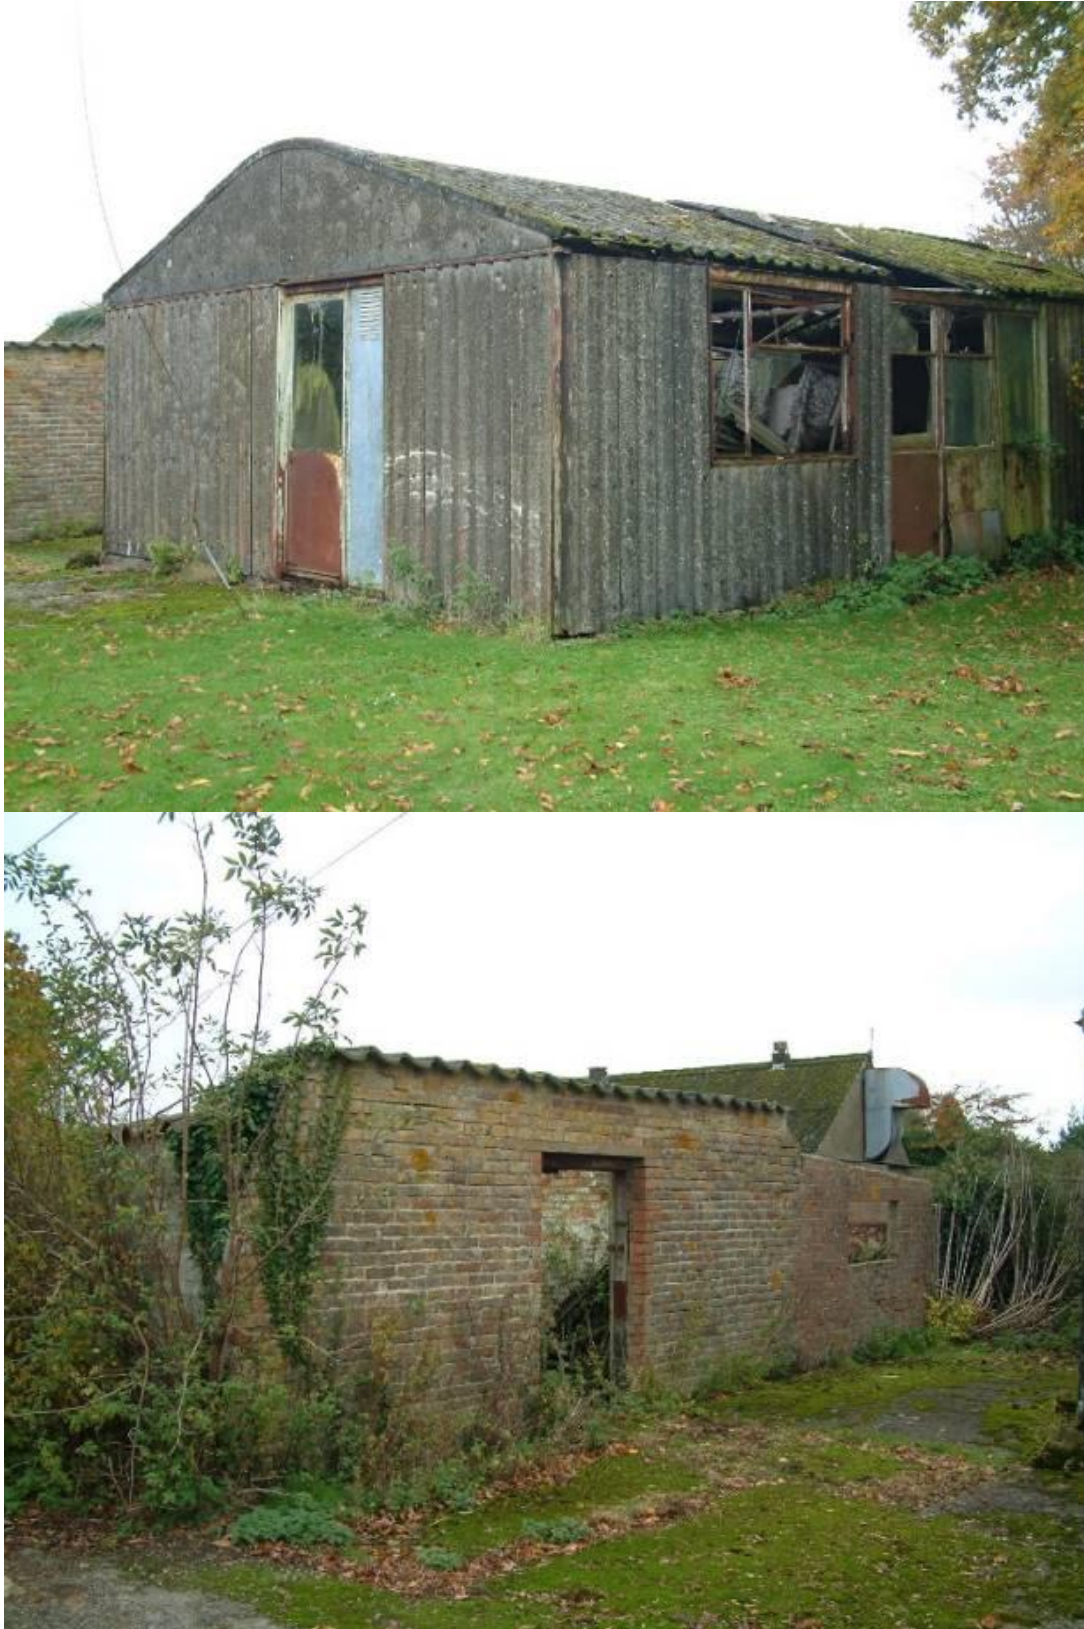
*Plate 13: Two of the possible surviving structures from the WWII munitions store.*

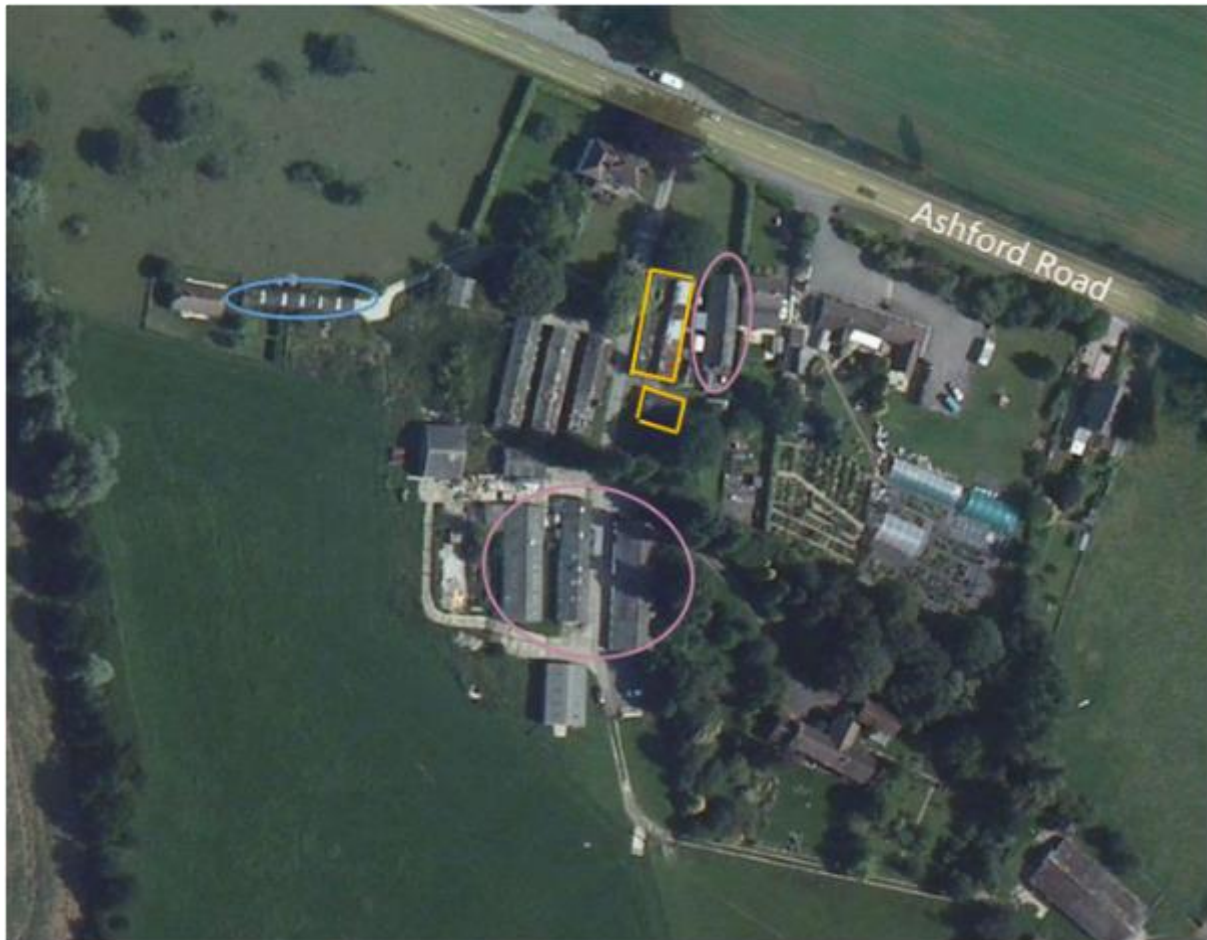
Plate 14: Google Earth image showing possible retained and re-used structures from the munitions store.

4.1.32 The image above (**Plate 14**) shows a Google Earth image on which the probable surviving structures are marked in yellow, the relocated Nissen hut in blue, and the possible re-used and relocated military huts in pink. Some further investigation is recommended to establish if these possible survivals and re-used structures are indeed military in origin.

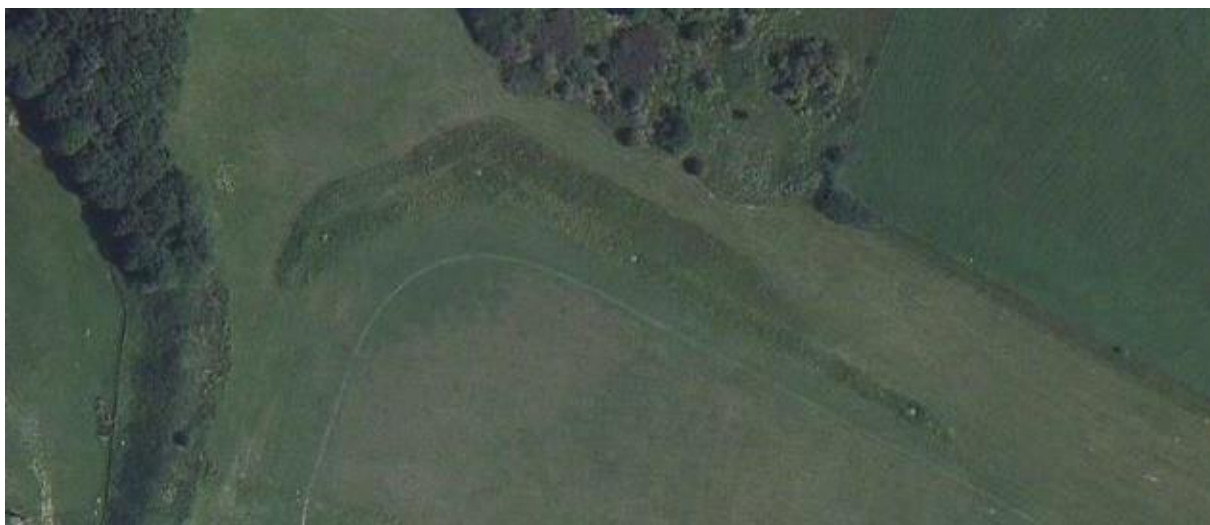
4.1.38 There are six Pillboxes (excluding the two Pickett Hamilton Forts) within the site boundary (**BH47, BH43, BH44, BH45, BH46, BH42**). At least two of these six are no longer extant (**BH47, BH43**) as they have been removed by development within the Link Park/Lympne Industrial Estate. At the time of the site visit it was not possible to confirm the presence of the remaining four assets due to access constraints. A further two (**BH46 and BH45**) are not visible on aerial photography and are assumed to be lost. **BH42** is possibly located within a stand of trees close to the Aldington Road through no remains were noted during the site visit and **BH44** may be extant to the northeast of the Link Park industrial estate (**Plate 15**).

Plate 15: Pillbox to the northeast of Link Park Industrial Estate (**BH44**) (Google Earth).

4.1.40 The remaining pillboxes are **not recommended** as likely to meet the listing screening criteria due to their common type and lack of evidence for survival.

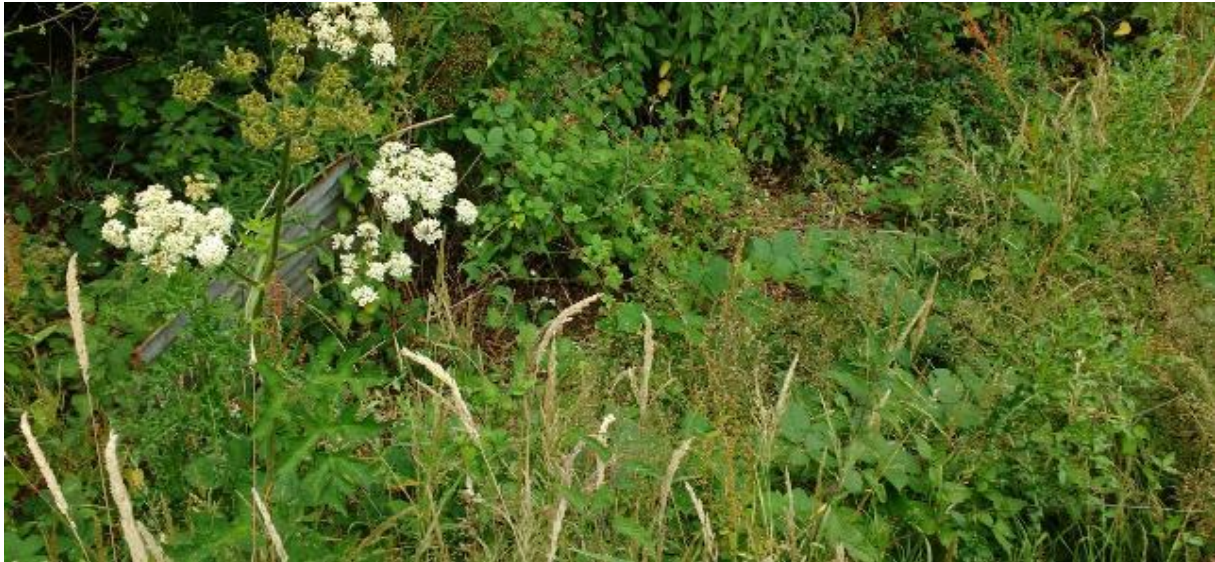
4.1.41 The Auxiliary Unit Operations Base (4) is located at the western boundary of the site on the edge of Harringe Brooks Wood. The structure's shape and design is unknown as the building is concealed in a dense wood and is covered in vegetation. What could be seen indicated that the Auxiliary Unit Operations Base was constructed out of concrete and corrugated metal sheeting (**Plate 16 and 17**). Internal access was not attempted due to the derelict and unstable nature of the structure posing a safety risk.

*Plate 16: Concrete roof of Auxiliary Unit Operations Base looking north.*

4.1.45 The Auxiliary Unit Operations Base was identified during the stage two site visit and appears to be extant, although internal condition of the asset is not known. This asset is presently **not recommended** as likely to meet the listing screening criteria as it is not an uncommon WWII building, it's visual appearance and condition is obscured by dense wood, it was not used for its intended purpose and its original setting has been lost to modern farming.

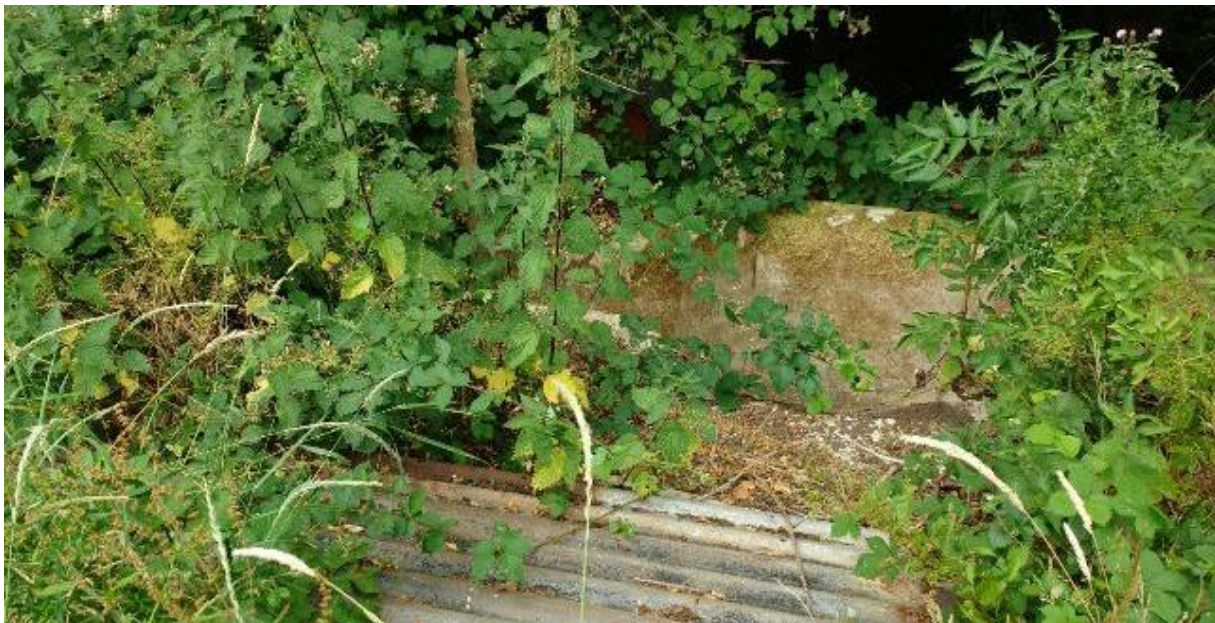
*Plate 17: Showing concrete entrance to Auxiliary Unit Operations Base looking west.*

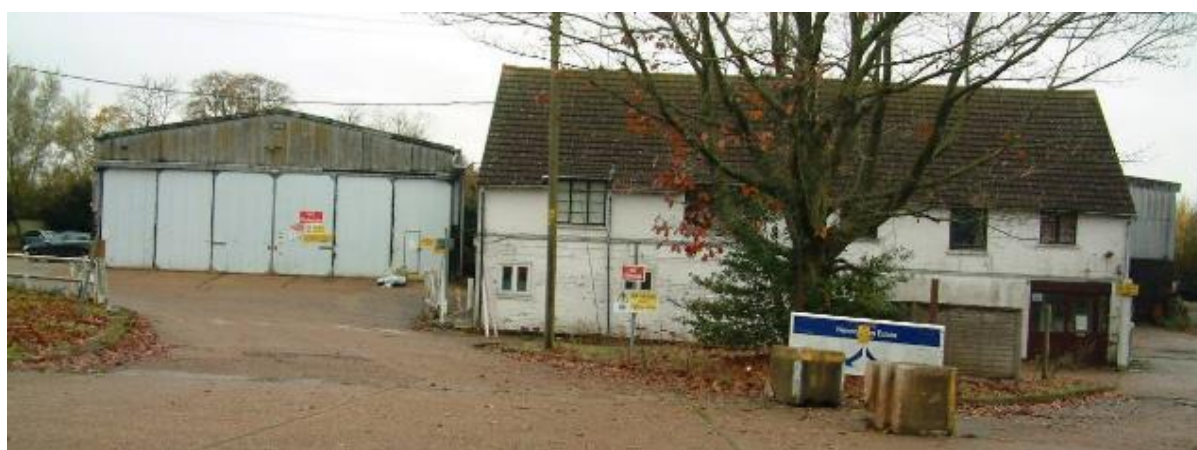
- 4.1.52 To the south of Westenhanger Village, on Stone Street, is a small industrial estate which contains one building of potential historic interest (**WS19**). This is a two-storied brick structure which has been painted white and has a modern composite tile roof. The structure has a brick chimney approximately central to the structure and slightly staggered on the eastern side of the roof (**Plate 19**).

Plate 19: Possible WWII or interwar structure south of Westenhanger village, looking west.

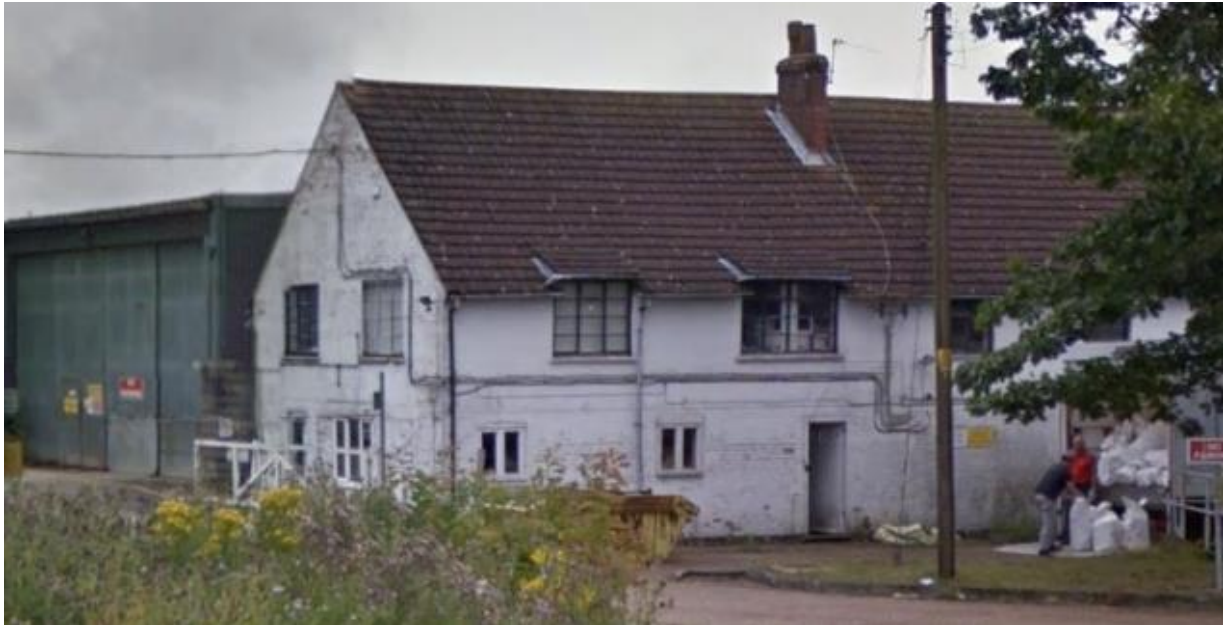
the eastern elevation. The windows on the southern elevation are consistent with those on the eastern elevation. There are two doorways in the eastern elevation of the building, the second of which appears to be a modern insertion.

Plate 20: Possible WWII or interwar structure south of Westenhanger village, looking north-west (Google Street View).

4.1.57 This asset (**WS19**) is **not recommended** as being likely to meet the listing screening criteria. This structure is not a remarkable survival and offers little heritage value above its local significance. It also appears that the structure has been adapted several times since its construction making internal survival of features unlikely.

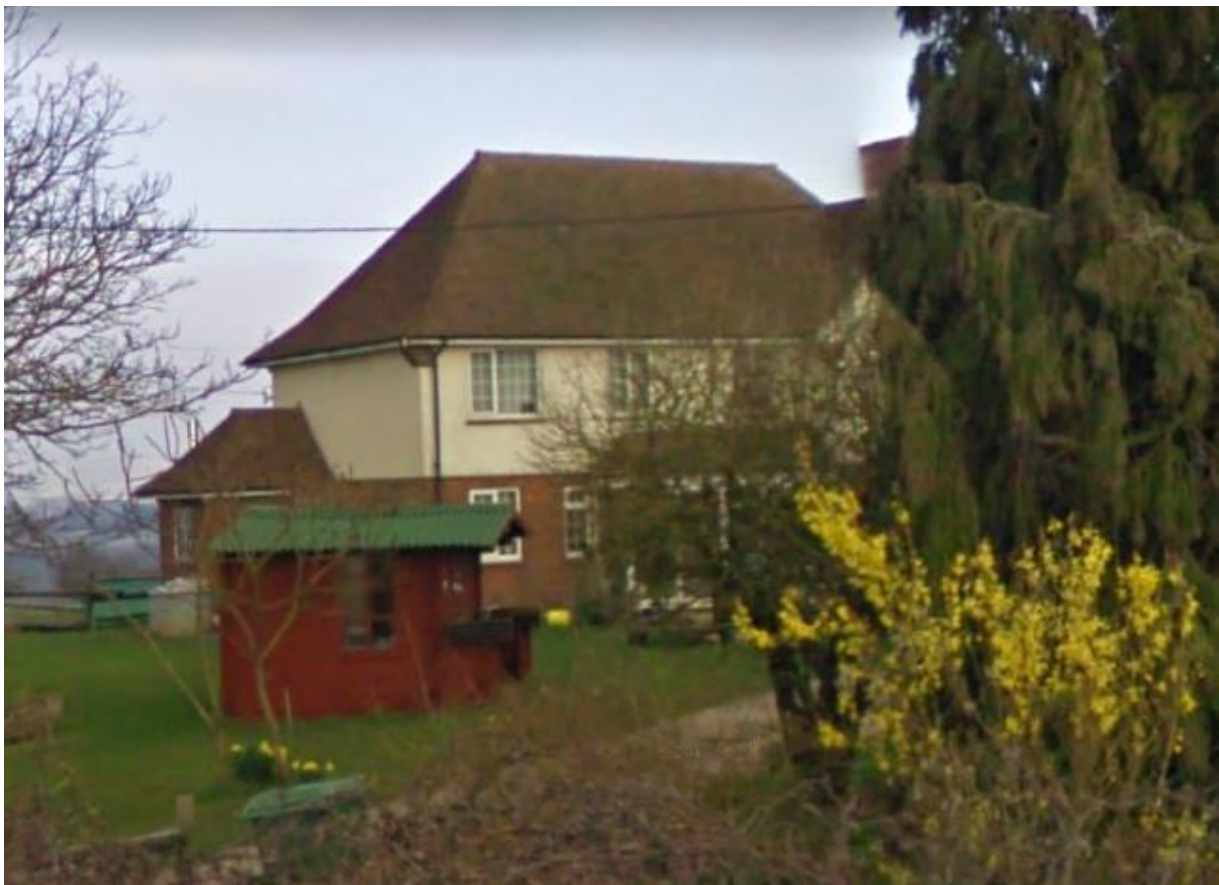
- 4.2.2 Harringe Court lies at the western edge of the Site and is described as a brick and stone house of probable 15<sup>th</sup> century date. The current farmhouse has been extensively altered and potentially rebuilt.
- 4.2.3 The current farmhouse is a two-storey house with a hipped roof, a single large chimney at the south-eastern end on the house, and is rendered and painted cream across the first floor. The house has a small, two-storey, gable ended extension to the south-east and a single storey annex to the northwest, the annex has a hipped roof in similar style. Windows appear to be modern UPVC (**Plate 21**). The outbuildings associated with the farm include a large brick-built barn of 20<sup>th</sup> century date close to Harringe Lane and steel-framed with sheet walls and roofs further from Harringe Lane.

Plate 21: Harringe Court Farm House, looking north-east (Google Street View 2009)

- 4.2.10 As the farmhouse (**BH6**) is of a 1970's origin it is **not recommended** as being likely to meet the listing screening criteria due to its modern construction date and loss of all historic elements of the farmstead.

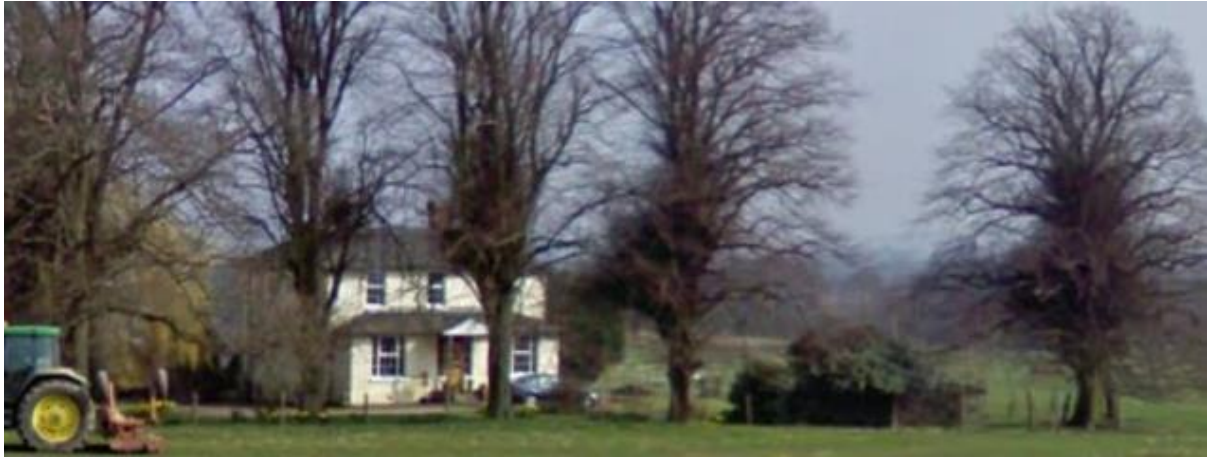
- 4.2.11 These three assets sit within the same farm complex (**BH13**) and shall be discussed together under a group significance.
- 4.2.12 Barrow Hill Farm (**BH13**) is located to the east of Barrow Hill and is described as a 19<sup>th</sup> century loose plan multi-yard farmstead. The farm house (**BH13**) is a two-storey structure with a sunken basement floor and rendered in white or light-coloured material across both storeys. The roof is hipped and clad in grey colour tiles. The southern aspect has a projecting annex or porch with a sloping roof and a projecting central covering. Above the annex or porch are three large windows with white frames. The north-western side of the building has thin, rectangular, white framed windows on each of its levels (**Plate 22**). To the rear of the property is a rectangular two-story extension with a gabled ended roof and chimney (**Plate 25**). The lower floor windows are curved at the top and framed in white surrounds (**Plate 22**).

*Plate 22: Barrow Hill Farm (BH13) looking north-east*

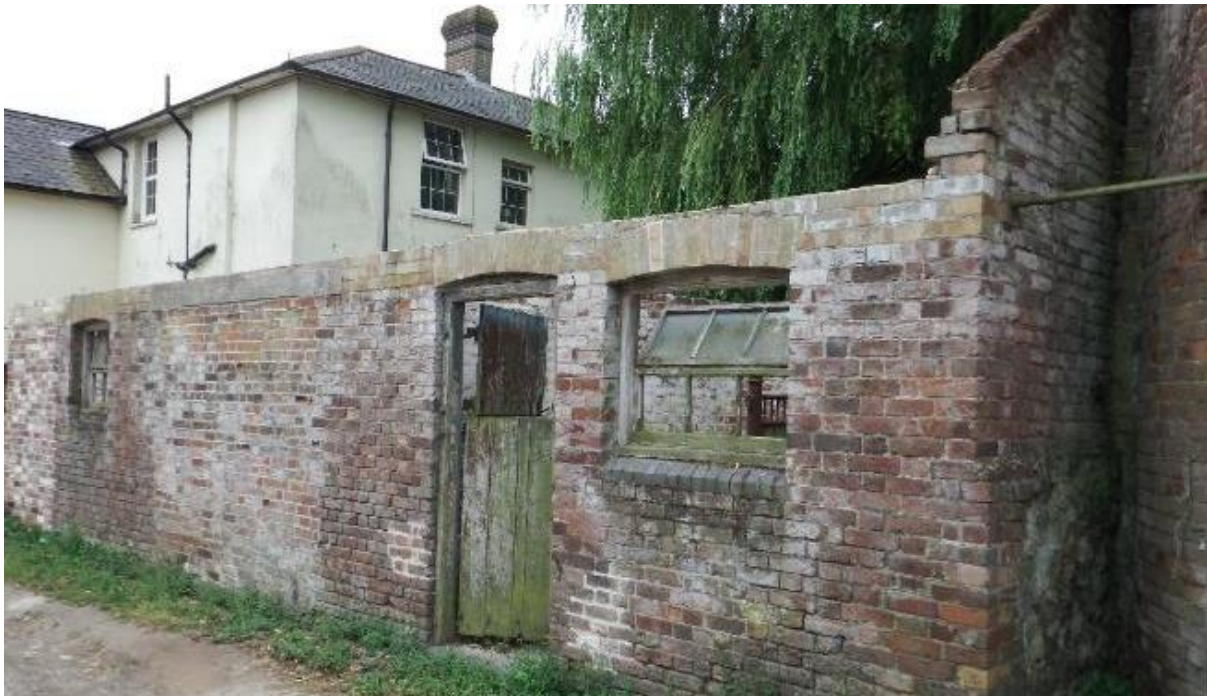
4.2.13 Immediately to the south-west of the farm house is a derelict, north-west south-east aligned storage building (**Plate 23**) which, at a later date, has been converted to a stable (**Plate 24**) which has an oast house attached (**Plate 25**).

*Plate 23: Storage and stables at Barrow Hill Farm*

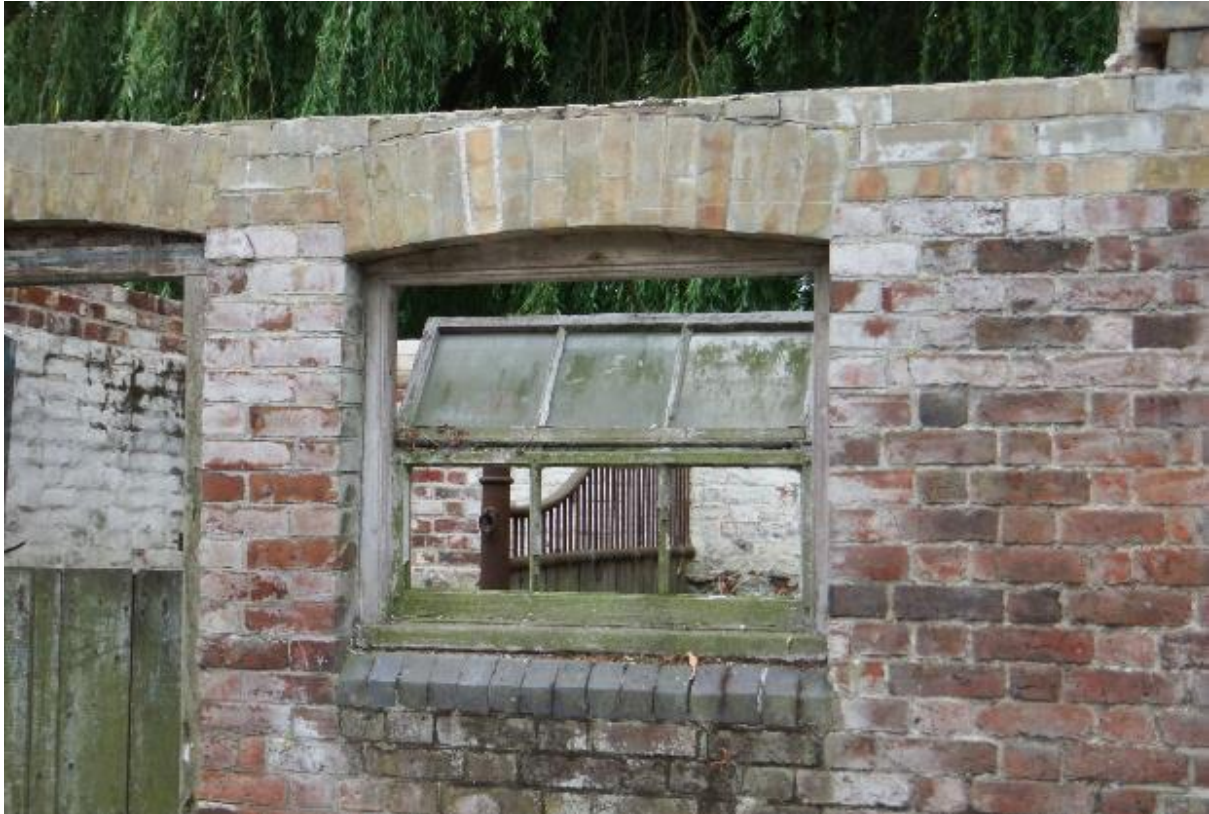
*Plate 24: Stables at Barrow Hill Farm*
