# OTTERPOOL PARK

# ENVIRONMENTAL STATEMENT

Appendix 9.5 – Historic Buildings and Structures Appraisal,  
Addendum 2022

Appendix 9.5 – Otterpool Park Historic Buildings and  
Structures Appraisal, 2017

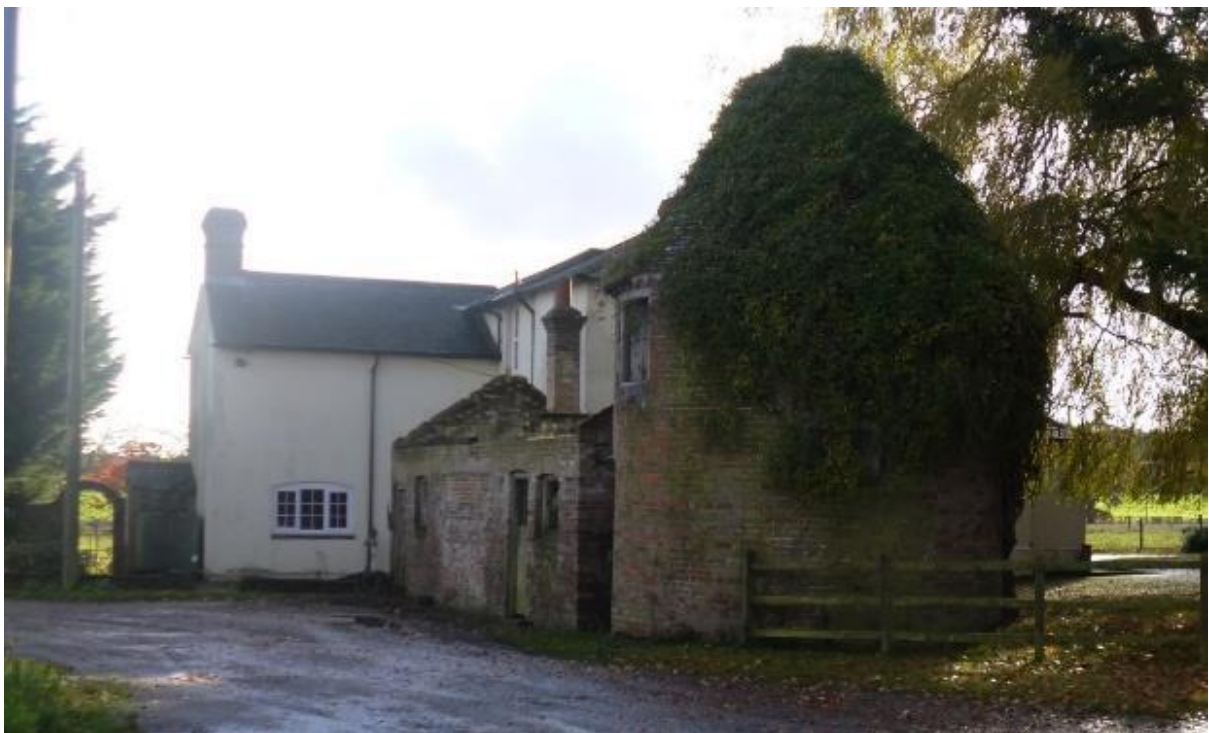
4.2.13 Immediately to the south-west of the farm house is a derelict, north-west south-east aligned storage building (**Plate 23**) which, at a later date, has been converted to a stable (**Plate 24**) which has an oast house attached (**Plate 25**).

*Plate 25: Oast house at Barrow Hill Farm (WS10) looking south-east*

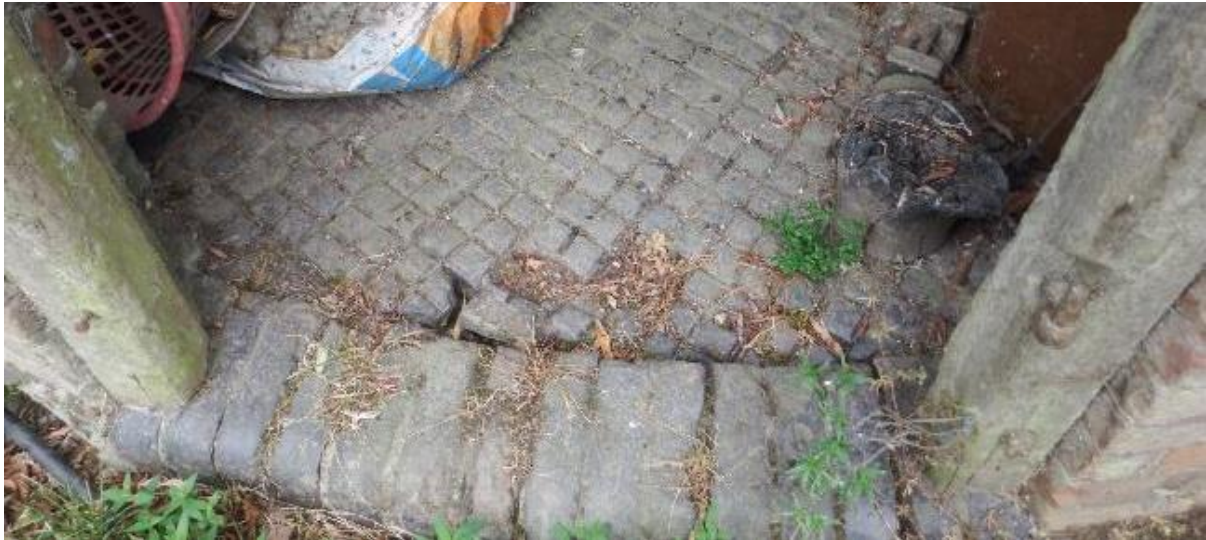
- 4.2.15 Within the interior of the oast house is a possible original floor (**Plate 26**) constructed out of grey regular square cobbles. There is also some survival of flooring on the first floor within the structure (**Plate 27**). There is an internal door leading to the stable area (**Plate 28**), this doorway may have been originally used to gain access to the storage area used in conjunction with the oast house. It is unknown if this door was used when the storage area was converted to a stable.

*Plate 26: Floor of oast house at Barrow Hill Farm*

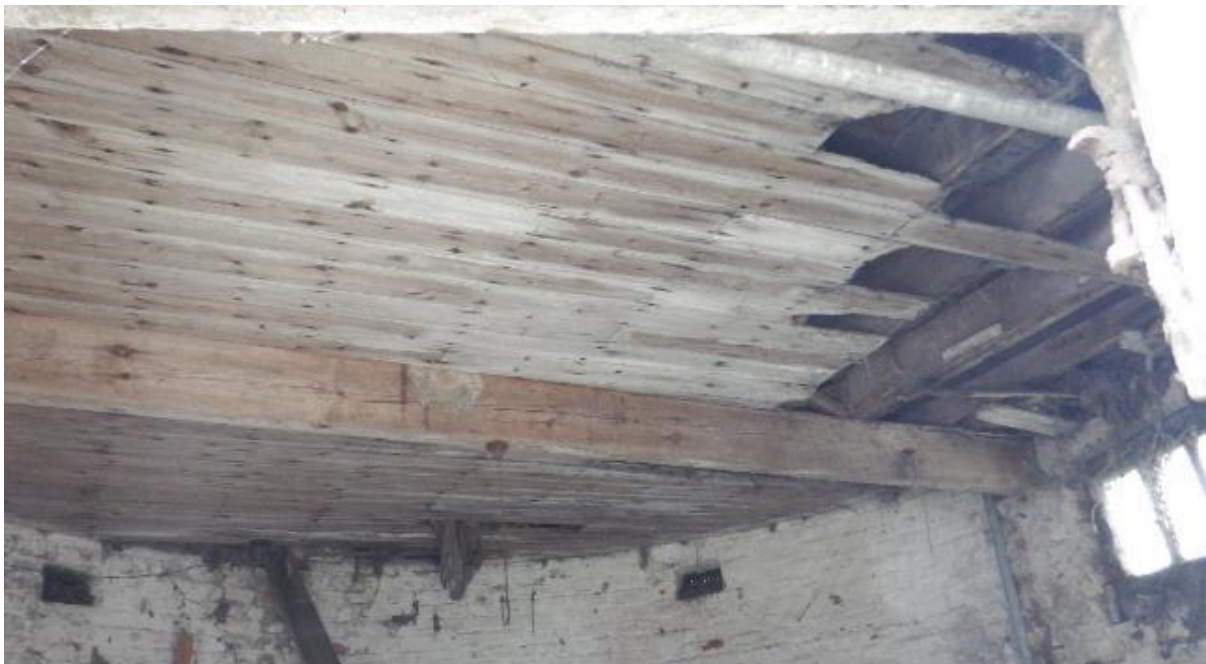
*Plate 27: Internal floor of oast house at Barrow Hill Farm*

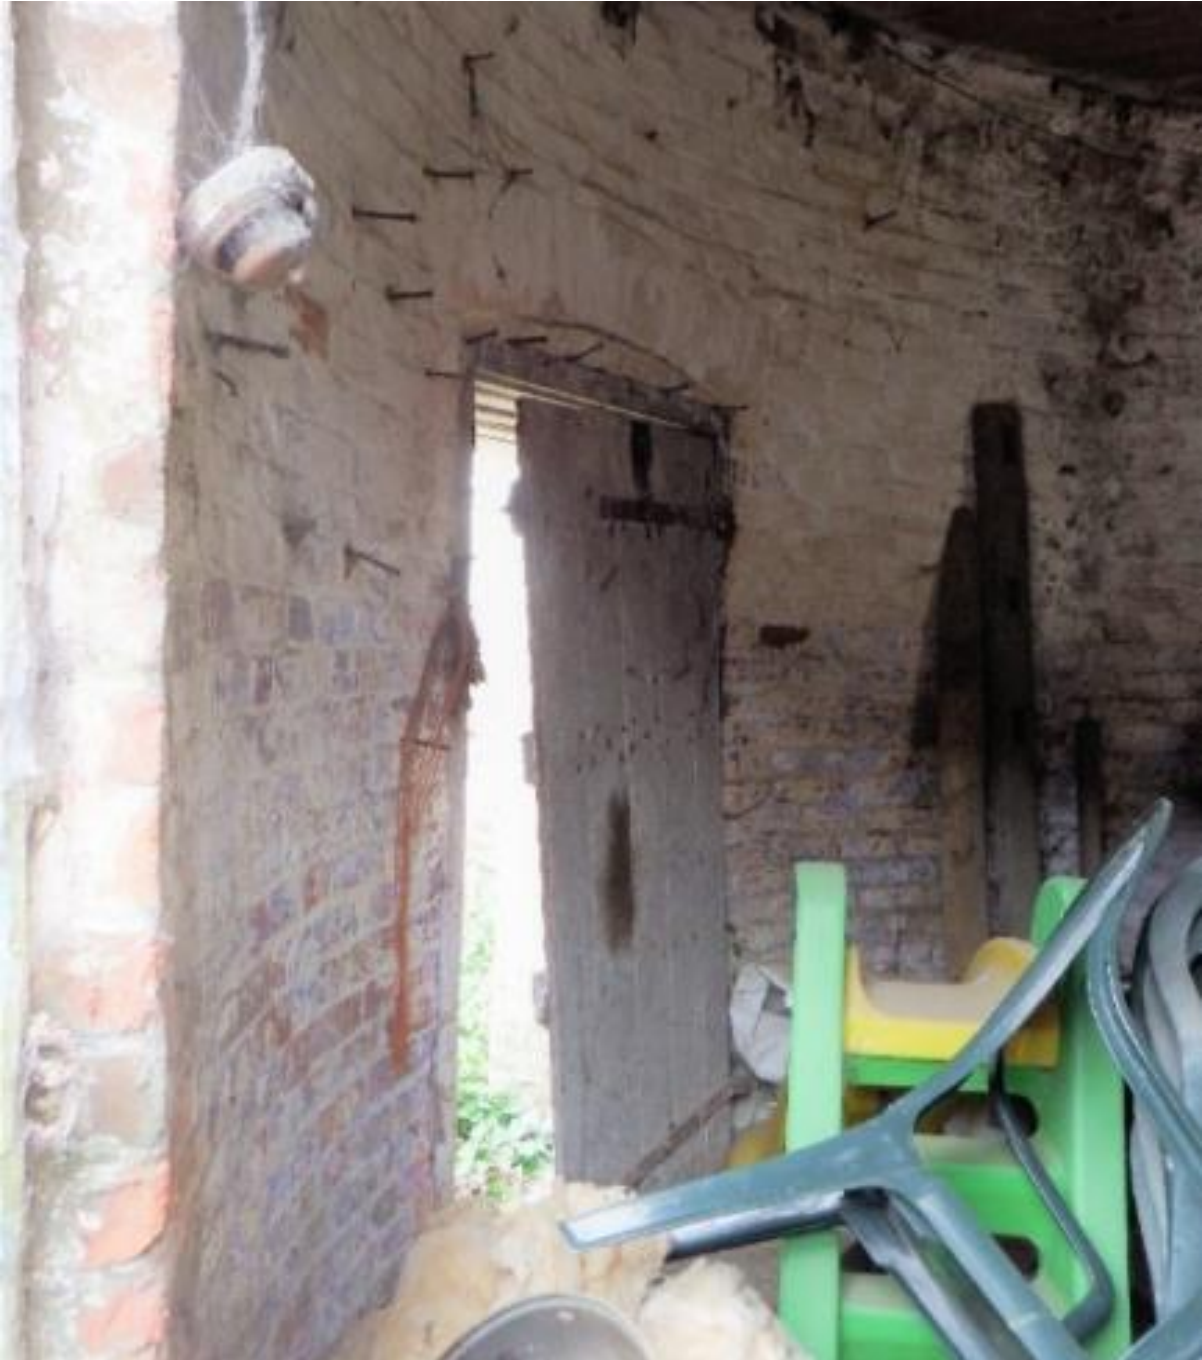
*Plate 28: Internal door within oast house at Barrow Hill Farm leading to stable*

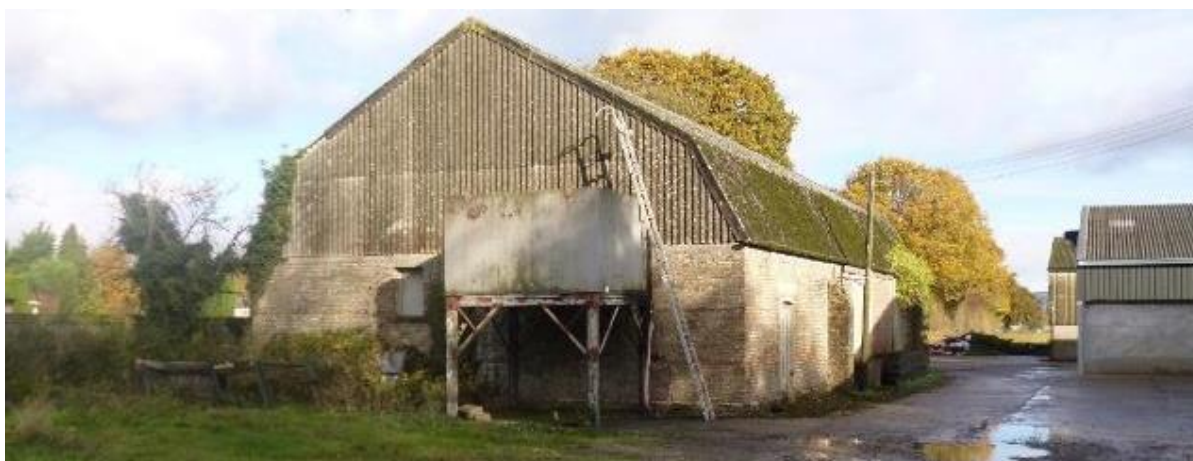
- 4.2.17 The large barn at Barrow Hill Farm forms the second part of **WS10**. The barn is constructed of yellow London Stock brick with two bands of red brick, one a third of the way up and the other at two thirds of the way up the building. There are windows and doorways along the sides of the building but whether these are original is unknown. The roof is gambrel with gabled ends and has been replaced in the 20<sup>th</sup> century. The roof appears to be made of a corrugated grey material, possibly asbestos (**Plate 29**). The style in the lower section of the barn is like that seen in the railway cottages at Barrow Hill, Sellindge (**WS5**), the Gables East and West (**WS20**) and in Westenhanger Station (**BH3**). The barn (**WS10**) and the Gables East and West (**WS20**) are contemporary, according to cartographic evidence, and may have been influenced by one another style wise or the style may simply reflect the style that had become popular in this area of Kent during the mid-late 19<sup>th</sup> century.

Plate 29: Barn at Barrow Hill Farm (**WS10**) looking north-east

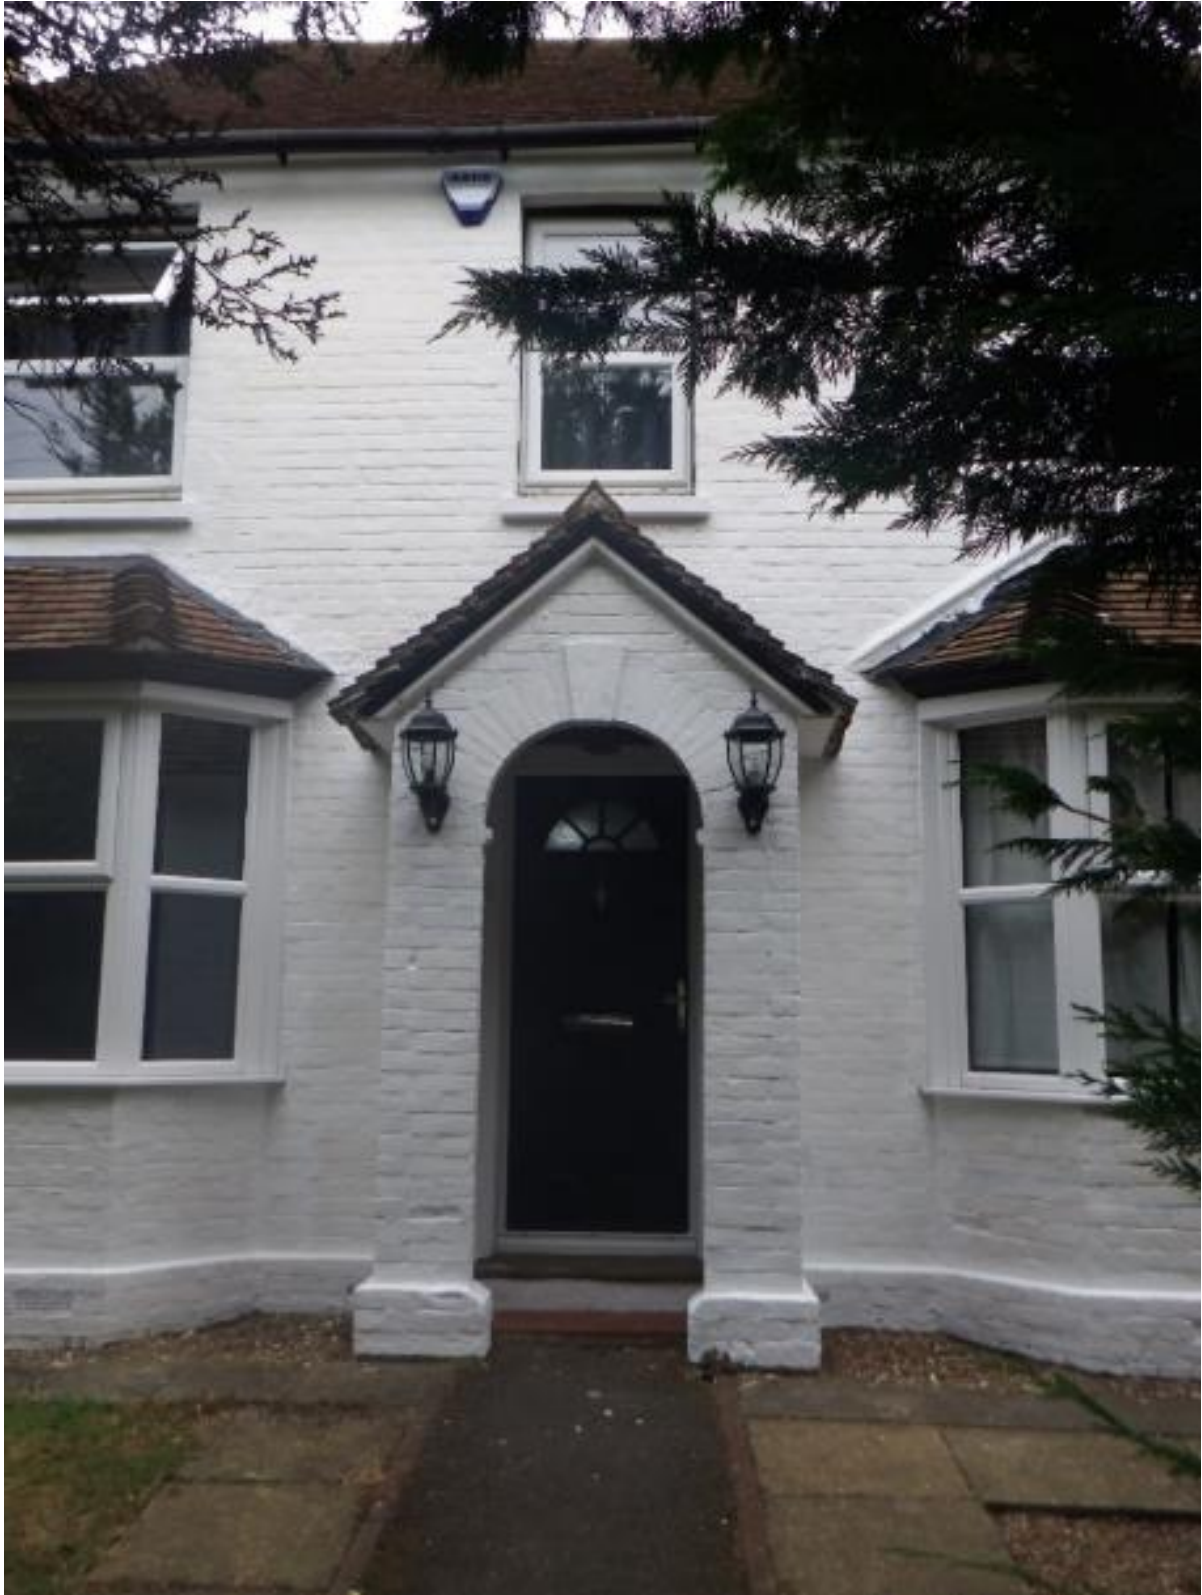
- 4.2.32 The farm house is an amalgamation of two structures, the original building to the south is square in shape with two rear facing wings and a brown tiled hipped roof. Two rear annexes can be seen, the southern is a conservatory and the northern is a hipped roof building. These sit within a large asphalt yard area. The later connected building to the north has a brown tile hipped roof with dormer windows and a sloping extension to the east at the southern end (Google Maps 2017). The southern building is two-storeys with white painted bricks (**Plate 30**). The front façade (southern building) has five windows and a central entrance way with a white painted brick porch with an arch and projecting key stone with a sloping brown tiled roof above. The windows are modern and rectangular with white plastic frames, the two-ground floor windows are both bayed while the top three windows are flushed to the façade. On the first floor, two windows mirror the bay windows position while a smaller window is positioned above the porch (**Plate 30**). The northern building could not be seen during either of the two site visits.

*Plate 30: Farmstead South-East of Railway Cottage (BH17) looking east*

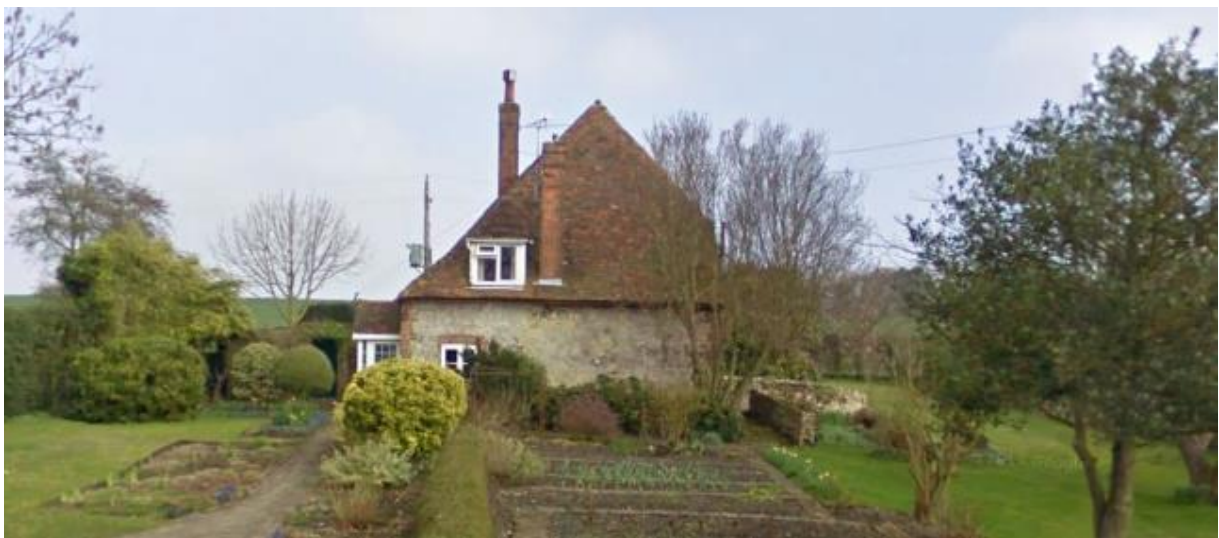
Plate 31: Twin Chimney Cottage looking east (Google Street View 2009)

- 4.2.38 The farm house structure is two-stories and is constructed of ragstone with red brick quoins. The roof is red tiled and is hipped to the east and has a catslide to the north and west with a white wooden dormer window set into the western pitch (**Plate 31**). The house has three chimneys which are built of red brick and are tall and narrow in character. There is a porch facing north with white framed windows and surrounds, with a red tiled roof (**Plate 31**).

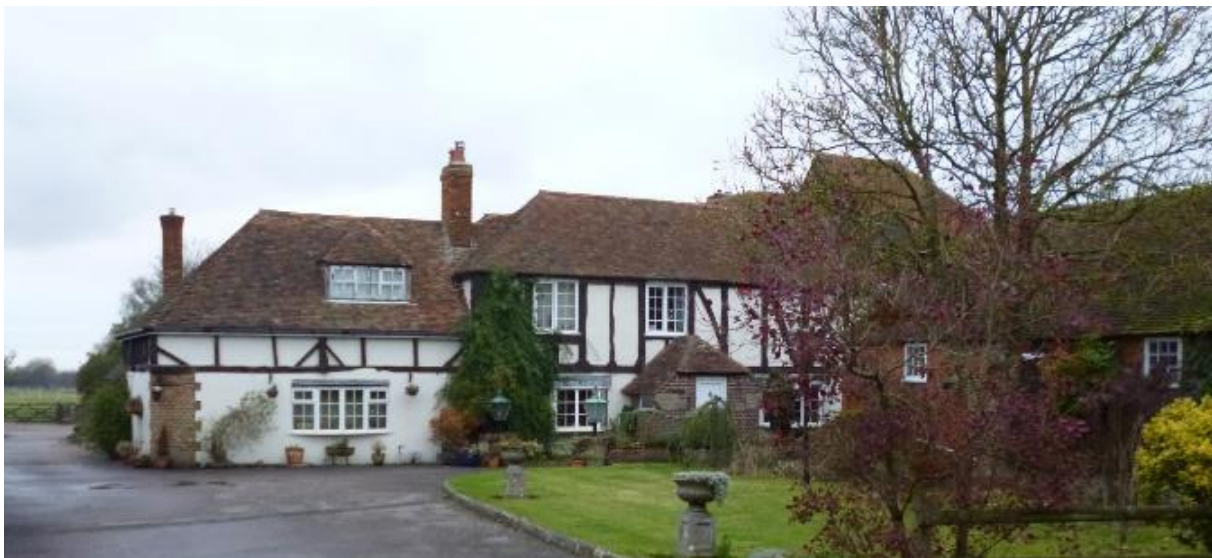
- 4.2.49 Newingreen Farm, also known as Stone Court, forms an enclosed complex of redbrick and straight tile buildings with hipped roofs, on an internalised courtyard plan. The roofs of the entrance buildings sport cupolas with weathervanes and the character of the complex and nucleated layout supports a 19<sup>th</sup> century date.

Plate 32: Newingreen Farm (view south)

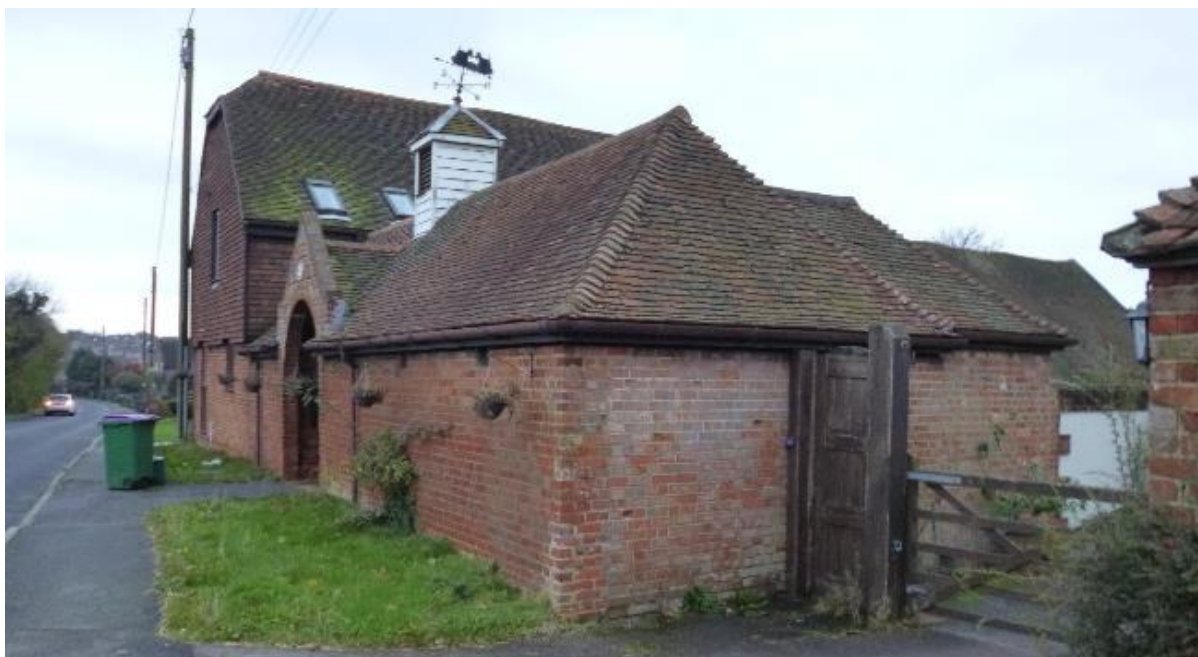
Plate 33: Newingreen Farm (view south)

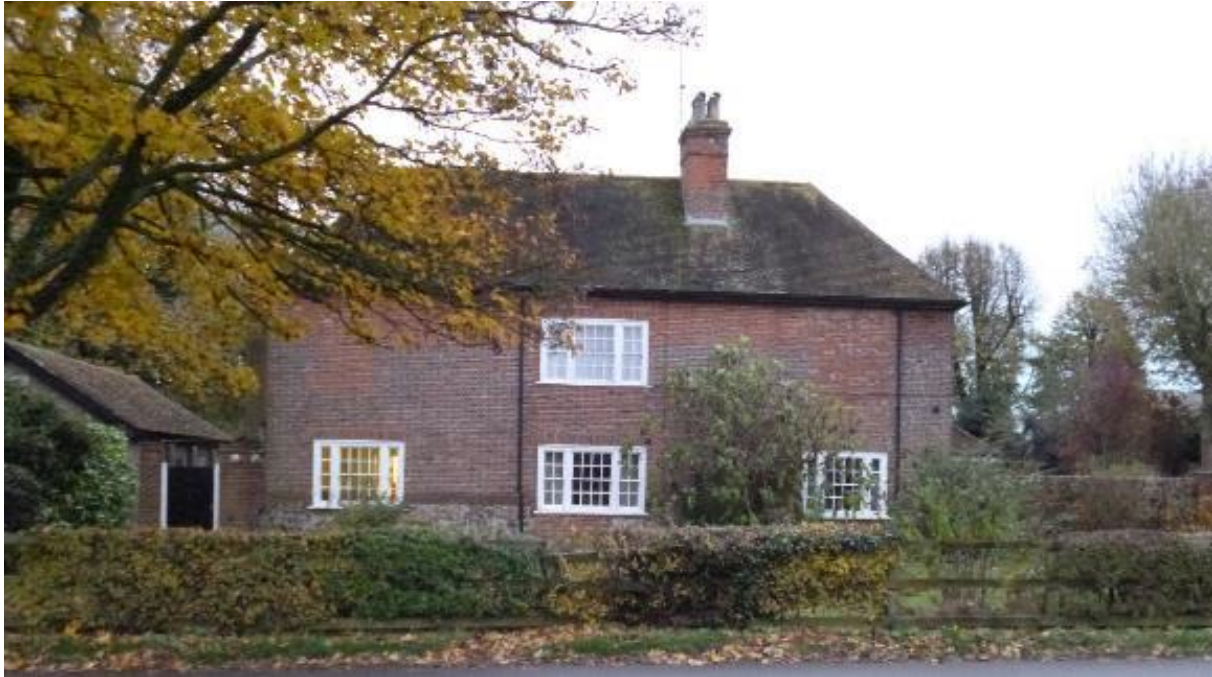
Plate 34: Berwick Manor Farm looking east

- 4.2.65 It is a two storey house set back from the road by a lawn. The aspect closest to the road is constructed out of a mix of red brick with four windows, three on the ground floor and one on the first floor. Each window is large and sashed (**Plate 34**). The building is rectangular, in line with the road, with three projecting annexes to the rear, the northern most one is the largest. On the southern side is a projecting porch and two upper windows. The roof is hipped and covered in brown tiles, two sets of chimneys can be seen (**Plate 34**). A ragstone wall encloses part of the garden to the south of the house.

- 4.2.66 The western façade shows that the farm has undergone a large amount of alteration over its history (**Plate 34**). Around the base of the structure ragstone coursing survives to the lintels of the ground floor windows, across the frontage the ragstone shows several areas of brick infill which likely represent former doors or other alterations. Above the north and south ground floor windows are two blocked windows which may relate to window tax given that this façade faces the road. The brick within the infilled areas appears to be different to that seen elsewhere on the property. Halfway up the first-floor level the bricks also change to a different character perhaps indicting a rise in the roofline at some point.

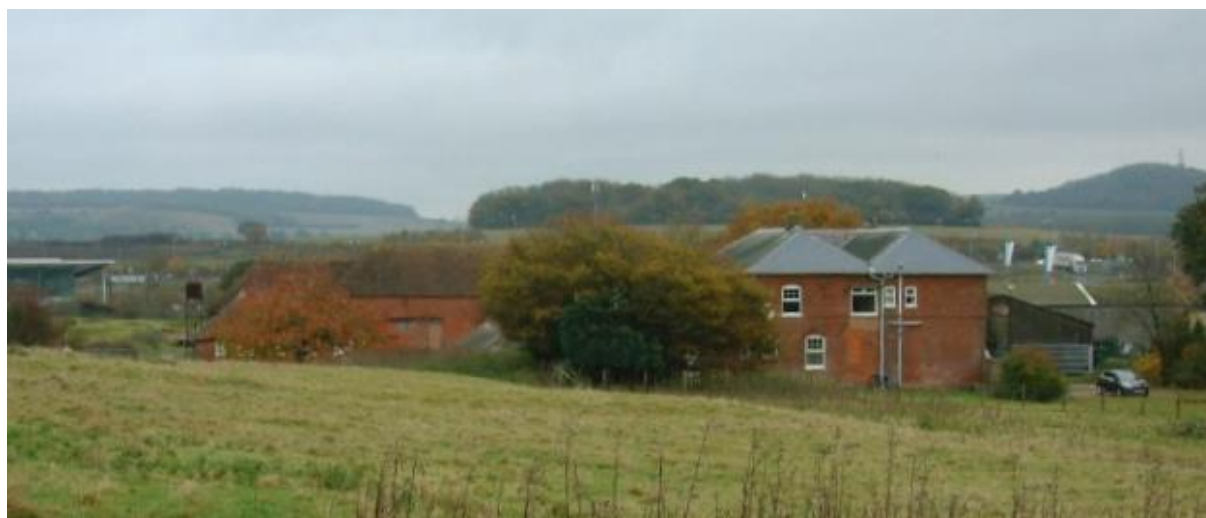
Plate 35: Hillhurst Farm

- 4.2.79 The farmhouse is two-storey and constructed with red brick with a double piled hipped grey slate roof. The windows on each level are modern with white frames and come in varying sizes (**Plate 35**). The complex is still a working farm with large yard-areas to the northeast which are surrounded by outbuildings. The outbuildings are constructed of redbrick with hipped roofs and brown tiles (**Plate 35**).

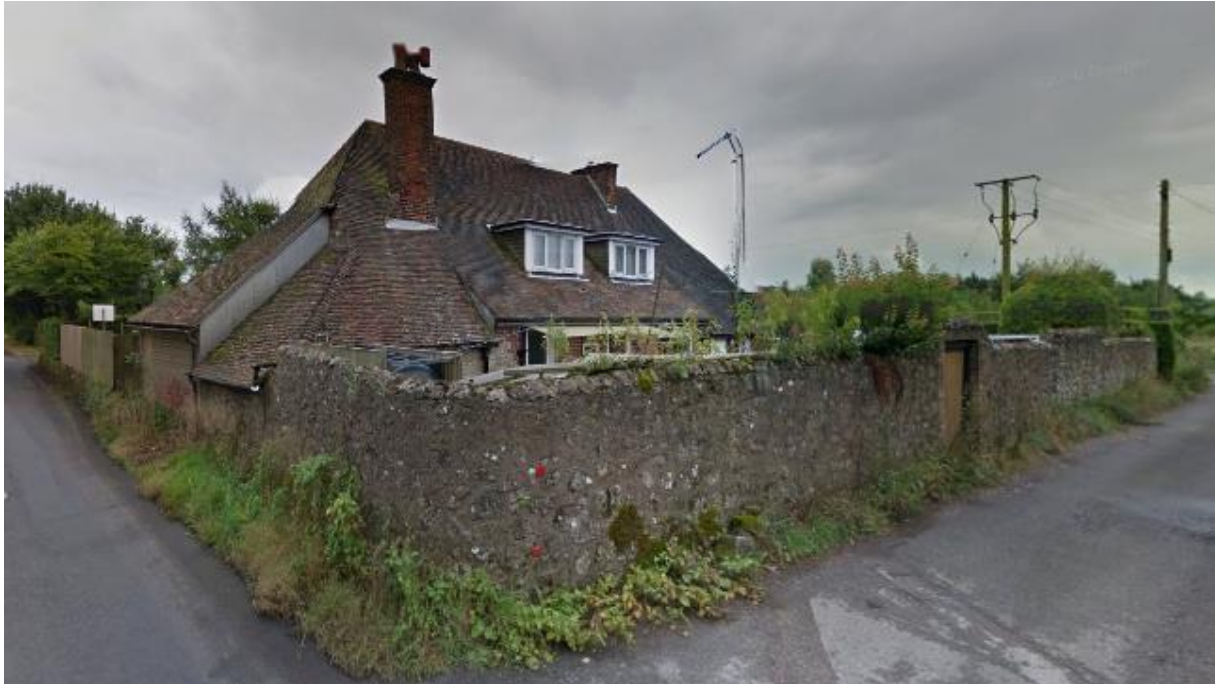
- 4.3.9 Old Mill Cottage (**WS3**), the property lies on Aldington Road at the southern end of Site. This cottage is a private residence and has two stories. The ground floor is constructed with red/brown brick and light-coloured sandstone rag stone walls with modern white framed windows (**Plate 36**). The western side of the building is a mixture of red brick and sandstone walls (**Plate 36**). The eastern side of the building is constructed out of redbrick with a large 1930's extension constructed out of brown brick to the south or rear of the building (**Plate 37**). The north side of the building faces onto the road and shows at least three phases of construction or repair. The roof is hipped with a catslide roof and two, three panelled dormer windows on the western side and a stepped sloping roof to the north (**Plate 36**). The roof is clad in grey tiles with one chimney stack at the northern end of the west side. A heavy-duty curving wall protects the house from traffic along the road and lane (**Plate 36**).

Plate 36: Old Mill Cottage (WS3) looking south-east (Google Street View 2017)

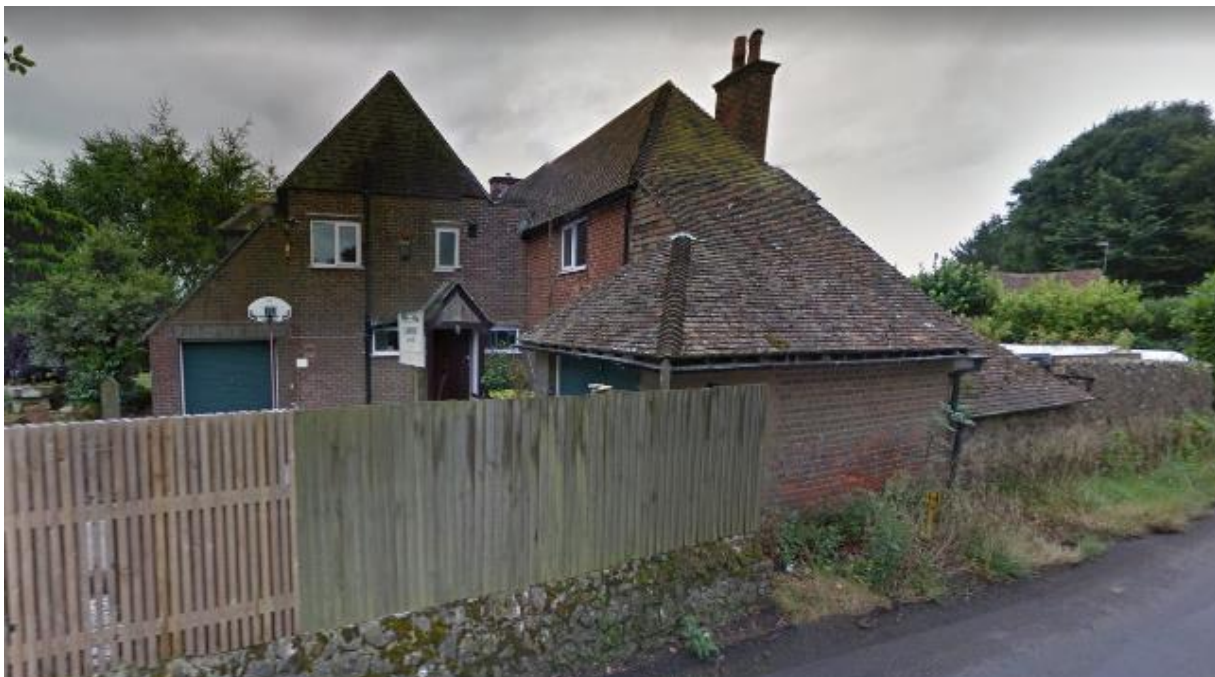
Plate 37: Old Mill Cottage (WS3) looking south-west (Google Street View 2017)

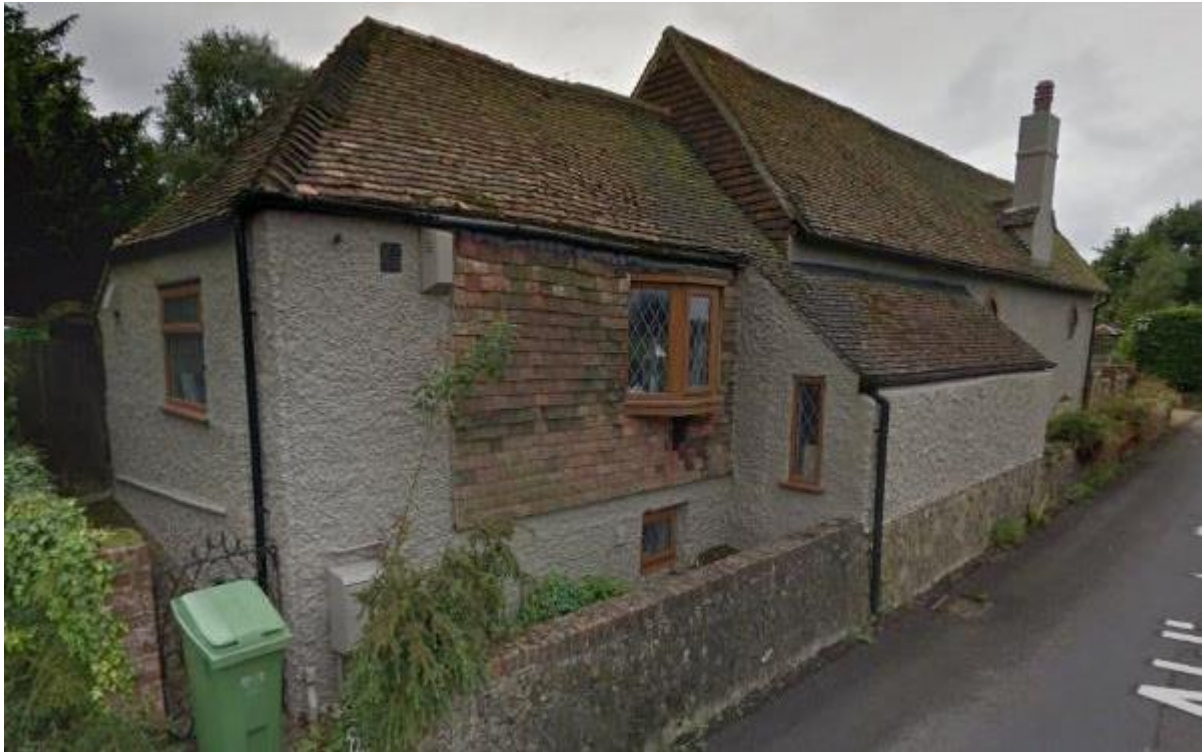
framed window. Here the roof is hipped with a chimney on the norther side (**Plate 38**). The western gabled ended side of the building has red square tile cladding and the projecting gabled ended annex is constructed out of red brick (herringbone and English bond) with black wood box panelling. There are two windows set within the panelling on the western side, these are rectangular, modern, and wooden framed (**Plate 39**).

Plate 38: Newell Cottage, Aldington Road looking south-west (Google Street View 2017)

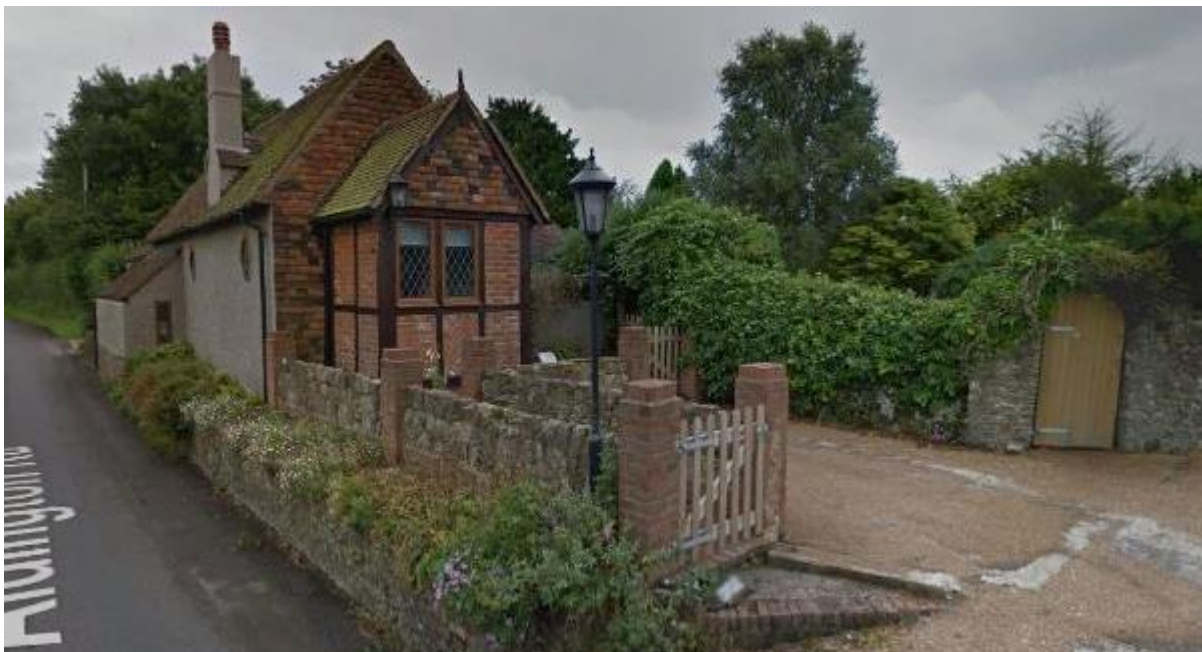
Plate 39: Newell Cottage, Aldington Road looking south-east (Google Street View 2017)

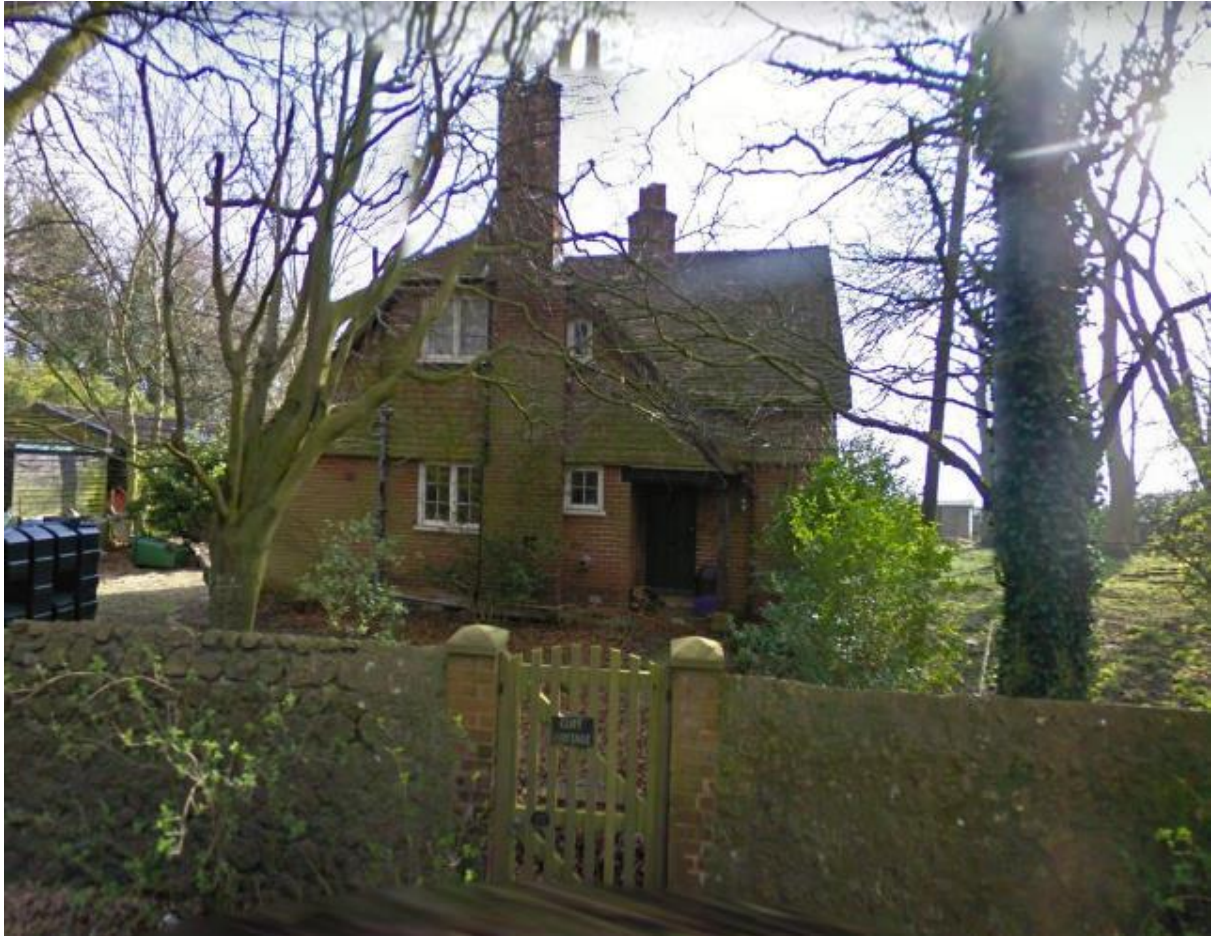
- 4.3.24 Cliff Cottage (**WS7**) is located on the southern border of Site along Aldington Road. The structure is two-storey with redbrick at ground floor and red/brown tile cladding on the above (**Plate 40**). The property is formed of two contemporary parts. The south side has gable ends, the western side has a large three panelled windows with white frames and two projecting bands of tiles above the top of the window. To the north, and lower, is a single panel window with a slightly projecting tiled lip above. Directly below and mirroring the upper story is another three-panelled window on the ground floor. The east gable also has large three panelled windows but with a projecting band of tiles above it. The northern part of the building has a large sloping roof all the way down to the ground floor. This sloping roof is incorporated into the south-west gable end, here the ground floor is projecting forward away from the gable end. Along the road side the roof is half hipped with a tall chimney stack. Surrounding the property on the road side is a stone boundary wall (**Plate 40**).

Plate 40: Cliff Cottage (WS7) looking south (Google Street View 2009)

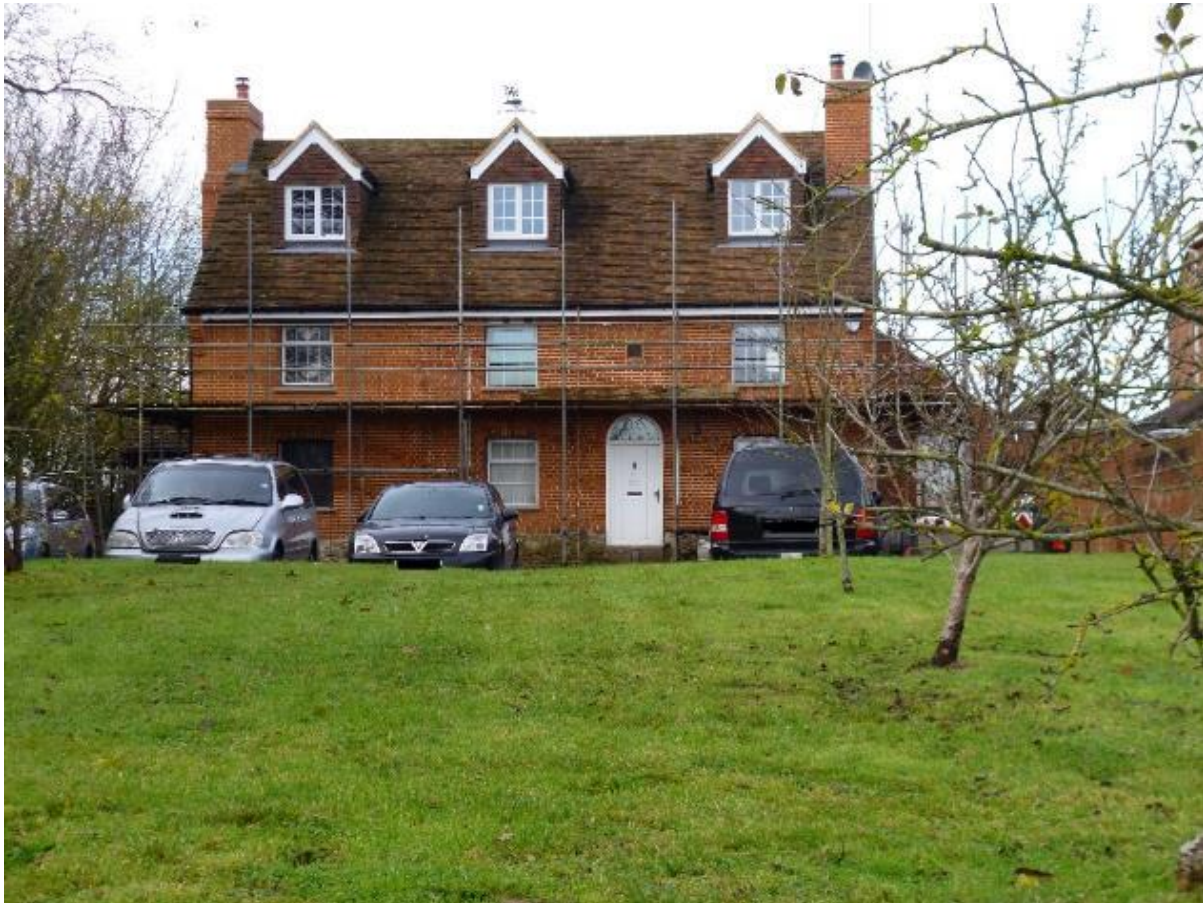
- 4.3.32 This property is situated on the western side of Site within the Barrow Hill. Sellindge area. It is constructed with two storeys in redbrick with dormer attic windows. Each floor has a set of three windows which are vertically in line with one another. The Dormer windows look modern and framed in white while the lower two floors windows are possibly sashed with white frames (**Plate 41**). The Dormer's are clad in brown tiles with white A-framed boarding above the windows. The middle dormer has a stylised weather vane of a horse, rider and possibly a plough. The roof is gabled ended, steeply sloped, and clad in brown tile. There are two sets of chimneys set at either end of the gables. The house is set back from the main road by a lawn and parking area. There is an entrance way between the northern two windows, the door is white with an ornate fan light (**Plate 41**). Above this and set between the upper two windows is a plaque reading 'TG 1763'.

Plate 41: Humble Bee Hall - 1763 looking west

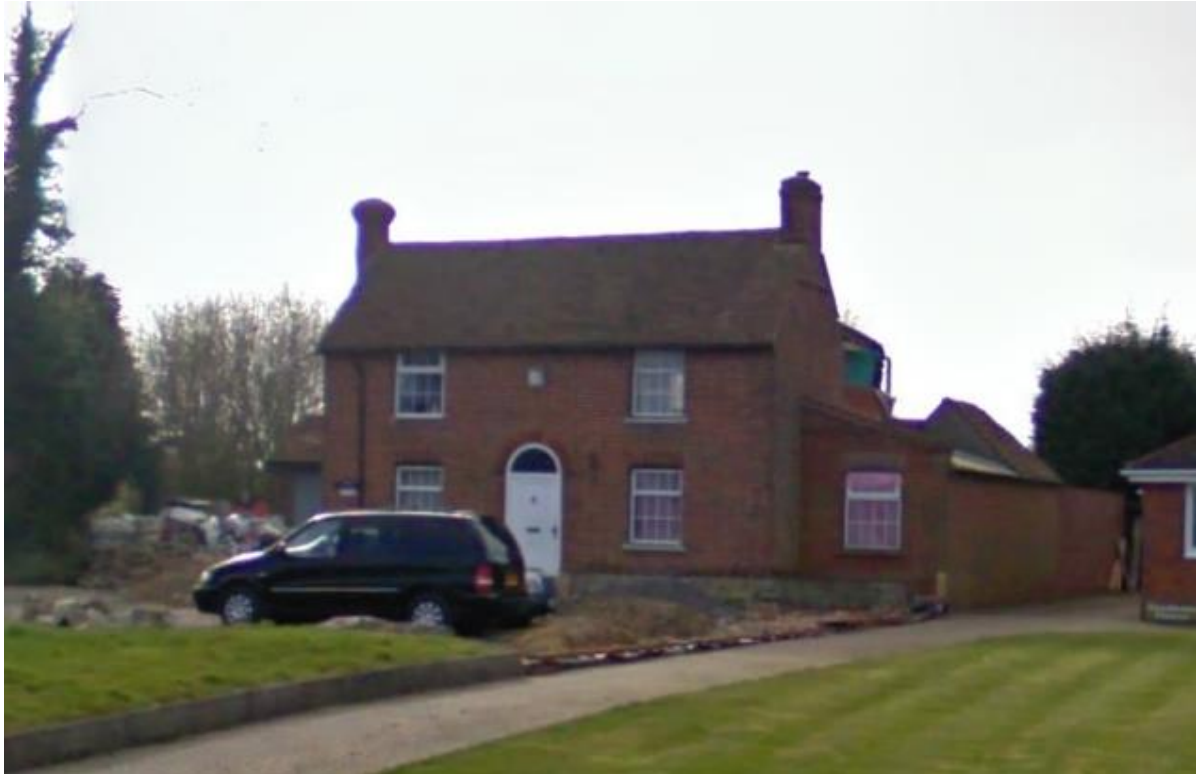
- 4.3.35 This building was undergoing renovation at the time of the site visit. There also appears to have been alterations and improvements to the building in the recent past. Before the recent scheme of improvements, the building appears largely unchanged since the 1840 Sellindge Tithe map. The improvements to the property, (**Plate 42**), include Dormer windows in the roof, an extension to the south, rebuilding of the southern chimney and the front has been repointed. The modern extensions are in keeping with the buildings character and it retains its aesthetic value..

Plate 42: Humble Bee Hall - 763 looking south-west (Google Street View 2009)

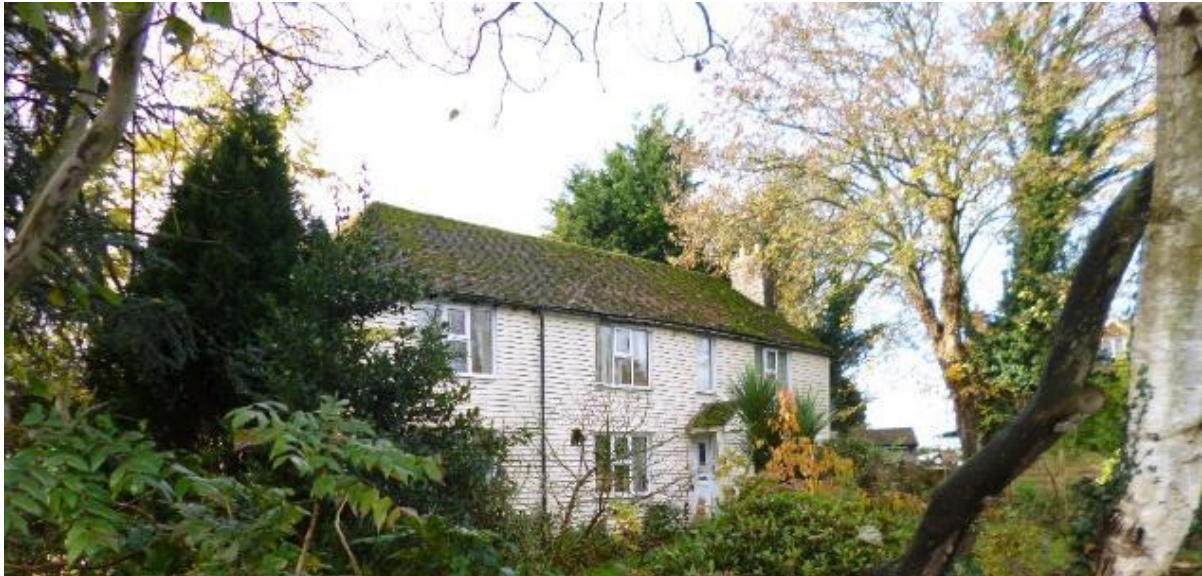
is white and modern. The roof is of reddish brown tiles and hipped with a large chimney stack to the north-west (**Plate 43**).

*Plate 43: Humble Bee Cottage looking west*

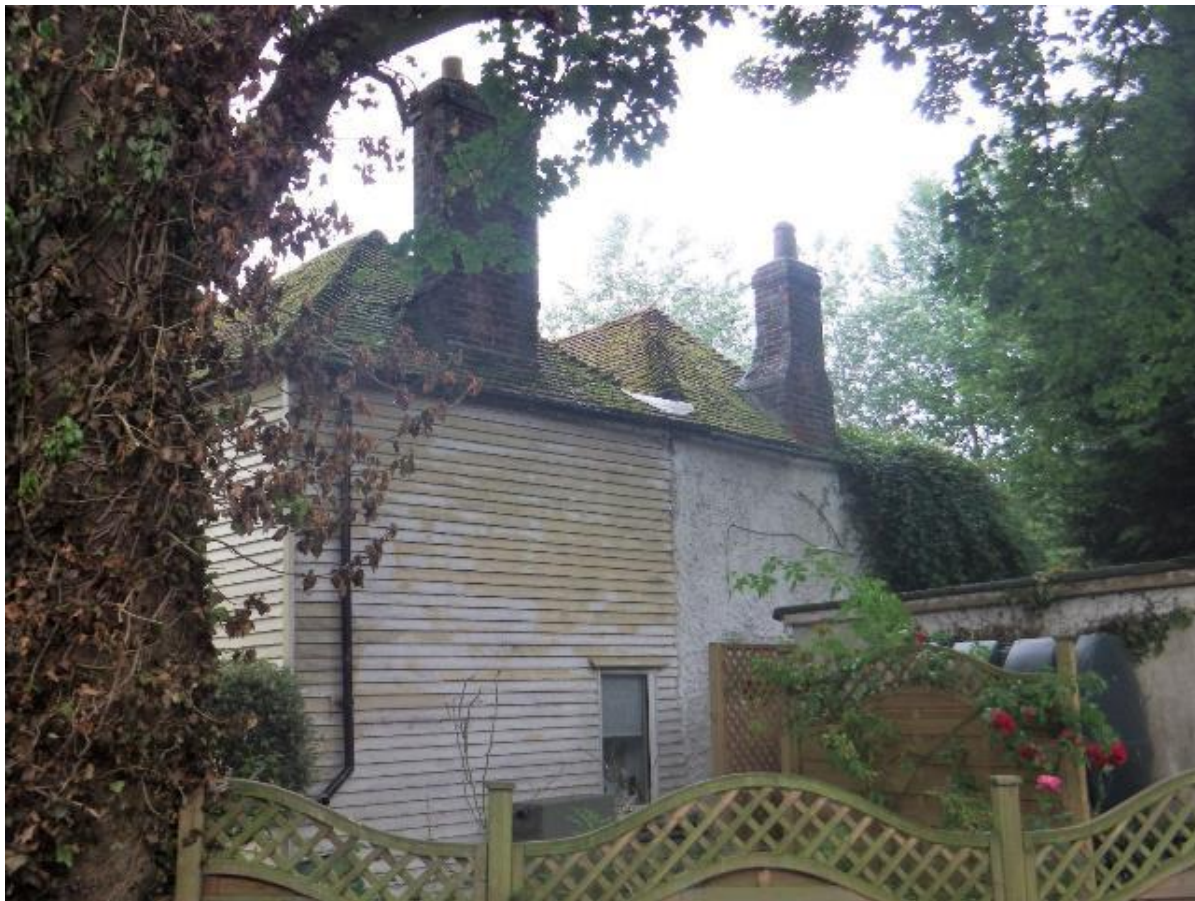
- 4.3.44 The side and rear of the property may retain some of the original features of the cottage. The two chimneys that can be seen from the north-west side are different to one another, the western one is more ornate and is part of the possibly unaltered part of the building (**Plate 44**).

Plate 44: Side view of Humble Bee Cottage looking south

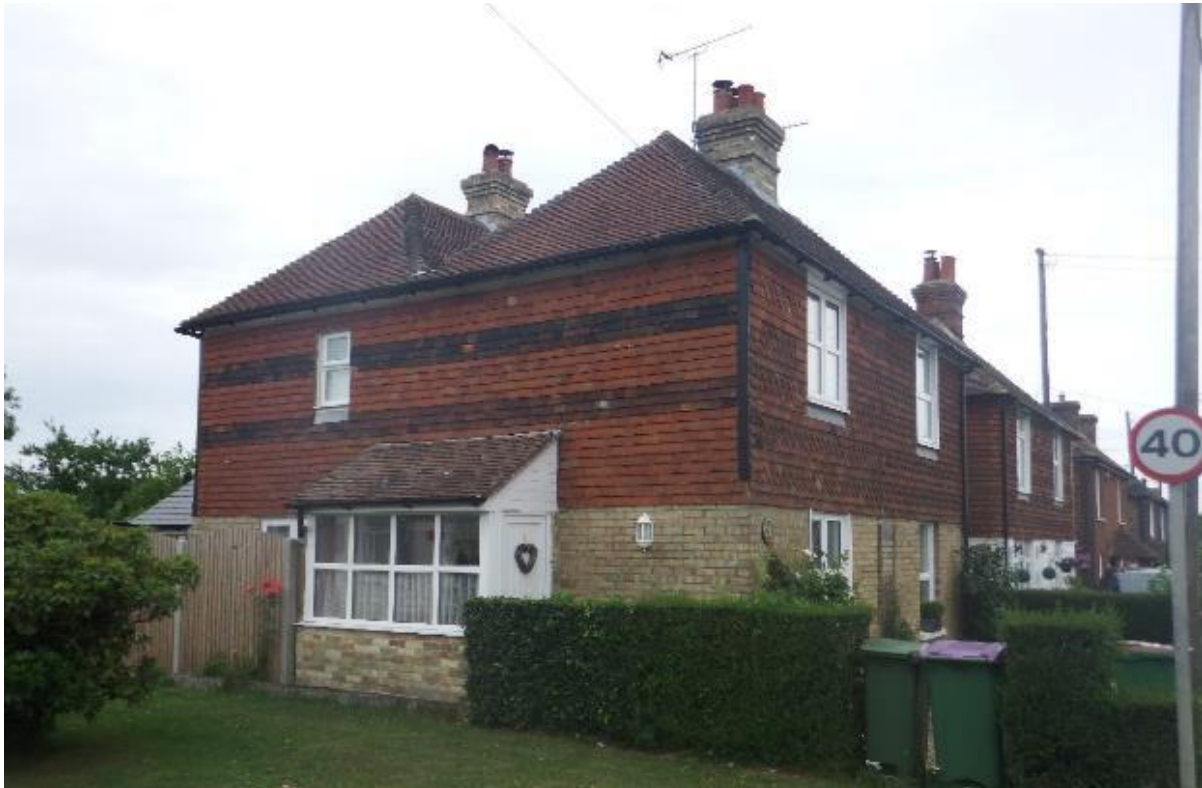
bands of three rows of brown square hung tiles along the south side (**Plate 45**). The north side is covered by brown square hung tiles.

Plate 45: Side view of number 1 and 2 Chapel Cottage (WS28), Barrow Hill, Sellindge looking north north west
