# OTTERPOOL PARK

# ENVIRONMENTAL STATEMENT

Appendix 9.5 – Historic Buildings and Structures Appraisal,  
Addendum 2022

Appendix 9.5 – Otterpool Park Historic Buildings and  
Structures Appraisal, 2017

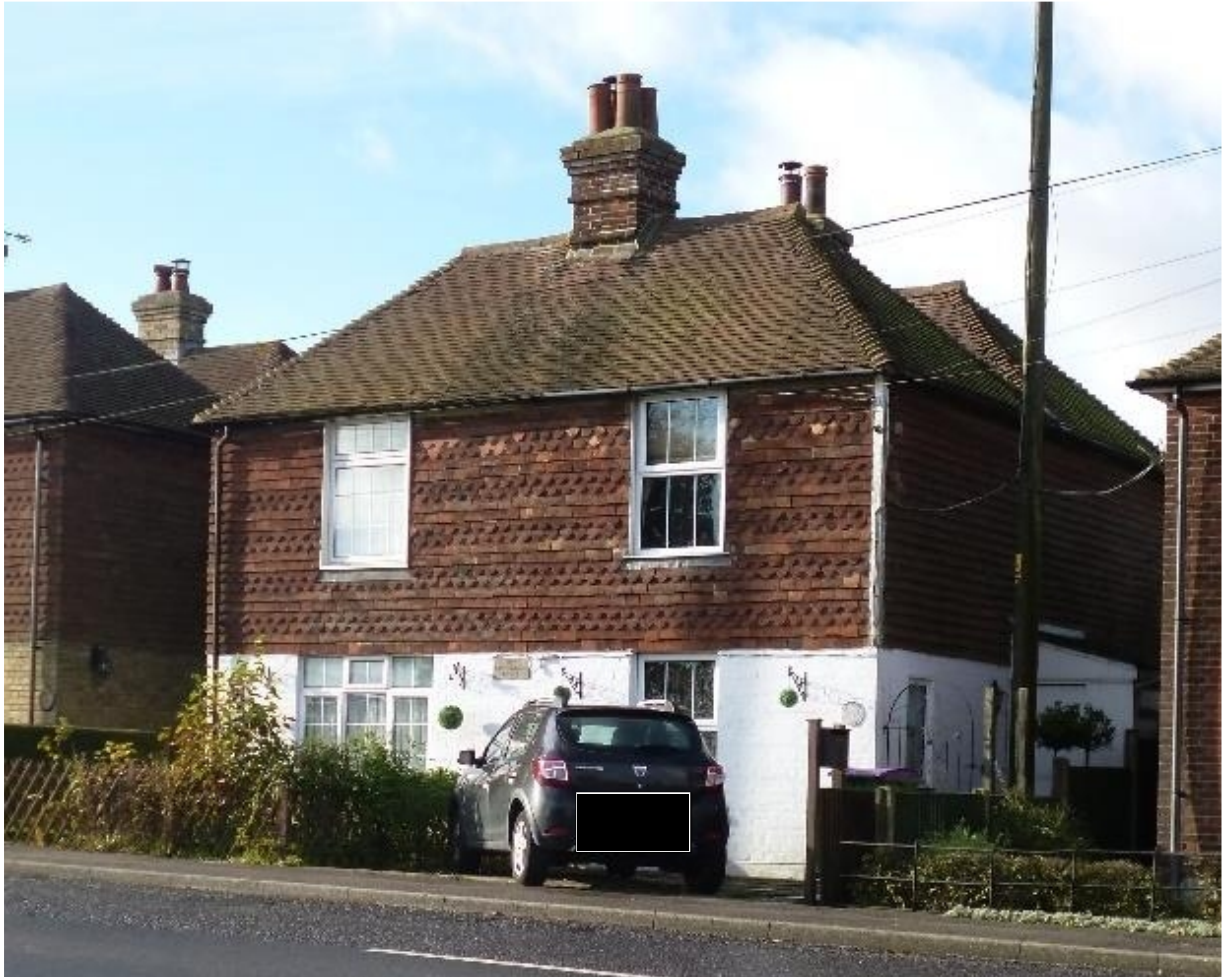
- 4.3.51 Numbers 1 and 2 Ivy Cottage (**WS5**) are next door, to the north, of Chapel Cottages (**WS28**) and are similar in construction and style. These semi-detached properties have a red/brown double piled hipped roof with chimneys set along the apex of each roof. The first floor is clad in red brown hung tiles of club and square style along the front façade (**Plate 46**). Both the north and south sides of the building, along the first floor, are brown square club tiles.
- 4.3.52 The ground floor is white painted brick (**Plate 46**) with a name plaque stating 'Ivy Cottage 1887' fixed just below the hung tiles in the middle of the two properties. Each

cottage has two windows, one on the first and one on the second floor. Number 1 has a rectangular white framed window on the first floor and a larger three panelled window on the ground floor, this is a modern introduction. Number 2 has two rectangular white framed windows on each floor which mirror each other (**Plate 46**). Each cottage has a side entrance with a white porch and door.

Plate 46: 1 and 2 Ivy Cottage (**WS5**) looking south west

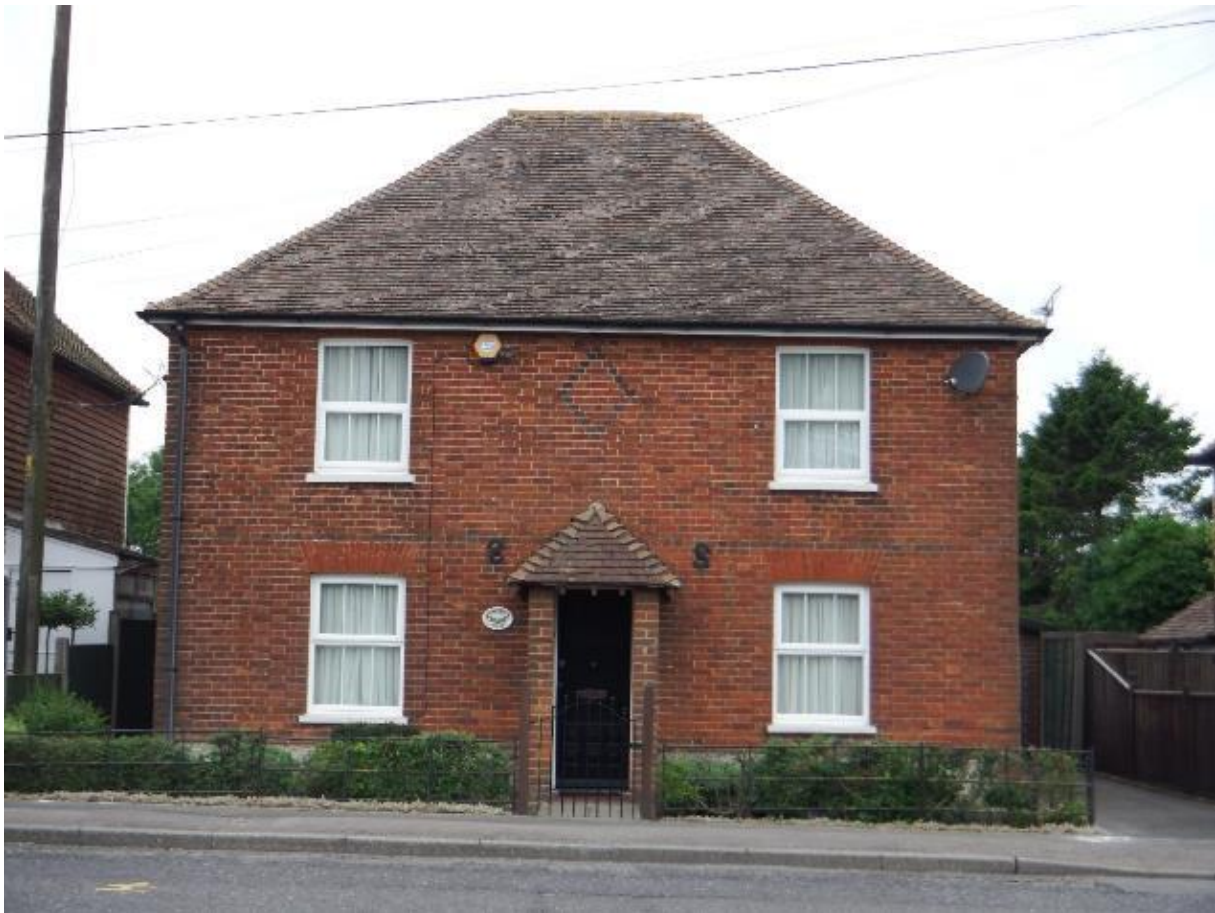
has a diamond motif formed of a single width of a dark coloured brick above the central door near to the roof (**Plate 47**). Below this is a thin door way with a projecting brown tiled porch with two red brick pillars and low walls. These are a later addition as the brick work is lighter and a slightly different depth to the rest of the buildings brick work. Either side of the door way are two white framed two horizontal panelled windows with a red rubbed brick header. Mirroring these windows above are two others (**Plate 47**). Just above the ground floor windows is a single band of darker red or dark coloured brick, this can only faintly be seen. Below the ground floor windows is a foot-high rag stone wall in which the red brick of the building sits with a slight lip, this is not seen along the side of the building and may be ornamental (**Plate 48**).

Plate 47: Merlin Cottage (WS27) looking west

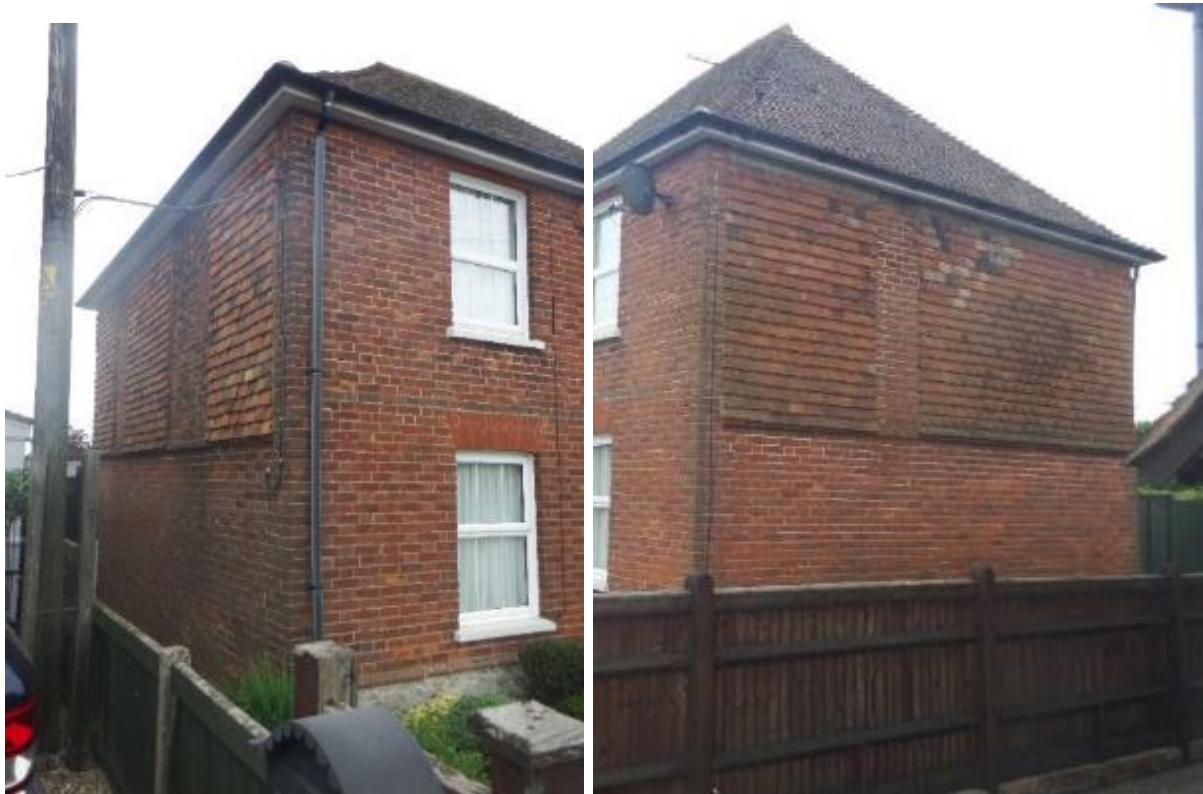
- 4.3.56 The southern side of the cottage has three vertical panels of brown/orange square tiles on the first floor (**Plate 48**). The northern side has two unequal vertical panels, the panel to the west is of orange/brown hung tiles on the first floor (**Plate 48**).

Plate 48: South and north sides of Merlin Cottage (WS27)

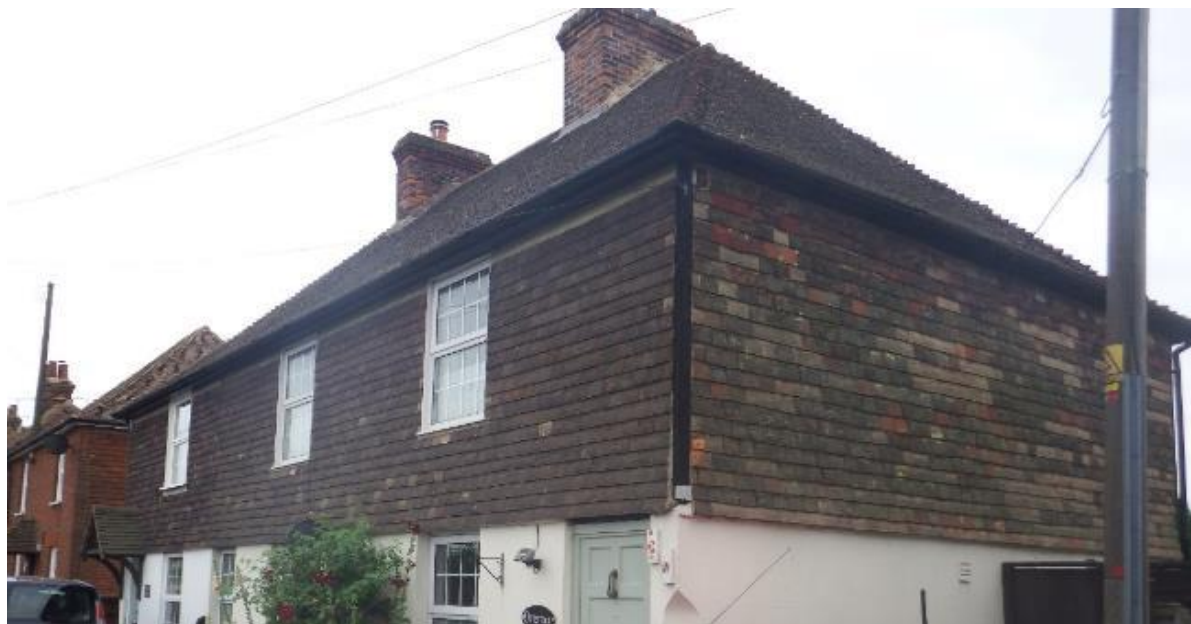
4.3.59 Mistletoe and Ottermere Cottages are a two-storey structure with a hipped roof clad in dark brown/grey tiles with two chimneys, one at the southern and northern ends of the cottages (Plate 49). The first floor is clad in dark brown/grey square tiles while the ground floor is a white/cream coloured render. Mistletoe Cottage has two white framed rectangular windows, one on each floor, their positioning mirrors one another. There is a door with a brown/grey tiles with a porch to the south of these (Plate 49). Ottermere has three white framed rectangular windows on the ground floor, the southernmost is thinner than the other two, and two on the first. There is a plain doorway flush to the front facade to the north of these (Plate 49).

Plate 49: Ottermere and Mistletoe Cottage (WS26) looking south

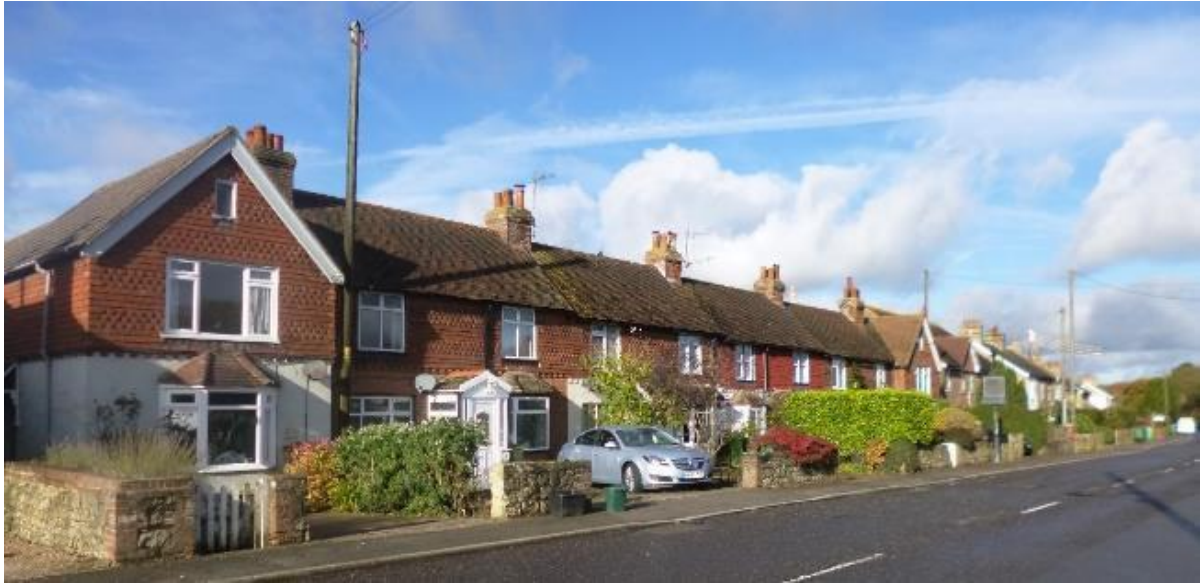
Plate 50: Oak Cottages (WS5) looking north-west

- 4.3.62 To the north of Baydon Cottages is a row of six terraced properties called Oak Cottages (WS5), which are constructed in a variation of the style shared by their neighbours Chapel and Ivy Cottages. The end properties of the terrace are distinguished by front facing gable-ends, with white barge-boarding.
- 4.3.63 The first property has three stories, the upper most of which is within the roof-space. The lower floor is painted white brick with bay window and a sloping roof above. The second floor is constructed with bands of red club and square tiles with a redbrick dentil-cornice dividing ground and first floor (Plate 50).

- 4.3.64 The next property, to the north, is constructed in a light orange/red brick. An A-framed porch has been inserted between the two front windows. The southern window is large and modern with a white frame and two rows of cambered soldier-bricks above. The northern window is smaller and bayed with a sloping roof. The upper floor matches the adjacent houses with red club and square bands of tiles and dentils. The roof is slanted with a chimney to the north (**Plate 50**). Next door the ground floor and dentils have been painted white. The window to the south is rectangular with no cambered soldier-brick detailing. The northern window is bayed with a white, bracketed sloping roof. Here the doorway is flush with the façade with a modern white door with two small square glass windows at the top (**Plate 50**).

- 4.3.65 The next property to the north has a white lower floor and dentils and the same tile cladding occurs on the top floor. There is a small, dark coloured A-framed roof over the central entrance way. To the south of this is a bay window with slanted roof with an adjacent window with a cambered head (**Plate 50**). The penultimate cottage has white club tiles below each window. The lower floor has a projecting cream coloured porch with grey tiled slanted roof. The window to the south is bayed with grey brown tiled slanting roof. The window to the north is large and modern and is surrounded in grey concrete (**Plate 50**). The last house mirrors the first, in being front gabled, but with a white/cream rendering on the ground floor (**Plate 50**), this property completes the group.

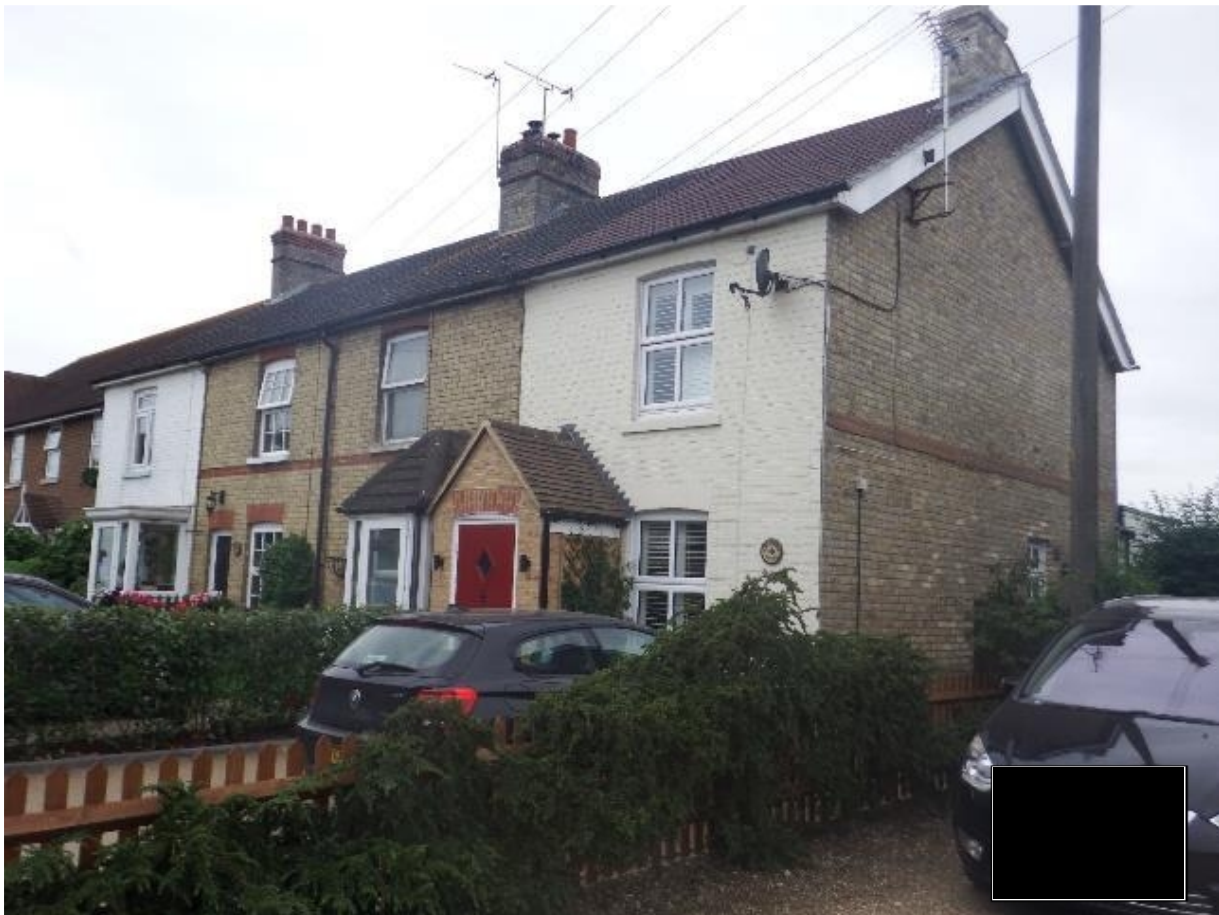
Plate 51: St Johns Villas (**WS25**) looking south

4.3.68 To the north of Oak Cottages (**WS5**) are a row of four properties, numbers 1, 2, 3 and 4 St Johns Cottages (**WS25**). These properties are similar in style to the Klondyke Villas (**WS23**) but these are smaller and have less red brick work. There are, however, two storeys tall and made of yellow London Stock brick with a single band of two red bricks below the first-floor window (**Plate 51**). Each property has a sloping roof with brown roof tiles with three chimneys, one at either end of the row and one in the centre. Each of the two end properties has a side gable. Each cottage has two windows, which mirror each other's position, on the first and second floors. The windows are wide and rectangular with white frames and arched red rubbed brick header above. This motif can be seen over the doorways (**Plate 51**).

4.3.69 Over the years each property has been altered externally with the exception of number 2, which retains all of its front façade features (**Plate 51**). Number 1 front façade has been painted white with a light blue window sill on the 1<sup>st</sup> floor and a modern white, flat roofed plastic porch attached to the entrance way. Number 3 has a brown tiled sloping roofed porch with a low brown brick wall with large white framed windows added to the entrance way. Number 4 has a later porch. The porch has a sloping, red/brown roof with a gable end with light brown/orange bricks with a red rubbed brick header over the door way. The front façade has been painted in a cream colour (**Plate 51**).

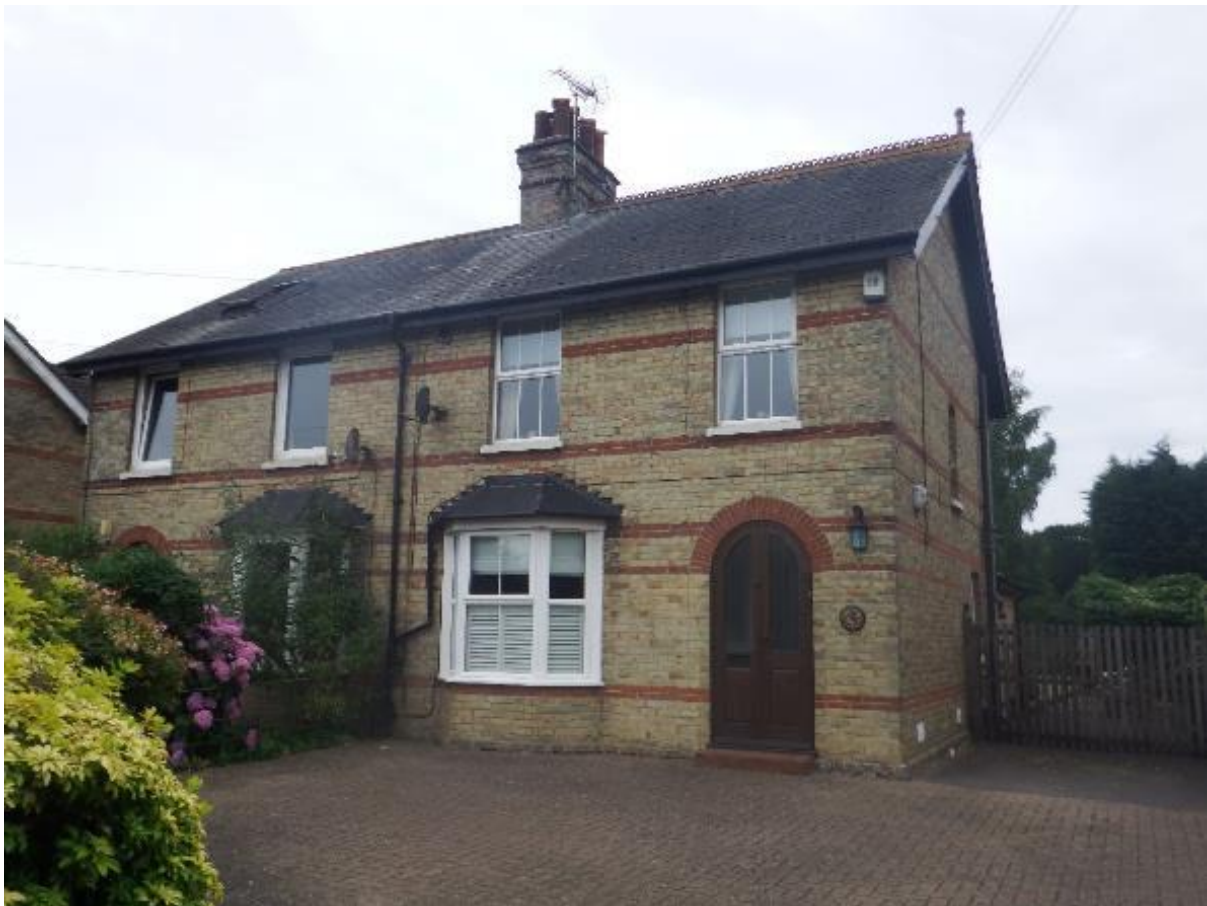
*Plate 52: Number 4 and 3 (Roseville) Klondyke Villas (WS23) looking south west*

4.3.71 To the north of St Johns Cottages (**WS25**) are two semi-detached houses with a similar style of brick work. Numbers 4, 3, 2 and 1 Klondyke Villas (going south to north) are two-storey houses in yellow London Stock brick with redbrick banding (**Plates 52 and 53**). The only notable difference between the properties is that the southern properties (number 4 and 3, number 2 has been renamed as Roseville, **Plate 52**) has a brown tile double-span roof with straight gables and crested ridge tiles on the northern house (the other house has had a loft extension). The northern semi-detached (numbers 2 and 1, number 1 has been renamed as Brenwood) has a grey slate half hipped roof with crested ridge tiles (**Plate 53**).

4.3.72 All the lower floors have bay windows with white modern window frames and sloped, brown tiled roofs. The upper floor windows are sashes in white over white stone sills. The main entrances have curved redbrick arched heads (**Plates 52 and 53**).

4.3.73 Cartographic evidence shows that these properties were built by the 1907 1:2500 OS map. They are depicted as square with an annex at the rear for each property. The first change to occur happens by the 1938-39 1:2500 OS map. Number 1 has a large rectangular irregularly shaped outbuilding to the north. Number 4 has a smaller rectangular outbuilding to the south. The outbuilding at number 4 has been removed by the 1970-74 1:2500 OS map and new outbuildings can be seen at number 3, now called Roseville, number 2, now called Klondyke Villa and the large outbuilding at number 1, now called Brenwood, has been removed and replaced by two other rectangular outbuildings. By the 1986-1991 1:2500 OS map Klondyke Villa has a larger outbuilding and number 1 has two outbuildings. There is no change from this map until the 2017 Google map.

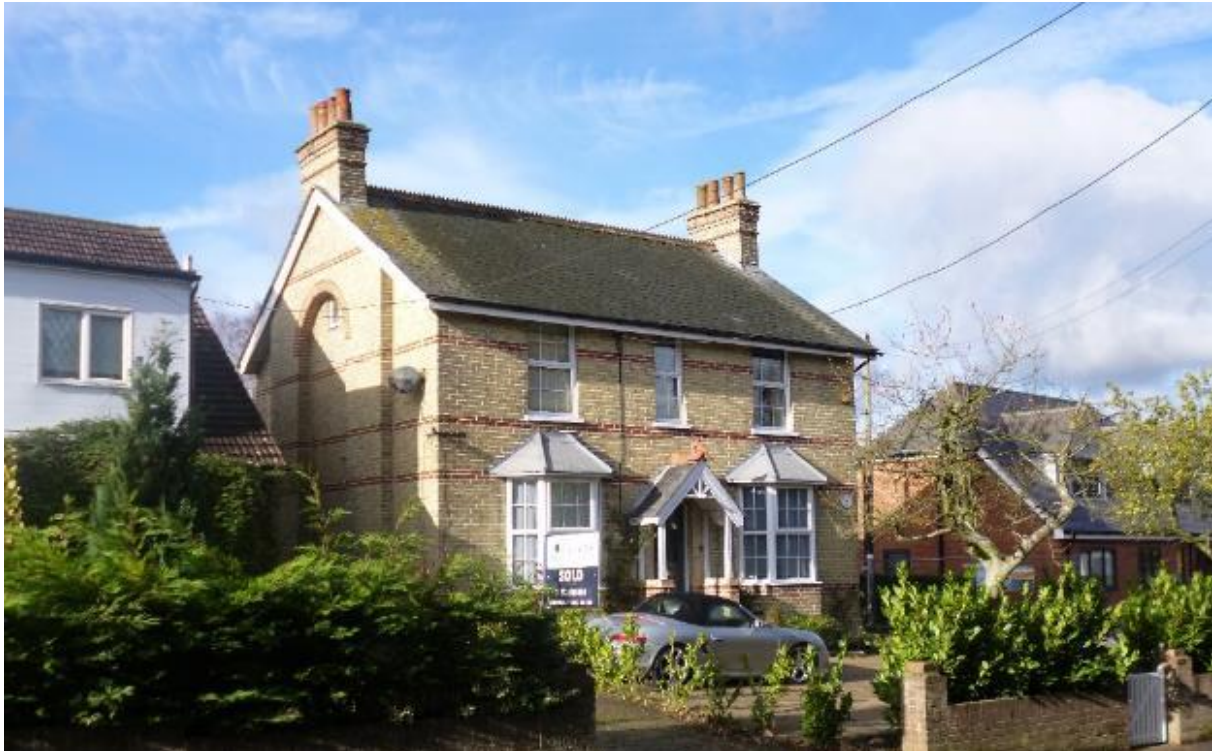
Plate 54: Grove Bridge House (WS22) looking north-west

4.3.76 The property has a central entrance with an A-frame porch with adjacent bay windows, framed in white, with grey tiled sloping roofs. Above the bay windows are white framed windows with a smaller window above the porch. The roof is double span and clad in

grey slate. There are chimney stacks to the north and south, along the top of the roof is a line of grey crested ridge tiles (**Plate 54**). Along the porch roof are more crested ridge tiles this time in red, at the end overlooking the entranceway is a terracotta dragon (**Plate 55**).

4.3.77 Grove Bridge House (**WS22**) is first depicted on the 1907 1:2500 OS map. It is shown as a square structure with a central porch and two rear annexes, one to the north and one to the south. A rear outbuilding can be seen at the far end of the property to the west. By the 1970-74 1:2500 OS map the house is depicted as a square with no annexes at the rear by the porch remains. There is a new square outbuilding to the south of the house. By the 1986-1991 1:2500 OS map there is a large out building to the west at the rear of the property with possible storage areas adjoined to the south.

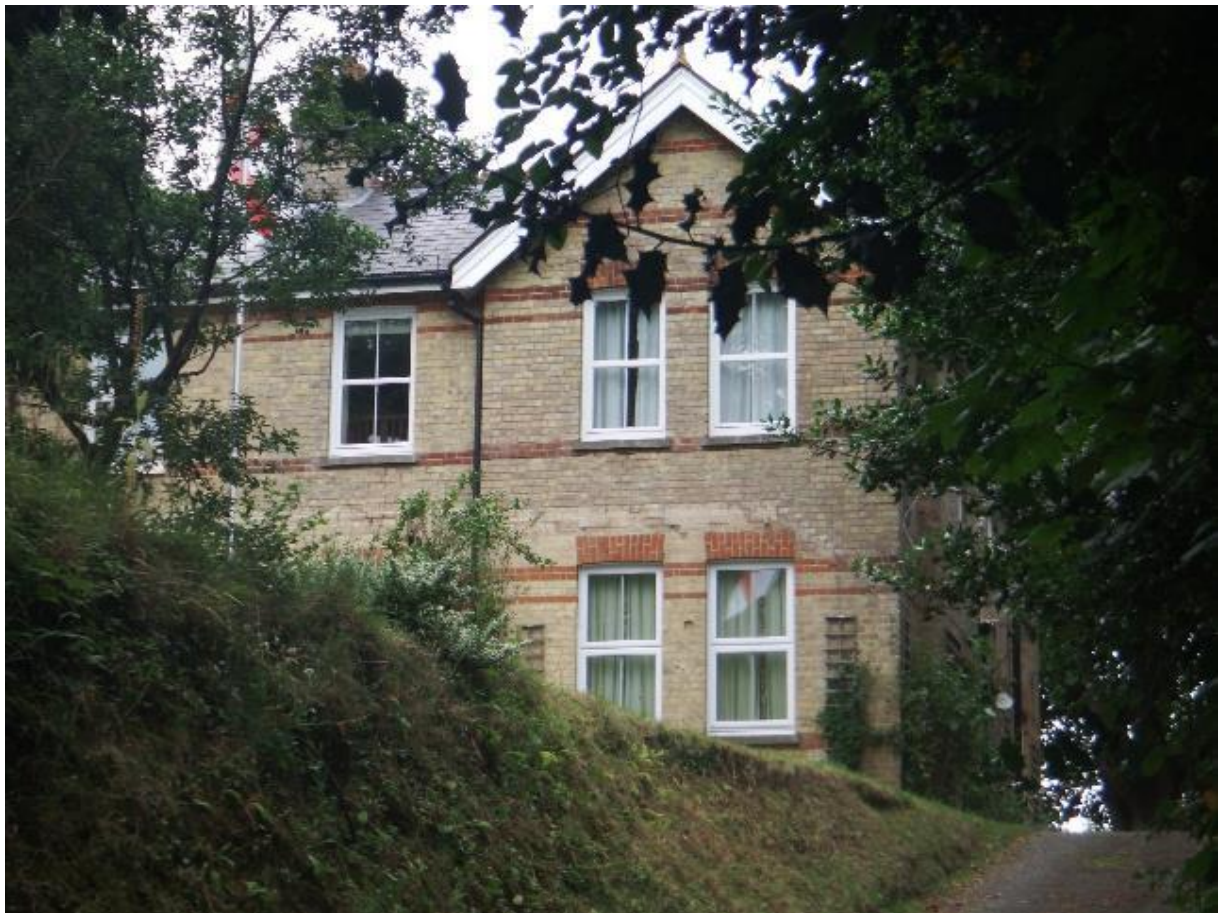
*Plate 56: Gables East (WS29) looking north east*

4.3.78 Further to the north on the opposite side of the road is the semi-detached property Gables East (southern building) and Gables West (northern building). This is the last property in the Barrow Hill area that has the characteristic yellow stock and red brick banding seen in the area. These houses are much larger than the others with a similar style but are also much earlier, their construction date is before 1898. It is possible that this building was once one large detached property for a wealthy owner and was later divided into two (see below in map regression). Both properties are obscured by a high ground level and large, thick vegetation which made assessing the properties difficult.

4.3.79 Only Gable East could be seen during the site visit, the property has a slightly projecting bay with a gable end and sloping grey tiled roof with central chimney (**Plate 56**). The two-storey structure has a double white framed, rectangular window in the bay area which mirror each other position on the first and ground floors. There is at least one window on the first floor to the north of the bay and possibly one on the ground floor. The front façade shows evidence of an extension which has now been demolished (**Plate 56**). Due to the thick vegetation Gables West could not be seen, with the exception of the porch on the northern side of the building which is in keeping with the rest of the buildings style (**Plate 57**).

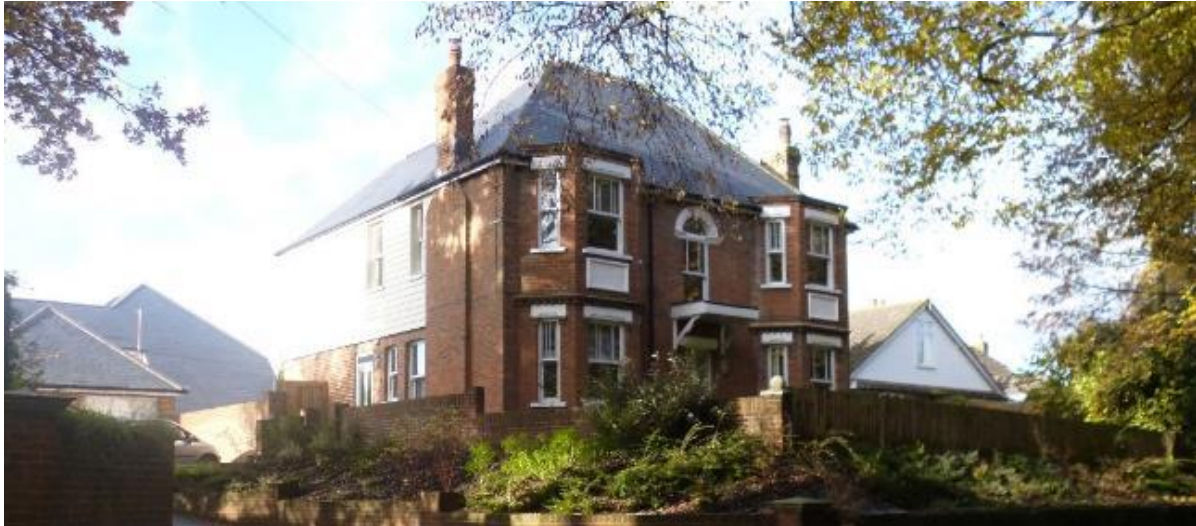
Plate 58: Bernhurst (WS21) looking north-west

- 4.3.81 The last property to be assessed in the Barrow Hill, Sellindge area is Bernhurst (**WS21**) which is a large two story detached house constructed in redbrick. It has white wooden cladding on both sides of the property. The front of the house has two bays each side of a central entrance. The entrance has a flat porch with white trim and brackets. Each of the windows is sashed with white frames and lintels above and below the windows (**Plate 58**). The stair window over the porch has a semi-circular fan window with a white arched head. There are white blind-panels on either bay between the ground and first floor and the roof is hipped and clad in grey slate with chimneys on either side (**Plate 58**). The original driveway entrance was to the north, this is denoted by carved or moulded decorative white stone or concrete finials. The void in-between these two features has been bricked up.

4.3.82 Bernhurst (WS21) first appears on the 1907 1:2500 OS map, it is depicted as a square structure with a recess in the north-west corner. There is a path or track way doglegged up to the centre of the building. There is a series of small rectangular outbuildings along the northern boundary. There are no changes from this map until the 2017 Google map.

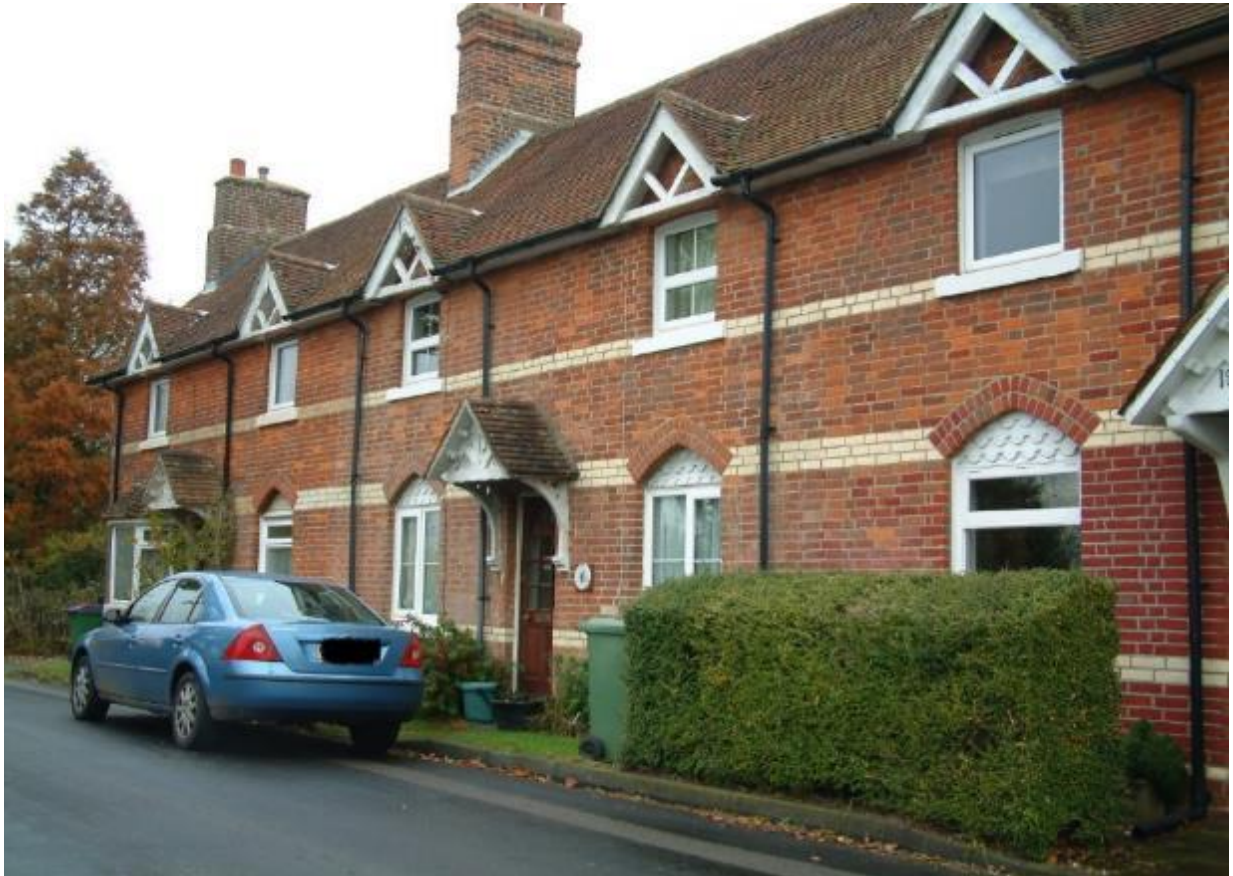
*Plate 59: Arts and Crafts Cottages (WS9) looking north*

- 4.3.88 Situated along the south-east edge of Site is a row of three Arts and Crafts style Cottages which will be assessed as one asset. The cottages are characterised by decorative timber-framed porches and dormer gables at roof-height and with a uniform unaltered style as a group.

- 4.3.89 Set slightly back from the road, these two storey structures are constructed from redbrick with three courses of yellow, possibly stock brick, banding around the base and the top-of the windows (**Plate 59**). The lower windows are rectangular, with white frames, and include some later insertions. Above the window are infill panels of white clubbed tiles surrounding by a crescent hood of paired red soldier bricks. The northern most cottage's window has been changed to a bay with a sloping brown tiled roof (**Plate 59**). The entrances have an A-framed porch with large wooden brackets with timber-detailing and are painted white. Within the A -frames are triangular timbered-panels with a large D at the top and the numbers 18 on the right lower panel and 73 on the left lower panel, forming that date 1873 (**Plate 60**). The upper floor windows are square with white frames and sills. Above the upper windows are small timbered A-frame dormers painted white. The roofs are of reddish brown tile with large chimneys set at each end and two in the middle (**Plate 59**). At each end, the terrace is gabled with the protruding chimney stacks which continue the decorative yellow brick banding seen on the front.

- 4.3.96 It **is recommended** that these cottages (**WS9**) meet the listing screening criteria as they make a strong positive contribution to Stone Street and represent of local Arts and Craft Movement architecture. They also differ from those already been listed in the Kent area. The cottages show a clearly use of materials and are largely unchanged externally.

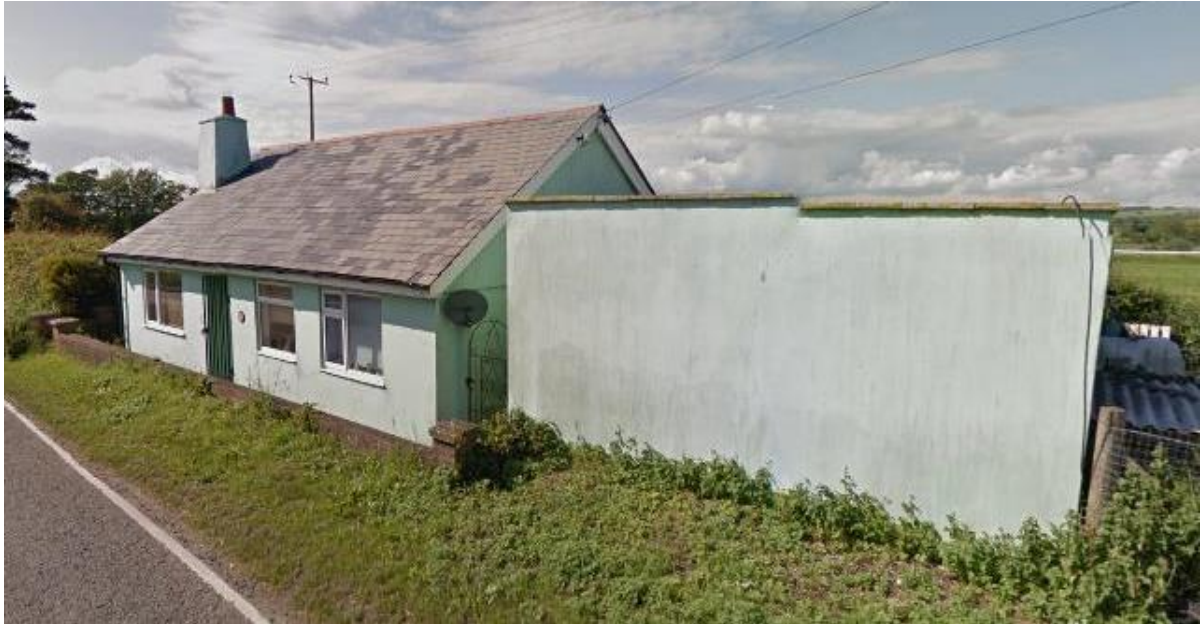
Plate 61: Rose Cottage looking north-west, Google Street View 2017

- 4.3.97 Rose Cottage is a small rectangular single-story bungalow which lies close to the A20. It is covered in a light green coloured smooth rendering (**Plate 61**). There are three windows along the front, one to the west of the door and two to the east. The windows are rectangular and modern with white frames and the door is wooden and recessed within a porch. The roof is gabled and clad in grey slate with a chimney to the western end. The gable-ends are timber clad and the cottage is set lower than the road and a small low wall runs the length of the building along the road side. To the east of the building are a set of double garages rendered in the same material as the bungalow (**Plate 61**).

4.3.102 This property is **not recommended** as being likely to meet the listing screening criteria as the original Rose Cottage has likely been replaced by the current property. The external rendering does little for the aesthetic value for the property.

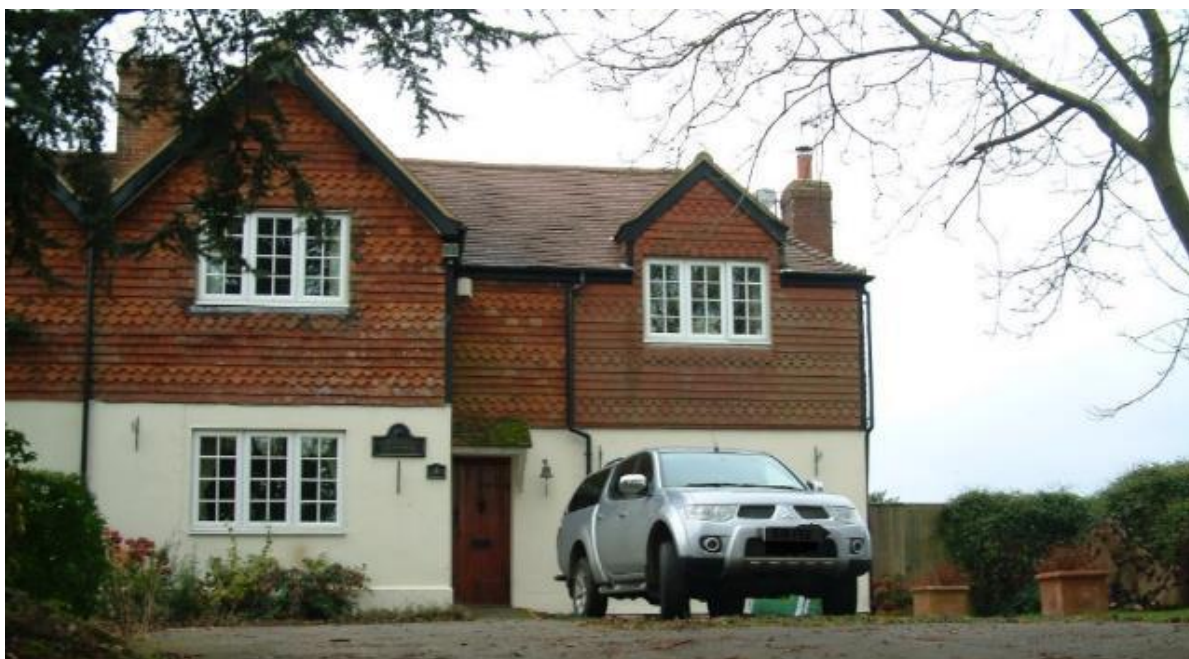
Plate 62: Northern semi-detached cottage Harringe Cottages (WS18) looking west

4.3.103 Harringe Cottages (WS18) is a large semi-detached building, comprising two residences, set back from Harringe Lane. It is two storeys with adjoining projecting bays at the centre, a hipped roof with reddish brown tiles and three chimney stacks, one on each end and one in the middle (**Plate 62**). The properties mirror each other by having red square and spade band tiles on the first floor and pale rendering on the ground floor. The northern property's entrance is set next to the bay in the main building with a small projecting brown tiled roof supported by white brackets, whilst its neighbour's entrance is set between the bay and the main building at an angle. This has a sloping red brown tiled roof and two thin rectangular windows either side of the door. Additionally, the rendering on the northern building is light grey and the southern building is cream (**Plate 62**). The windows on the first and second floors are large, rectangular and have white frames. The first floor has a triangular gable projecting up and over a window (**Plate 62**). The sides of the property are hung with tiles and rendered.

4.3.106 It is **not recommended** that the buildings meet the listing screening criteria as they are of a local significance with a common design which is well represented elsewhere.

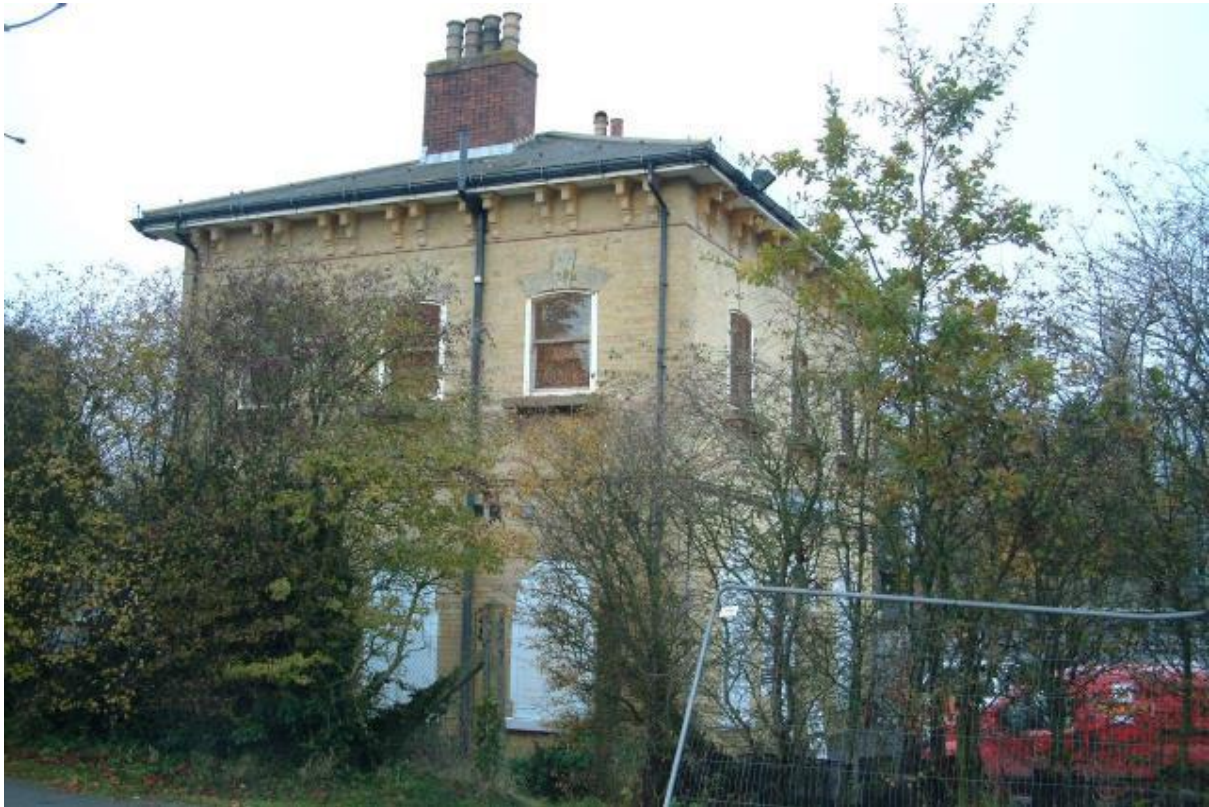
Plate 63: Westenhanger Station (BH3) looking north

4.4.3 The station is a two-storey square building constructed in yellow stock brick with a red and yellow brick pronounced banding between the two floors (**Plate 63**). All ground floor windows and doors are headed with a semi-circular stone arch with a slightly projecting keystone. In the front (east) aspect these are painted white and on all four sides have white shutters. The upper floor windows have slightly curved heads with pronounced keystone and soldier brick. The roof is hipped and covered with grey slate and has two chimneys, there is a bracketed cornice below the projecting roof (**Plate 63**). The northern aspect looks out onto the railway platform with a bricked-up door on the eastern side and three windows on the lower and upper floors. There is an entrance on the east side with two windows either side and three windows on the upper floor. The west side has two doorways, the southernmost has been bricked-up and there are three windows on each of the floors. The southern aspect has a bricked-up doorway, two windows on the ground floor and three on the upper floor.

- 4.4.10 The Station (**BH3**) is **recommended** as being likely to meet the listing screening criteria as it reflects an architectural style which is rare in Kent and South-East Rail Line. The station also forms part of the early stage of the second phase of the development of the railway industry and as it is relatively unaltered. The building also displays a strong character which may have influenced other buildings within the local area.
- 4.4.11 In advance of any redevelopment of the building it is recommended that a more in-depth investigation is conducted to establish if any of the original station features remain internally and what condition they are in. Archival research may provide historic photographs of the station.

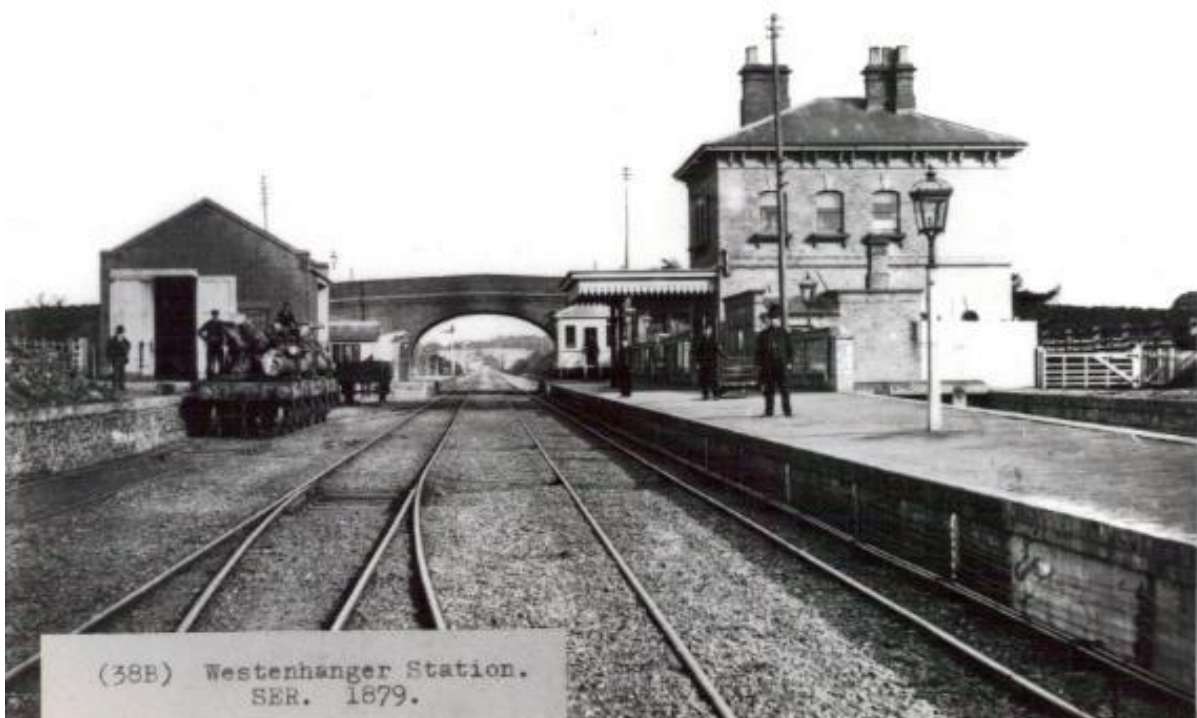
Plate 64: Westenhanger Railway Station 1879 looking east (Warrenpress 2017)

4.4.4 The first depiction of the station occurs on the 1871-1883 1:2500 OS map, here the station building has an annex to the west and a protruding shelter at the platform (Plate 64). There also appears to be a small porch on the east side of the main rectangular building. Surrounding the building is what appears to be a loading or yard area with a trackway approach from Stone Street.

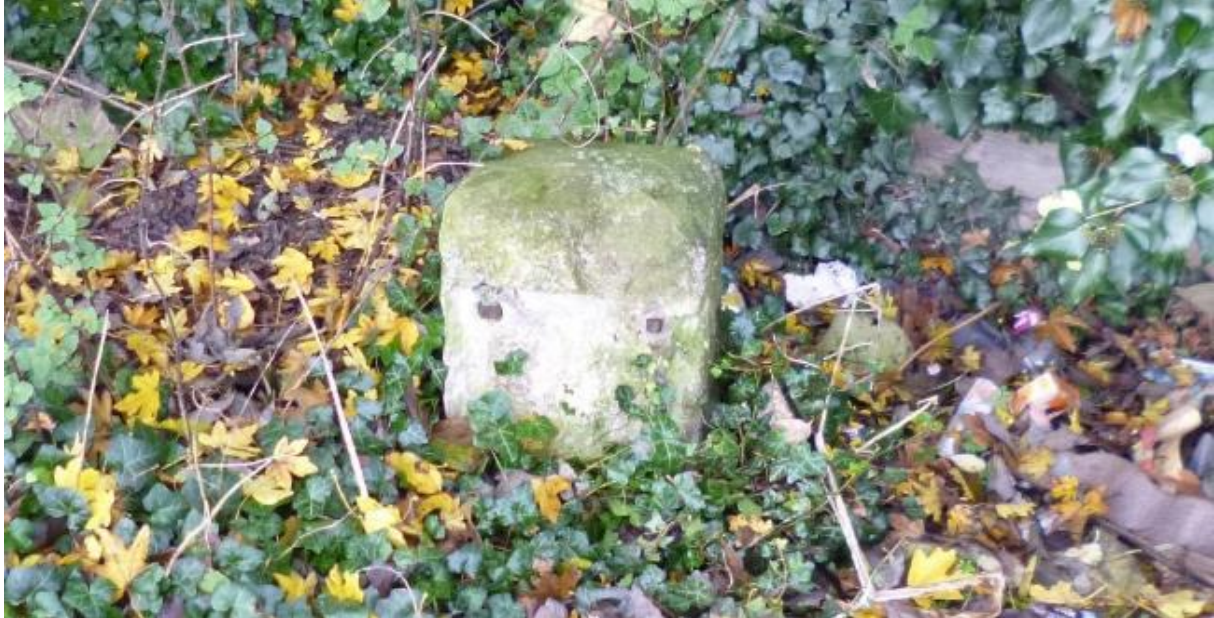
Plate 65: Milestone (WS4), looking south-west

- 4.4.12 The milestone or marker is constructed out of sandstone and is heavily decayed due to weather erosion. It lies just south of Barrow Hill on the A20 near a slight curve in the road and is surrounded by vegetation. The writing on the stone is no longer legible (**Plate 65**).

- 4.4.16 It is **not recommended** that the milestone is likely to meet the listing screening criteria as it is in a poor condition and no longer legible and there are others present within the wider area.

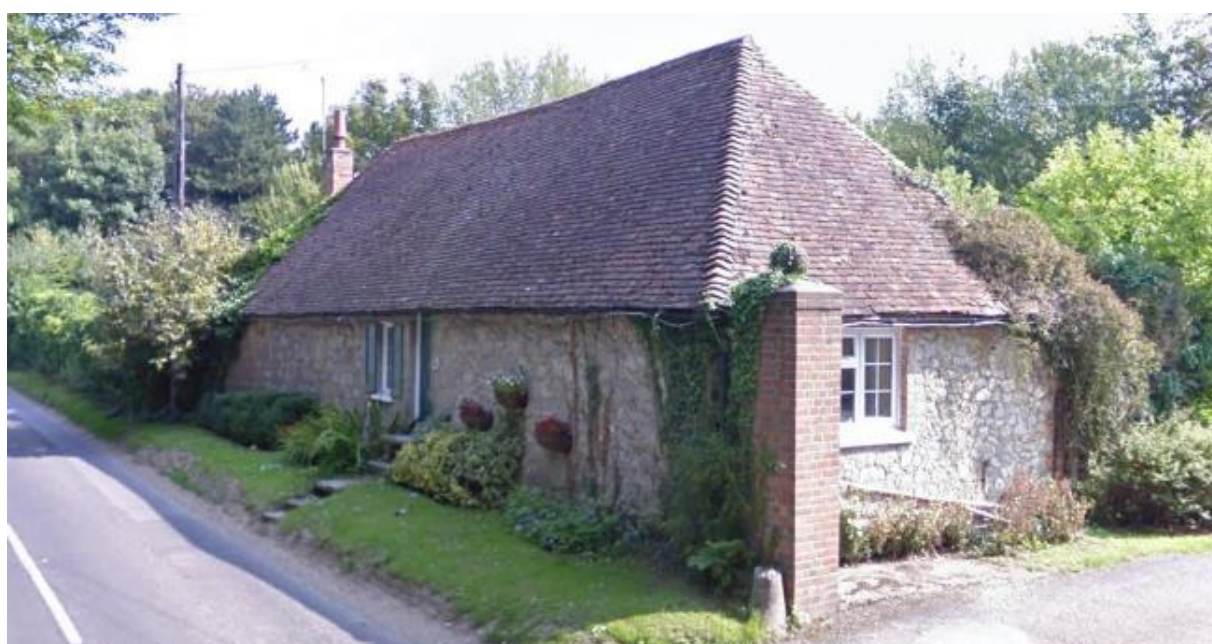
Plate 66: Otterpool Cottage (WS24) looking north north-east (Google Street View 2017)

4.5.3 Otterpool Cottage (**WS24**) is a single-story building constructed out of sandstone with shaped grey sandstone around the door and windows. There is a single rectangular window framed in white with green shutters and a slightly projecting white window sill. To the south of this is a door which is also green with six small infilled panels below and nine clear glass panels above (**Plate 66**). There is a stadler-stone in front of the door which restricts access. To the north of the window is a blocked-up aperture. At the southern end of the building is a pillar of red bricks with a spherical finial. Along the southern side of the building is a wide rectangular window framed in white with horizontal red bricks along the edges and a white window sill. The roof is hipped with red tiles and a single chimney stack at the northern end (**Plate 66**).

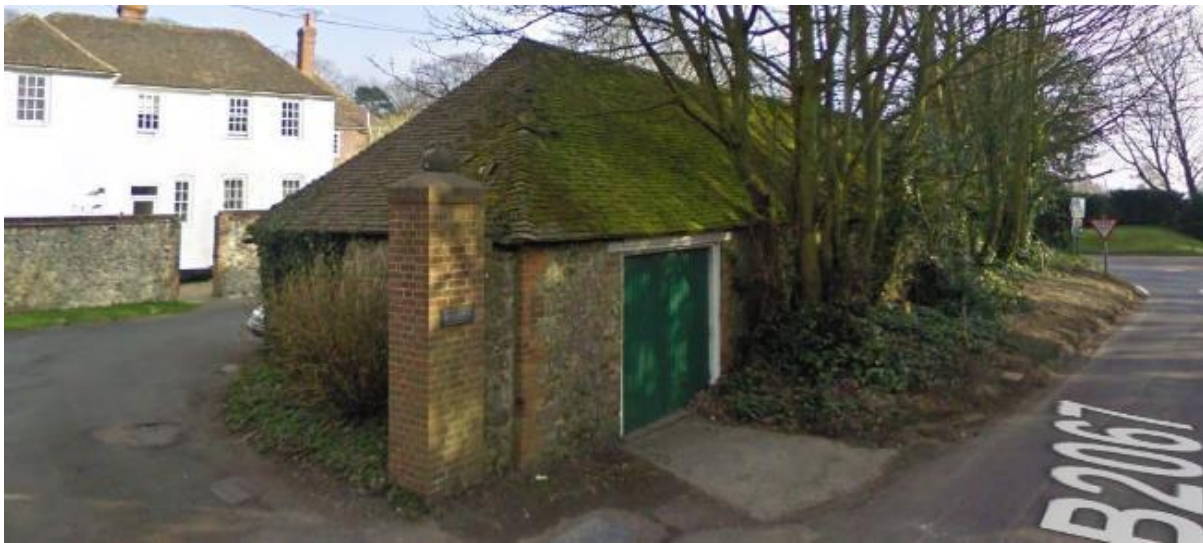
Plate 67: Outbuilding at Bell Vue (**WS6**) looking south-east (Google Street View 2009)

- 4.5.5 Outbuilding at Bell Vue (**WS6**) is longer than Otterpool Cottage (**WS24**) and forms a very similar single storey building constructed in pale sandstone uneven blocks, which are smaller and of a different colour to the northern barn. On the north-west corner, there are vertical line of crenelated red bricks. Attached to this is a small wall that joins to a redbrick pillar topped with a carved or mould stone finial. Just to the south of these features is an additional floor to ceiling entrance way into the lodge. The entrance is wide and green in colour with a white surround, along the vertical sides are some pale red/brown horizontal bricks (**Plate 67**).
