# OTTERPOOL PARK

# ENVIRONMENTAL STATEMENT

Appendix 9.5 – Historic Buildings and Structures Appraisal,  
Addendum 2022

Appendix 9.5 – Otterpool Park Historic Buildings and  
Structures Appraisal, 2017

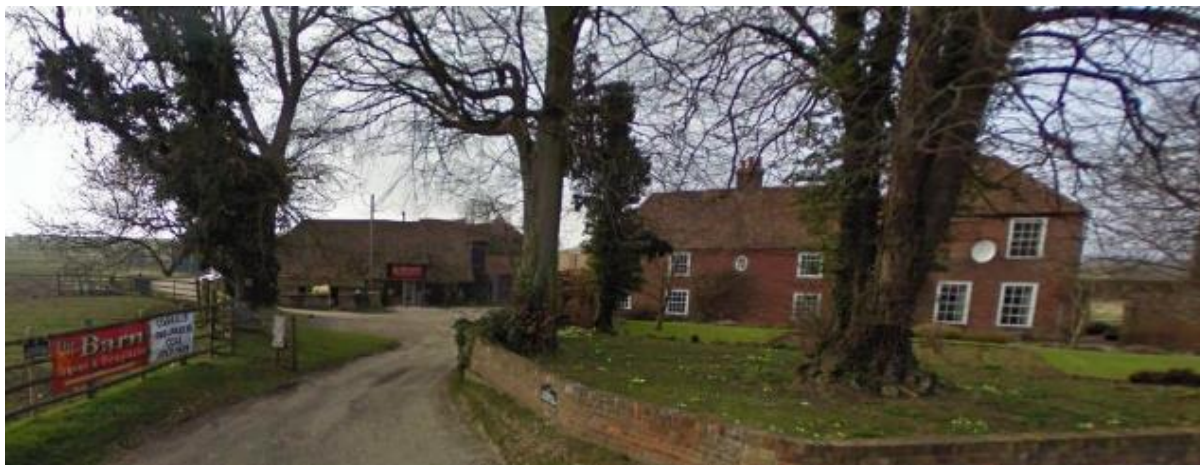
Plate 68: View of Medieval Barn at Otterpool Manor (**WS8**) and Otterpool Manor (**LB38**) from Otterpool Lane (Google Street View 2017)

- 4.5.11 The barn is built mostly of red brick in English Cross bond with a red tile roof (**Plates 68, 69, 70**). There is some ragstone in the north of the barn at ground level forming 3-4 courses (**Plate 70**). The doors and windows are wooden with some cladding in evidence on the former hayloft access/loading door and in the central portion of the structure (**Plate 70**). A large barn door is still present on the east side of the structure but there is no sign of a corresponding threshing door on the west side.

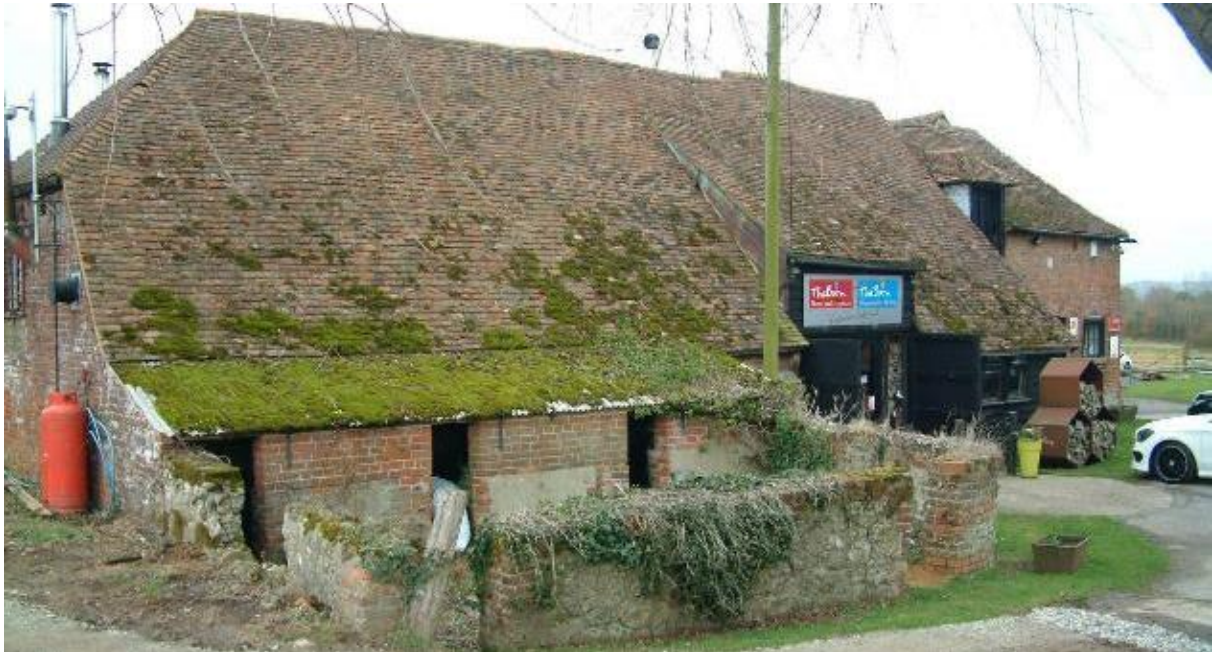
Plate 69: Medieval Barn at Otterpool Manor (WS8) viewed from the southeast.

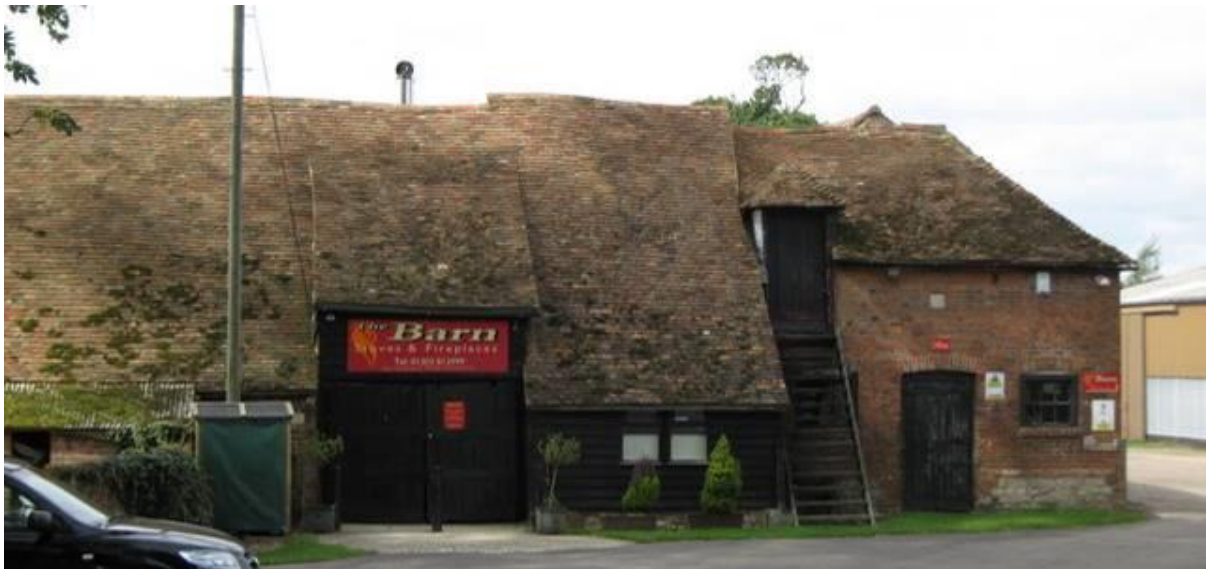
Plate 70: The Barn viewed from the east (Geograph.org, No Date)

4.5.14 To the north of the 'main' barn is a second building which abuts the northern gable of the 'main' barn. The structure is two storeys and appear to comprise a stable or storage barn below and a hayloft above. The structure is built of red brick with a hipped red tile roof and wooden fittings. The ridge line is approximately 1ft lower than that on the northern end of the 'main' barn (**Plate 70**). There is some brick detailing above the

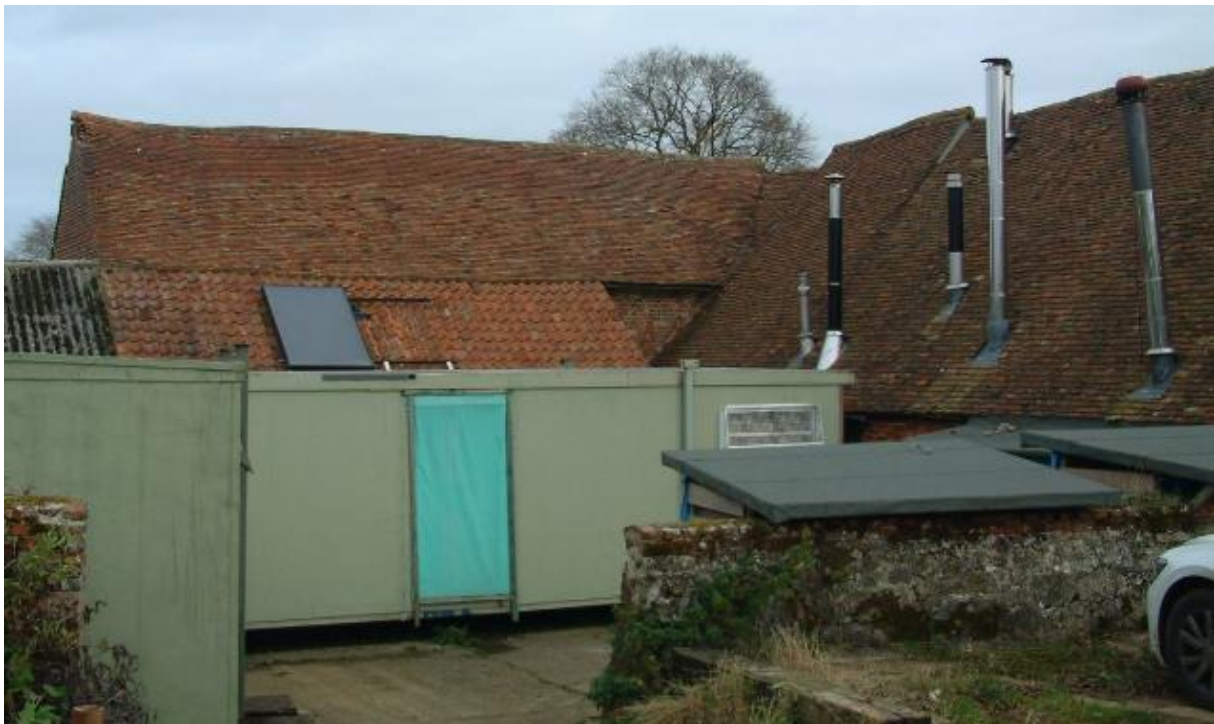
- 4.5.16 Set at right angles to the northern building of the eastern range, a further barn forms the northern range of the L-shaped plan. This barn is constructed on red brick in running bond with a red tile roof, the roof ridge is slightly higher on this barn than on the northern structure of the eastern range. Fittings appear to be painted wood. Further modern additions have been made to the south and west of this barn (**Plate 71**) which appear to be of little interest.

Plate 71: Rear view of Medieval Barn at Otterpool Manor (*WS8*) looking northeast.

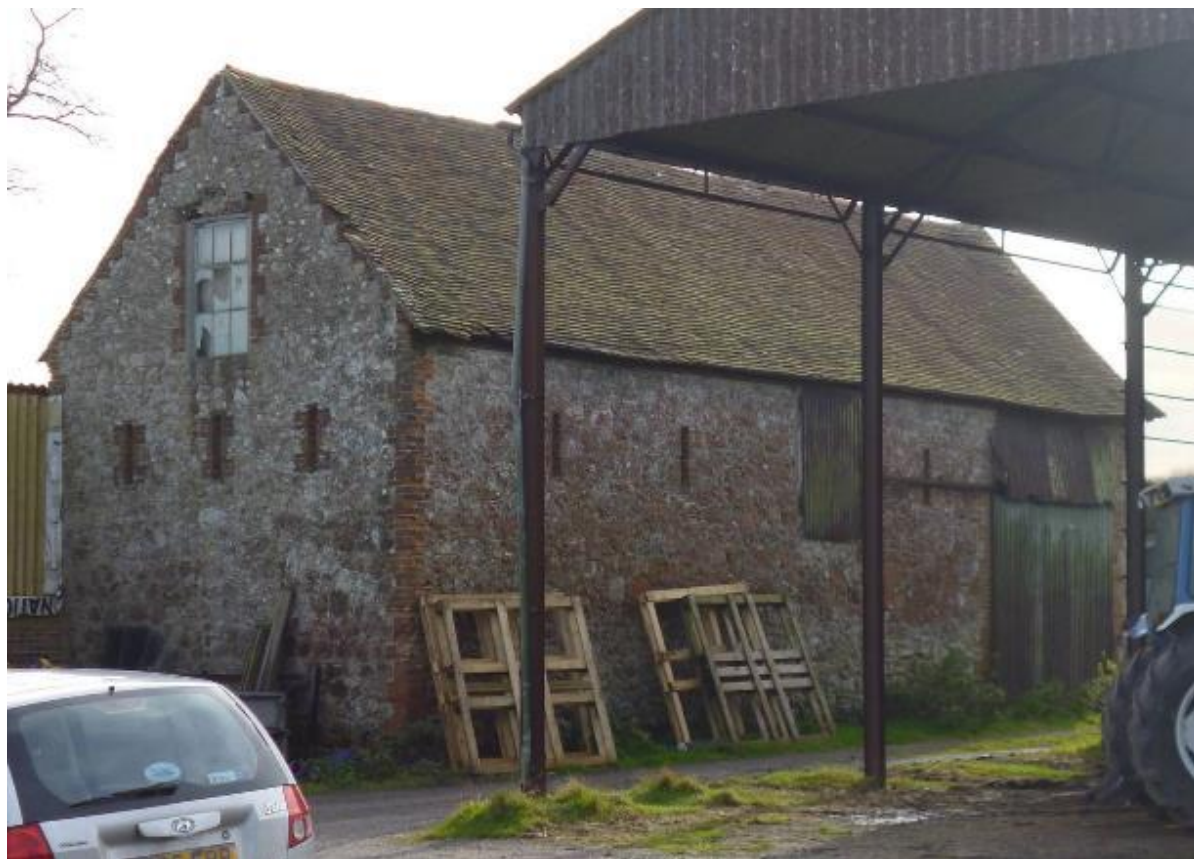
Plate 72: Mid-19<sup>th</sup> century ragstone barn with red brick quoins and detailing to the west of the Barn (WS8).

- 4.5.24 The L-shaped barn has group value with both Otterpool Manor (**LB38**) and Upper Otterpool (**LB20**), as well as the ragstone barn to the west. Its main setting comprises the surrounding farmland, which is slightly impacted by the presence of later 20th Century agricultural buildings.

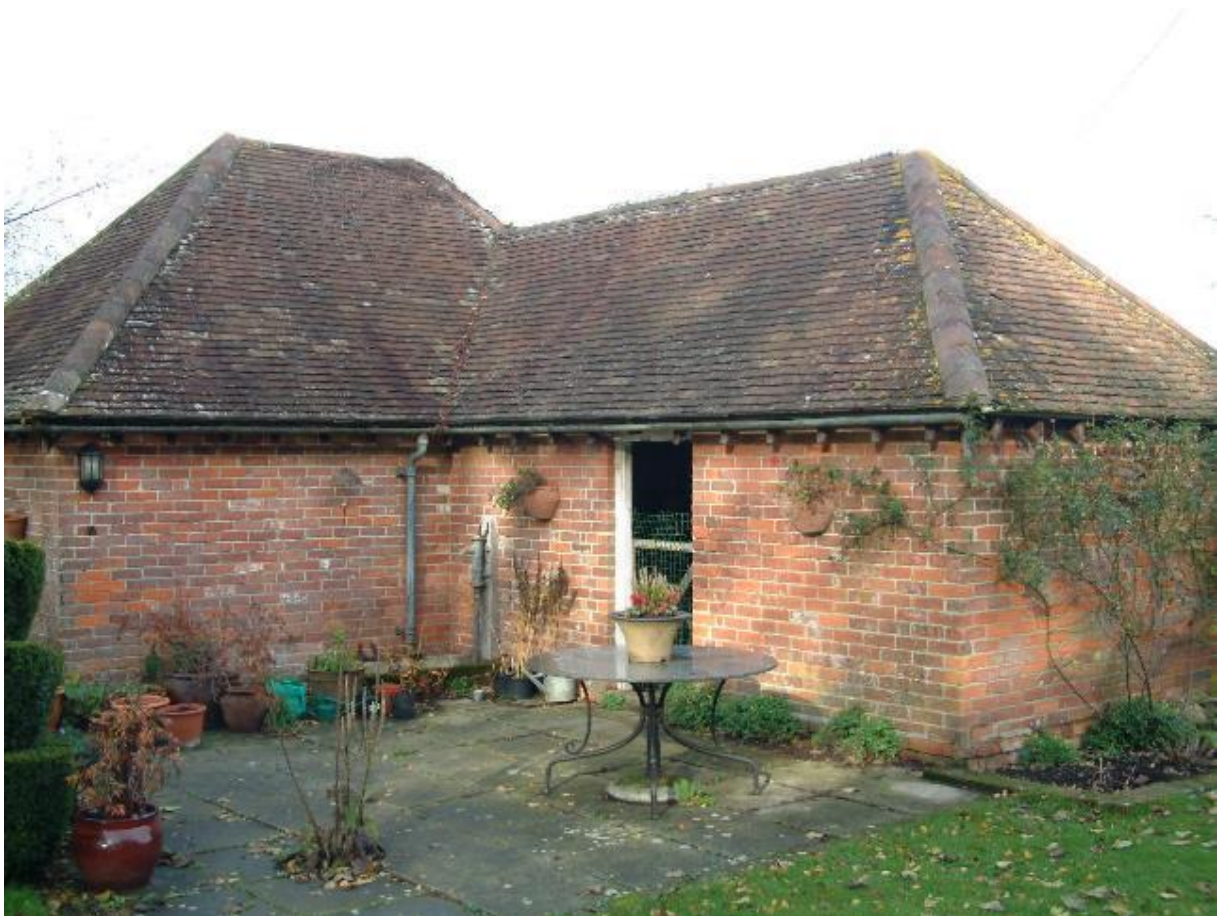
- 4.5.29 The pigsty is a single story red brick squat L-shaped building constructed in stretcher bond with a hipped roof clad in brown tiles. Behind and supporting the grey guttering is a row of projecting dentil bricks. Repair work can be seen, from a slightly different red brick and mix match in the bond, on the southeast side. In the corner of the L-shape is an old water metal water pump and trough, it is unknown if this is an original feature (**Plate 73**).

Plate 73: Pig Sty at Upper Otterpool looking north

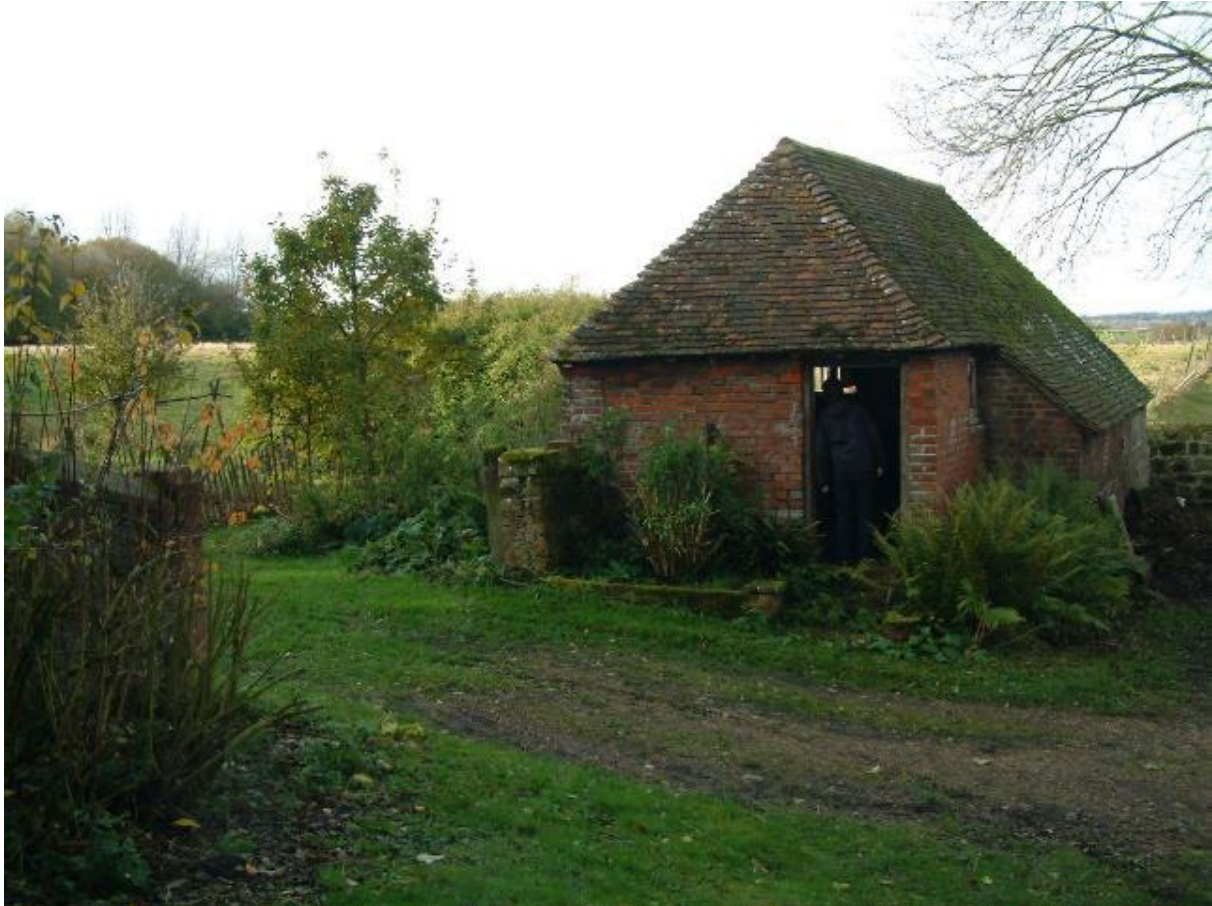
*Plate 74: Second barn at Upper Otterpool*

4.5.30 A second outbuilding at Upper Otterpool exhibits likely aspects of early post-medieval character including timber-framed construction and a catslide roof (**Plate 74**).
