# OTTERPOOL PARK ENVIRONMENTAL STATEMENT

## Appendix 10.1 - Ground Conditions Report

## Otterpool Park ES - Appendix 10.1 - Ground Conditions Report

Report No OP\_ARC\_610\_RP\_EN\_D01

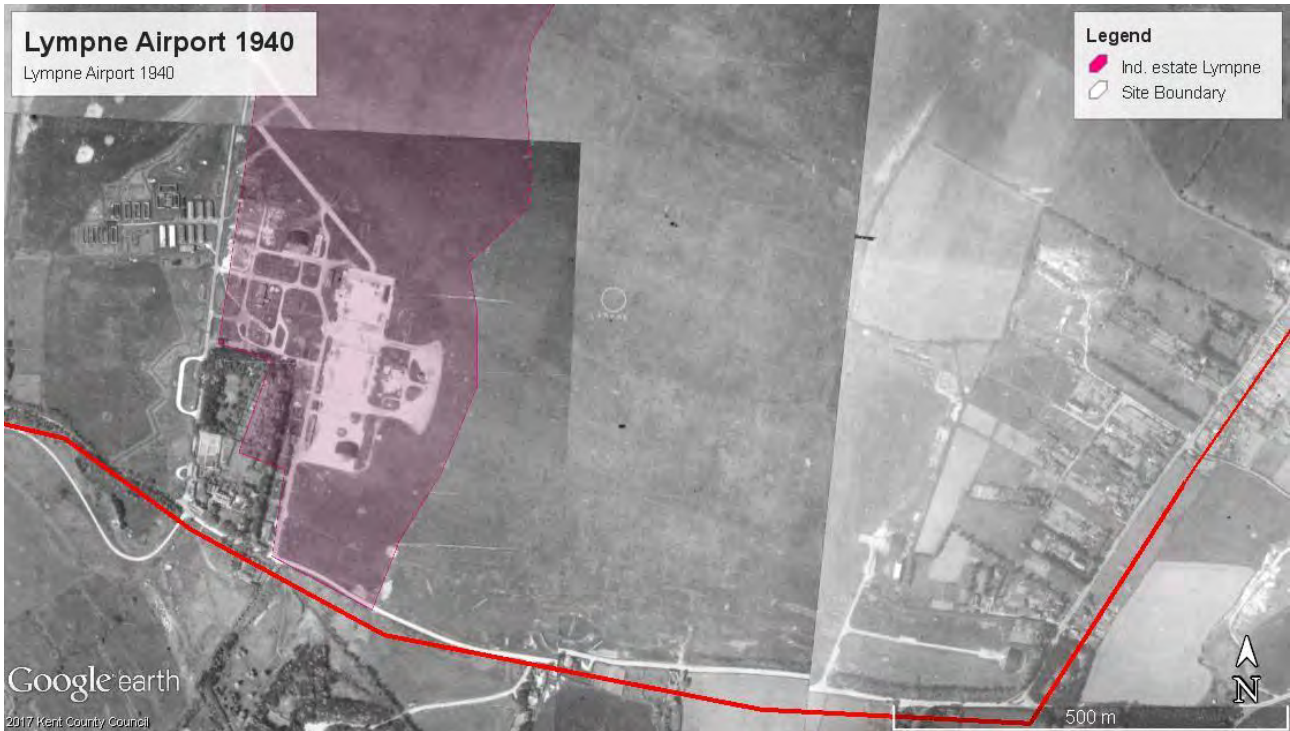
Figure 5 – Aerial photograph of Lympne Airport 1940 with Framework Masterplan red line boundary and current extent of industrial park [8]

Figure 6). The huts to the east of Otterpool Lane (currently derelict, Section 2.2.2) are shown in aerial photographs from 1940 to 1990, some having been demolished over time. Paved runways are not shown until 1990 (Figure 7) when they appear in their current (partly demolished) layout.

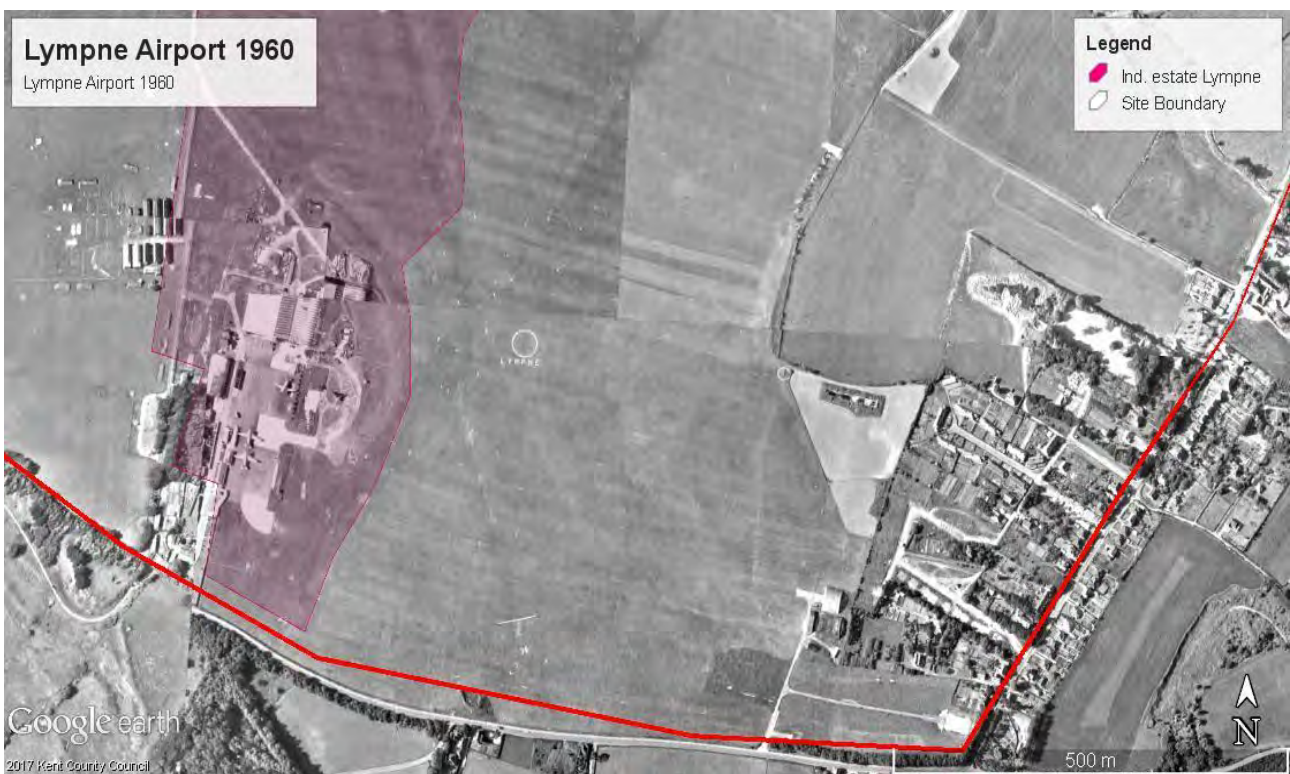
Figure 6 – Aerial photograph of Lympne Airport 1960 with approximate Framework Masterplan red line boundary and current extent of industrial park [8]

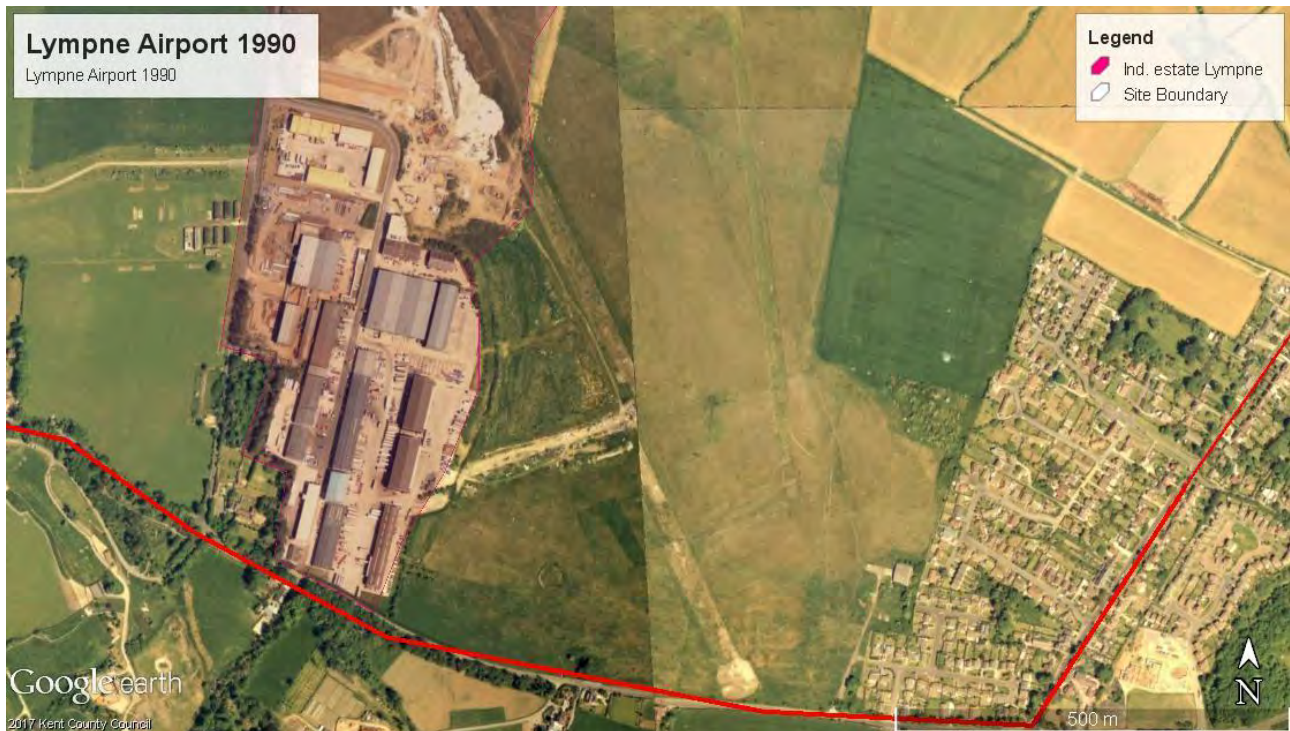
Figure 7 – Aerial photograph of Lympne Airport 1990 with approximate masterplan red line boundary and current extent of industrial park [8]

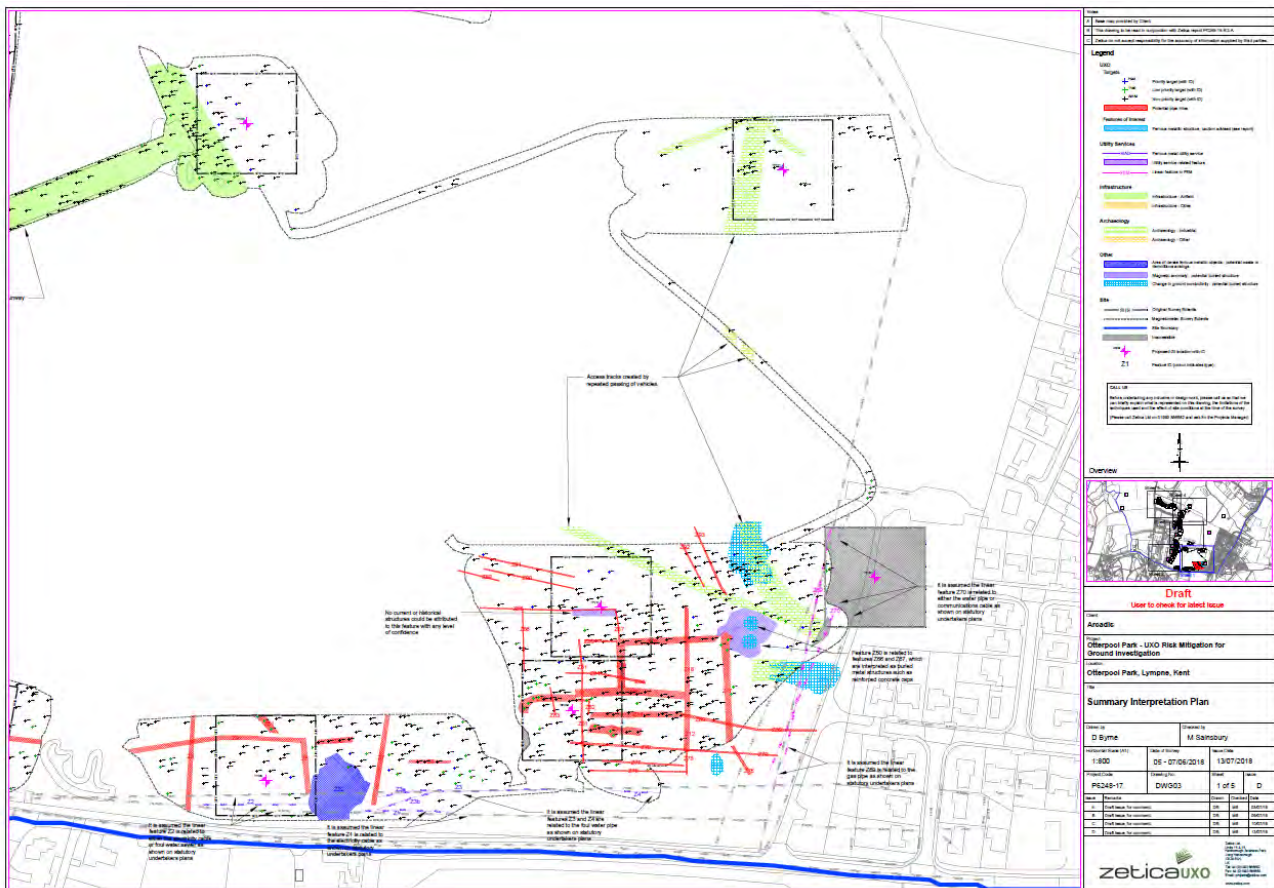
- Phase 2 exploratory holes were moved a minimum of 20 m from potential pipe mines; and,
- No magnetic anomalies indicative of potential UXO were detected with the down-hole magnetometer during drilling of the window samples and boreholes.

Figure 10: Extract from Zetica drawing P6248-17-DWG03-D Summary Interpretation Plan (Appendix E)

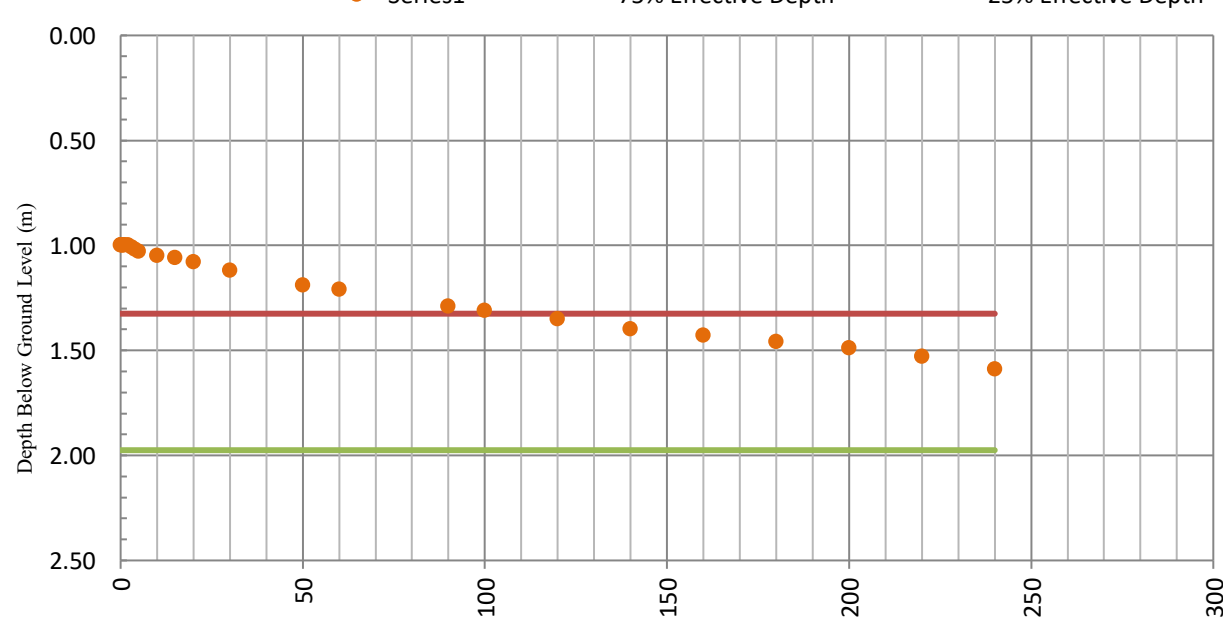
Infiltration Rate =  $8.69 \times 10^{-6}$  m/s

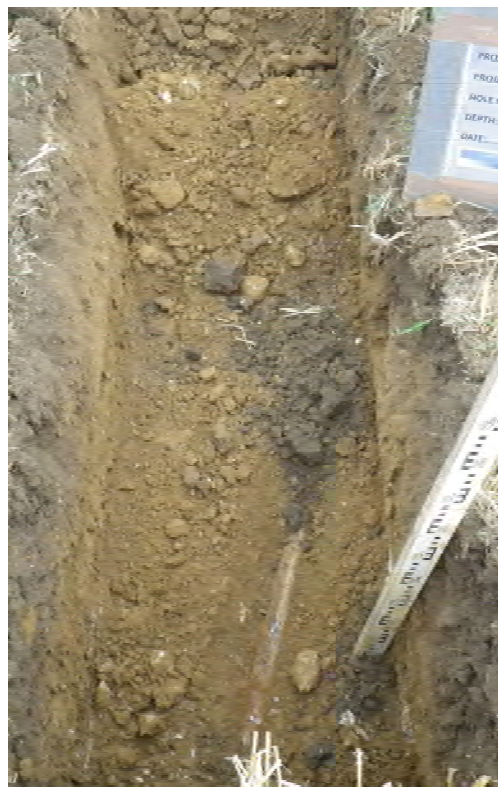
<p><b>PLAN DETAILS</b></p> <p>Long Axis Orientation: 20</p> <p>Shoring / Support: None</p> <p>Stability:</p> <p>Groundwater (description):</p>	<p><b>Remarks</b></p> <p>Terminated due to metal pipe found at a depth of 0.65 mbgl. CAT picked signal on power and radio mode.</p> <p style="text-align: right;">Termination Depth: <b>0.65m</b></p>
--	---

[TRIAL PIT NUMBER 219: METAL PIPE]
