II Manor House

2.6.2 OUTER COURT

16 East–West Barn

17 North-South Barn

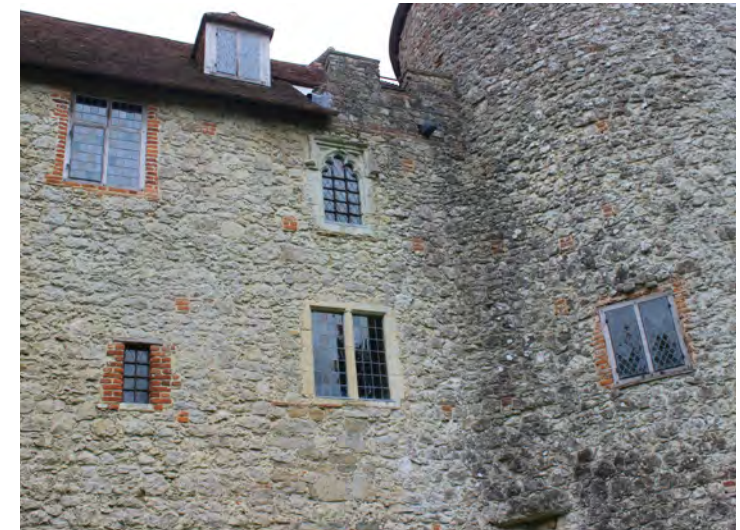
Figure 47: Detail of the east elevation of the rear wing showing several altered windows, as indicated by the later red brickwork, as well as an older mullioned window and a 14th century cinquefoil-headed light above

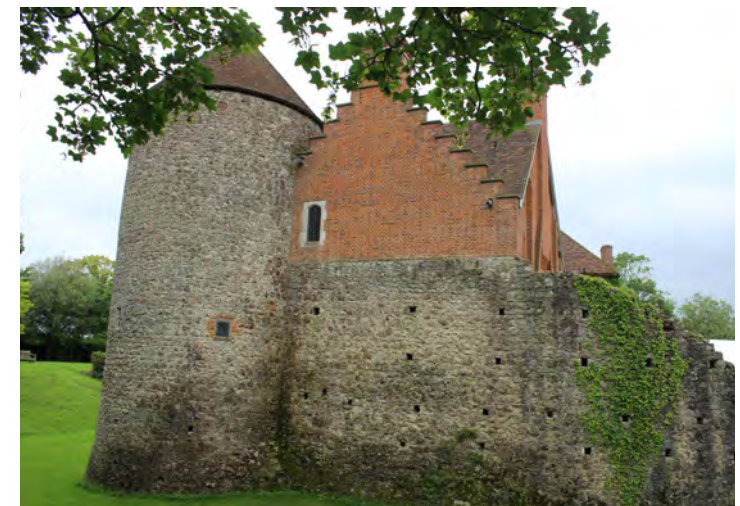
Figure 49: View of the north-east tower from the north showing an original window on the left and a modified window on the right

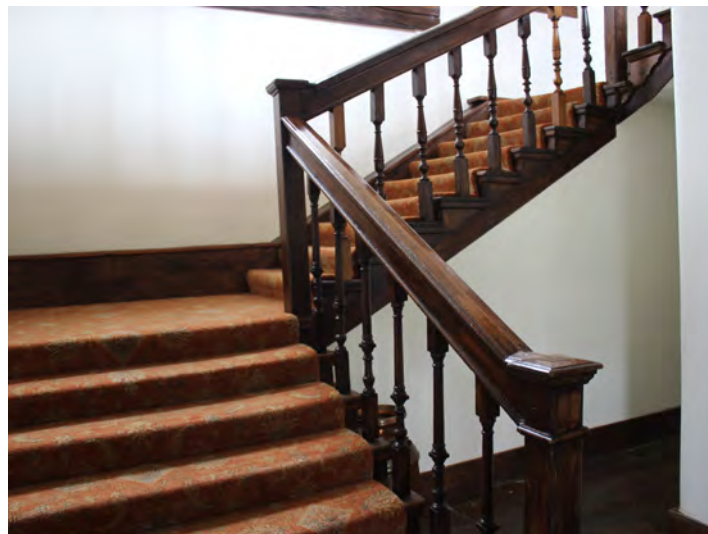
Figure 54: Historic staircase, potentially including 16th century fabric

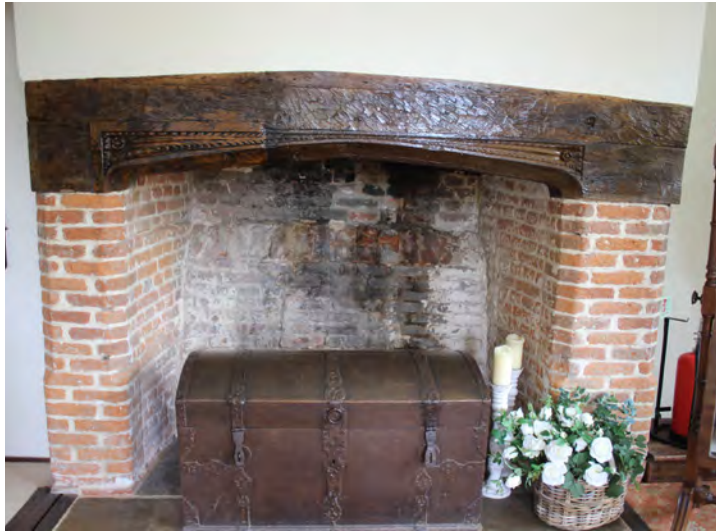
Figure 56: 15th century chamfered brick fireplace with arched wooden bressummer and carved spandrels at first floor

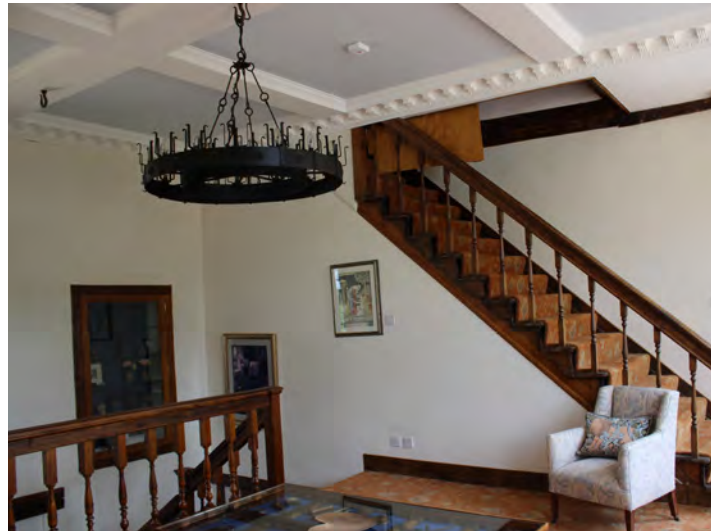
Figure 57: First floor landing and stairwell

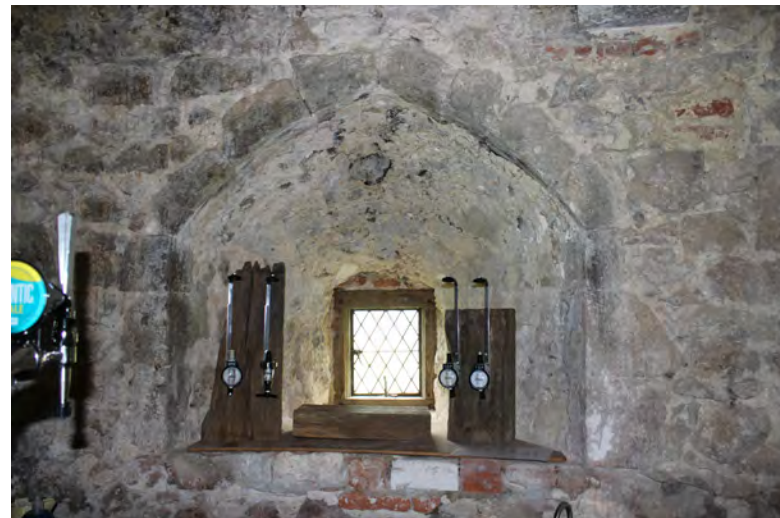
Figure 68: Modified window in north-east tower

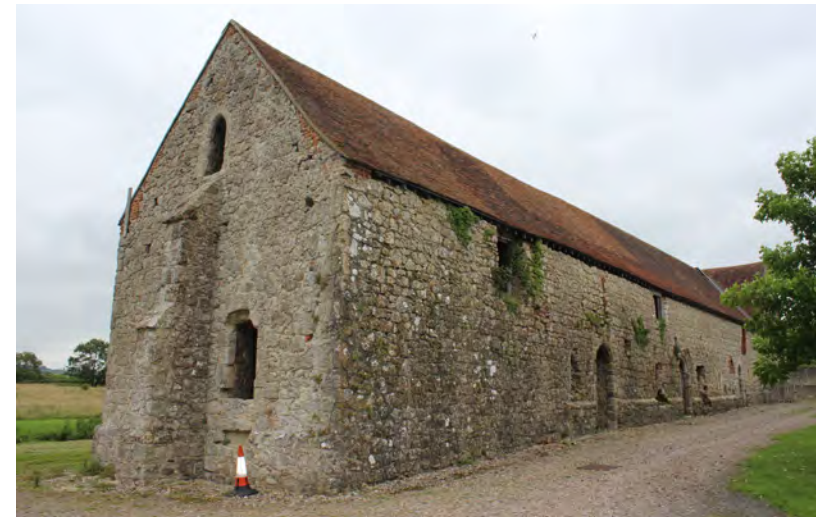
The west gable end features a central buttress on a chamfered plinth and a pointed arched chamfered upper window and a chamfered, but not pointed, window at lower level. The gable shows signs of reconstruction evidenced by red brick additions. The east gable end, complete with stone base plinth, can be seen from the inside of north-south barn.

Figure 84: View of the west gable end and south elevation looking north-east

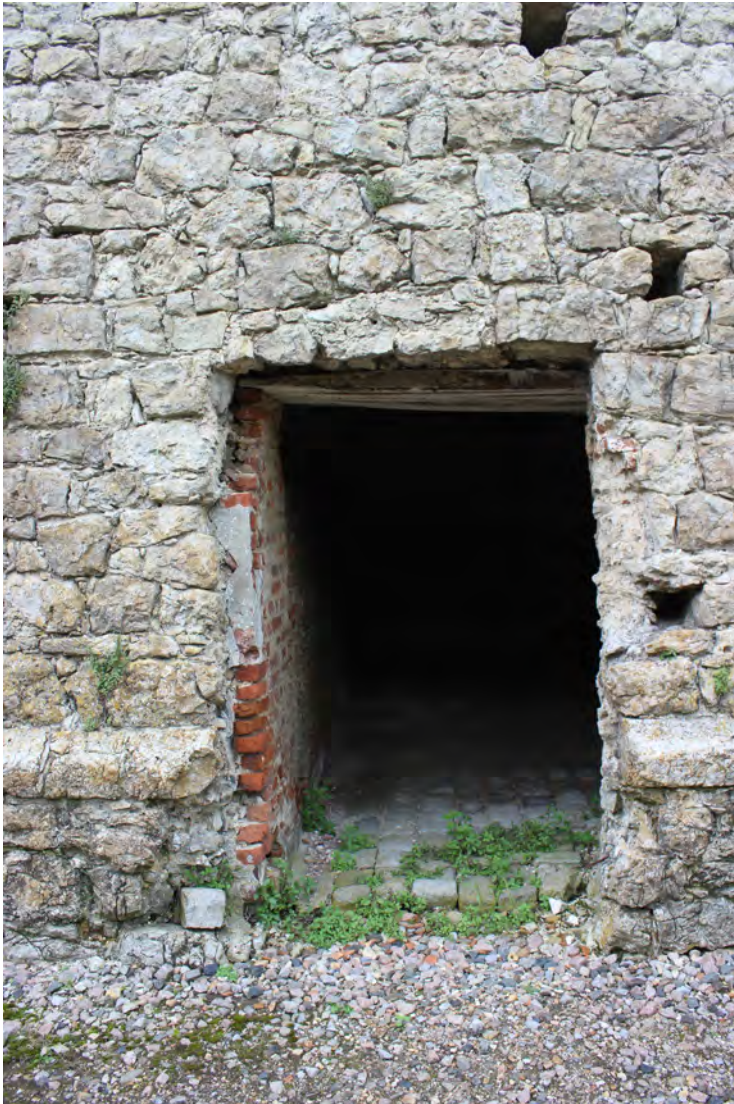
Figure 86: Later inserted doorway featuring a flat arch and later brickwork

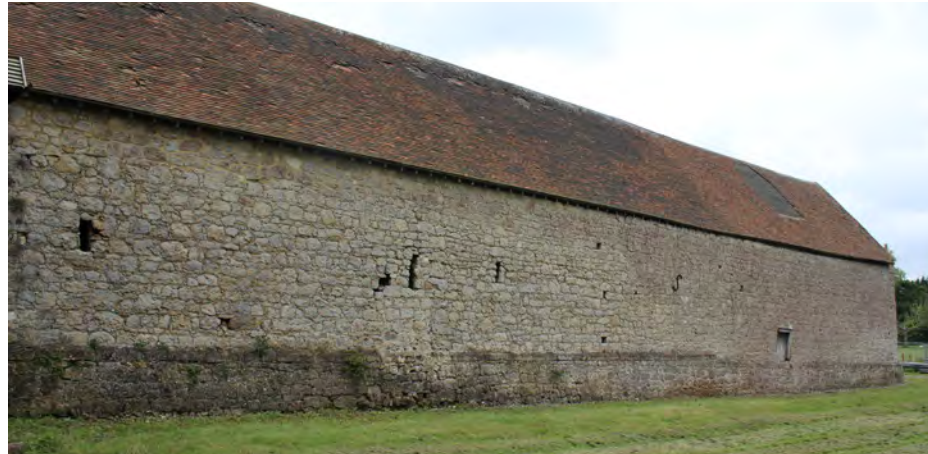
Figure 87: View of the north elevation looking south-west showing later ventilation slits and openings

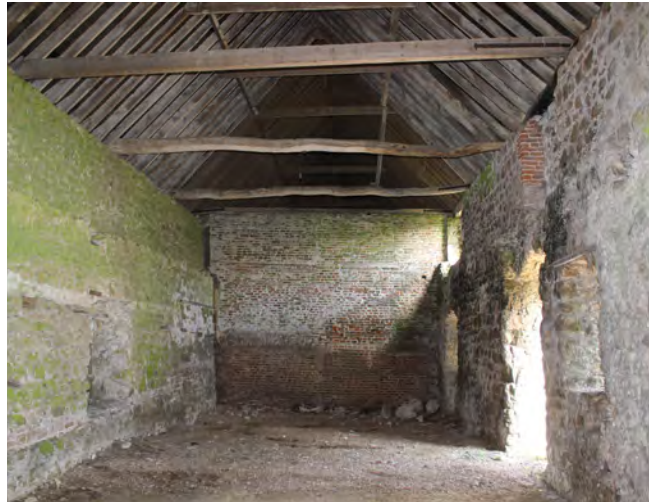
The barn is in disrepair and its condition is deteriorating; walls are leaning and cracked in places, ivy is eroding features and the timber joist floor to the loft is unsound.

Figure 90: View of the west room looking east showing a later brick partition

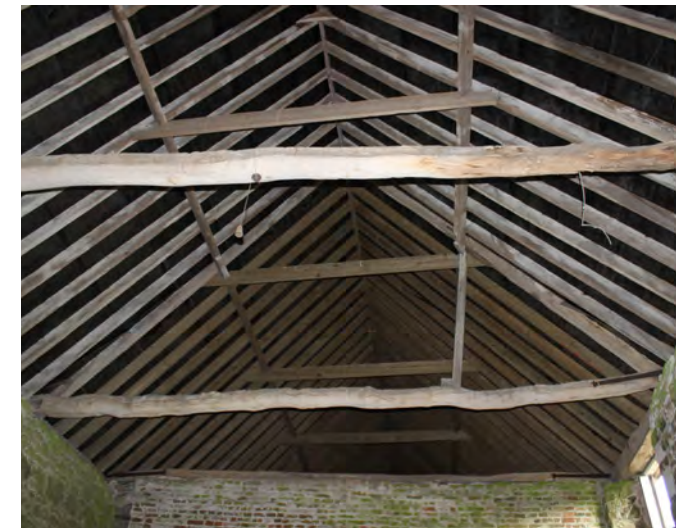
Much of the roof-structure has undergone modern alteration, although some historic timbers survive.

Figure 93: Roof structure in the west room showing largely modern timbers

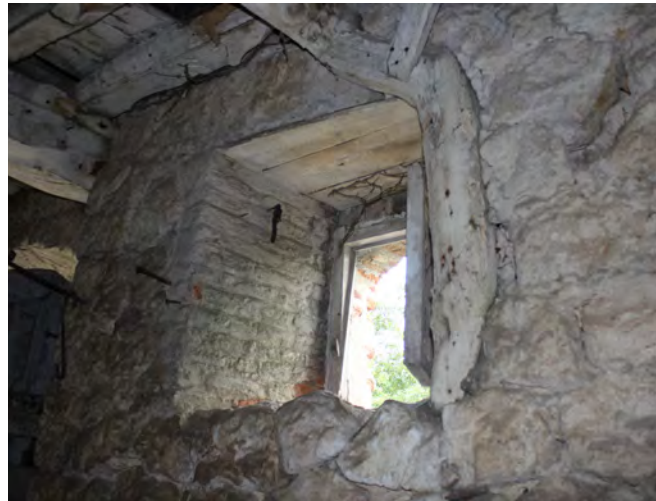
Figure 98: Internal view of a later window as indicated by the brick and timber construction around the opening

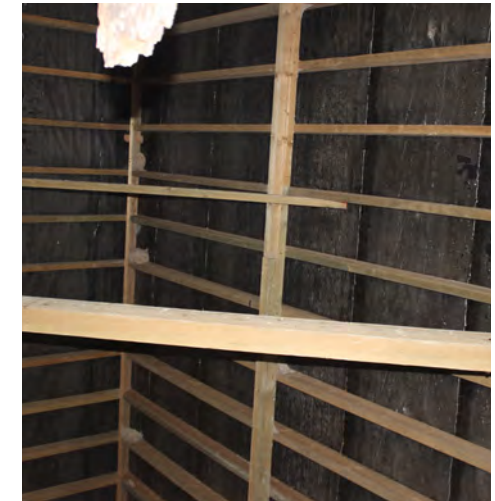
Figure 100: Detail of the largely modern roof structure at the east end of the building

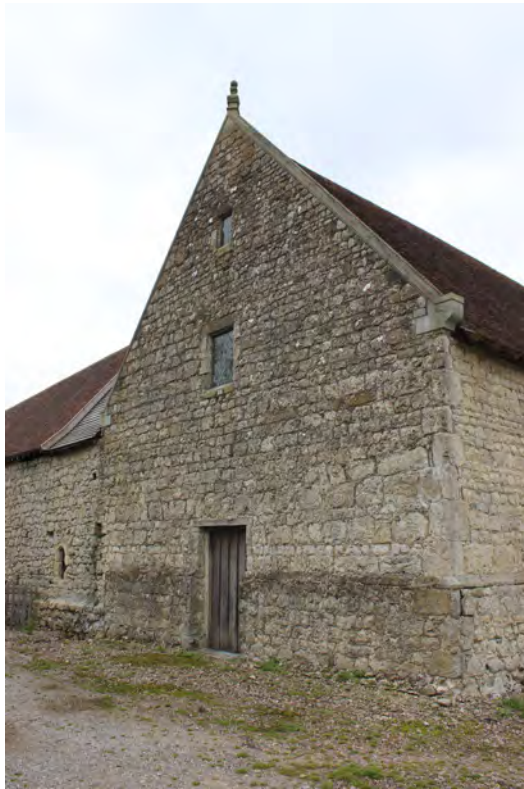
Figure 105: View of the south gable looking north-west showing the original window openings and the later doorway below

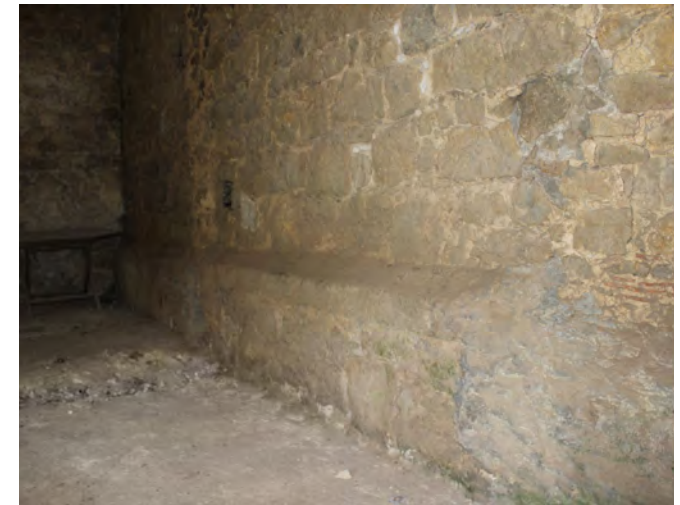
The barn interior is a large open space without subdivisions or internal supports. The west wall of the earlier east-west barn is visible at the south end of the barn, where the wall bulges inwards and features a stone base plinth, like that around the rest of east-west barn. There is an 11-bay hammerbeam roof with bevelled arch braces to the hammer-beams springing from pendant posts resting on dressed stone corbels. Hammer-posts terminate in collars which carry queen-struts to higher collars. There are two tiers of aligned butt purlins, one with windbraces, below lower collars, and one without windbraces just above upper collars. Each bay has six common rafters, morticed into purlins. The entire structure is pegged together.

Figure 112: Detail of the east elevation of the east-west barn, featuring its distinctive stone plinth, projecting into the later north-south barn. This is a reminder of the construction sequence of the two barns, indicating the north-south barn was added on to the end of the earlier east-west barn.
